2023-08-04-WTM 250L Hydraulic Oil

GN reference #: 2023-330

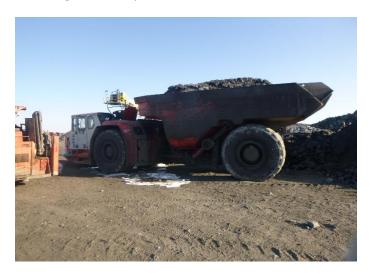
A haul truck experienced a hydraulic hose failure while dumping its load, resulting in an accidental spillage of 250L of hydraulic oil on the ground at the underground ore pad.

Hydraulic Hose Failure

A comprehensive investigation was undertaken to ascertain the root cause of the hydraulic hose failure. It was determined that the introduction of a foreign object, specifically a rock, between the equipment and the hose, resulted in the premature degradation of the component due to friction caused by vibration. These findings were subsequently communicated to all equipment users, with a strong emphasis on the necessity of conducting visual inspections following loading, in strict adherence to the established procedure.

The operator immediately shut down the equipment and called a mechanic to carry out the necessary repairs. Spill pads were deployed to contain the oil, and the contaminated material was collected and transported to the Whale Tail landfarm for proper handling and disposal.
