## 2023-10-02-WTM 200L Hydraulic Oil

GN reference #: 2023-420

Please find the following information as a follow up to the Spill report submitted October 2<sup>nd</sup>, 2023, by Agnico Eagle Meadowbank division. This detailed report is submitted to the Inspector in compliance with the conditions under the Nunavut Water Board License 2AM-WTP1830, Part H, Item 8c.

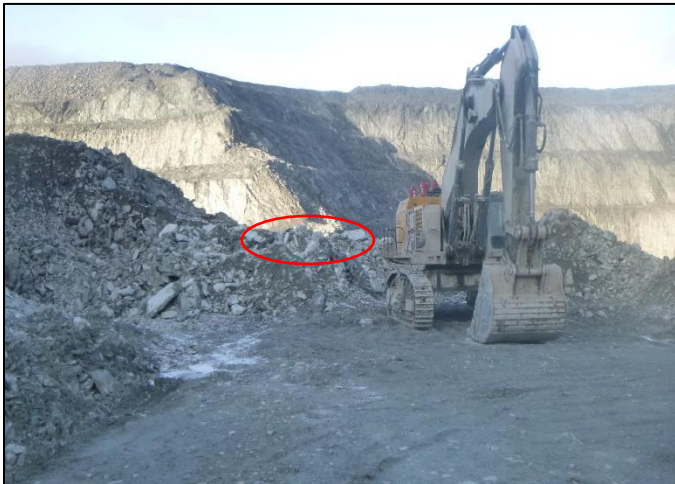
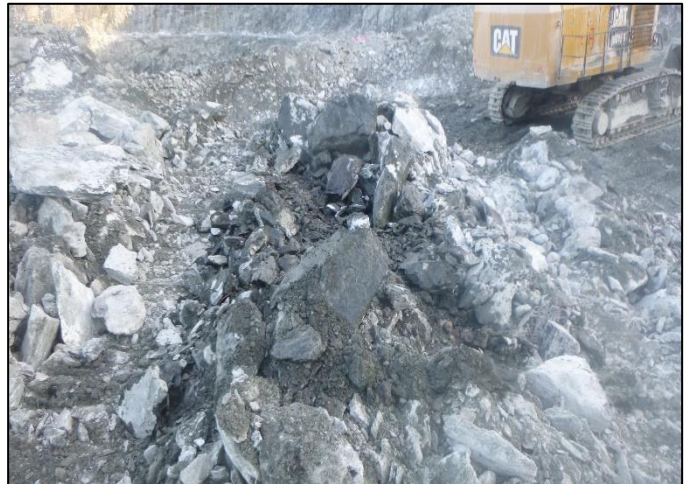
During operations at the Whale Tail Mine, an excavator suffered a hydraulic component failure while loading equipment, causing 200 liters of hydraulic oil to spill onto the ground at the bottom of the IVR pit. The spill occurred in an area of active excavation within the IVR Pit.

Hydraulic Hose Failure
