2023-10-05-WTM 300L Hydraulic Oil

GN reference #: 2023-424

Please find the following information as a follow up to the Spill report submitted October 6th, 2023, by Agnico Eagle Meadowbank division. This detailed report is submitted to the Inspector in compliance with the conditions under the Nunavut Water Board License 2AM-WTP1830, Part H, Item 8c.

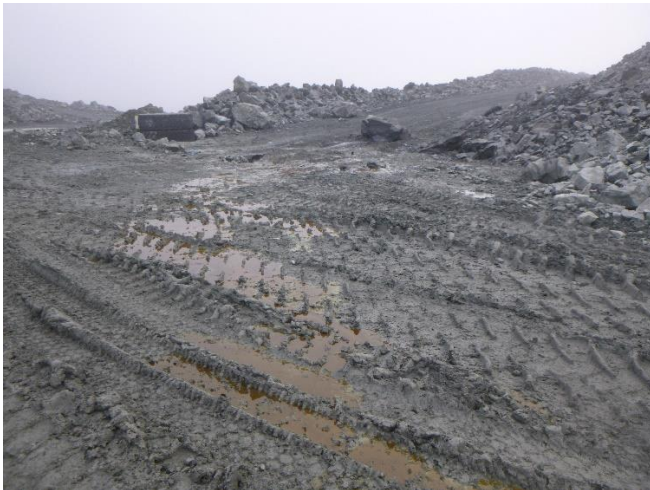
During operations at the Whale Tail Mine, a haul truck ran over a large rock as he was heading to the stockpile. This cause the hydraulic hose to disconnect from the equipment, causing 300 liters of hydraulic oil to spill onto the ground at the Pad K.

Damaged Hydraulic Hose.

A comprehensive review of the incident and investigation was conducted involving all crews. Subsequently, a reminder was issued to all crews that bumpers should be used to block any road or ramp instead of boulders.
