2023-10-11-WTM 1000L Diesel Exhaust Fluid

GN reference #: 2023-428

Spill Description

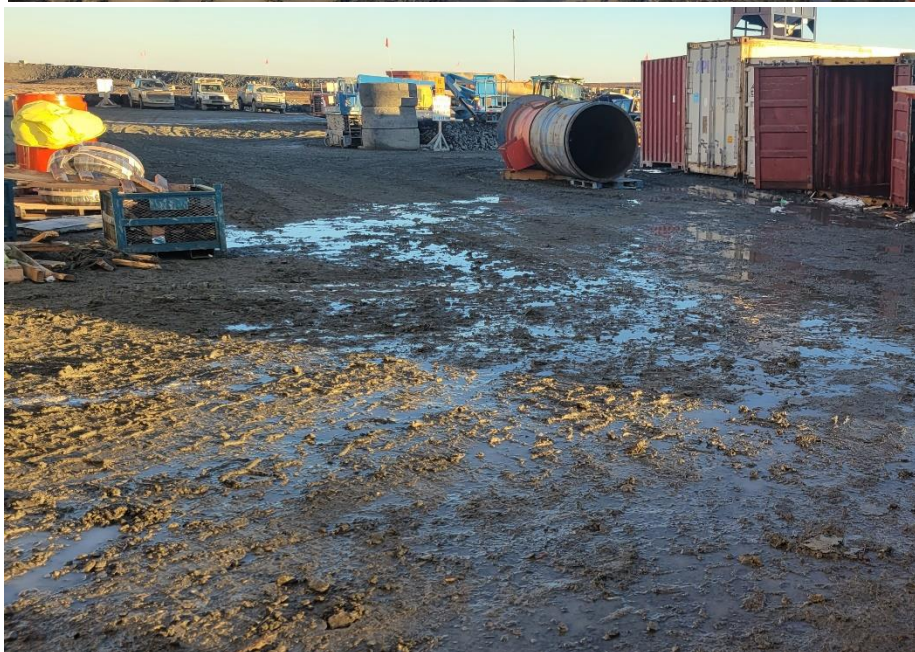
Spill Location: N 65°24'21.63 W 96°40'50.24 on IOL

During operations at the Whale Tail Mine, an operator was trying to move a tote with a forklift, but due to bad visibility caused by the sun, the tote was punctured causing a spill onto the ground.

There were no off-site impacts or discharges. Distance to the closest water body is 940 m to Whale Tail South Lake.

Human Error - Punctured tote caused by misalignment of the equipment forks with no spotter present.

Spill pads were placed on the ground and an excavator was used to scrape and remove the contaminated material. Contaminated material was collected and disposed of in the Meadowbank TSF.

A procedure has been implemented on site since August 2023 for handling totes and barrels with forked equipment. A comprehensive review of the incident and a reminder regarding the tote handling procedure were provided to the crews. The operator received further coaching regarding the task and procedure.
