2023-11-20-WTM 300L Diesel Fuel

GN reference #: 2023-502

Spill Description

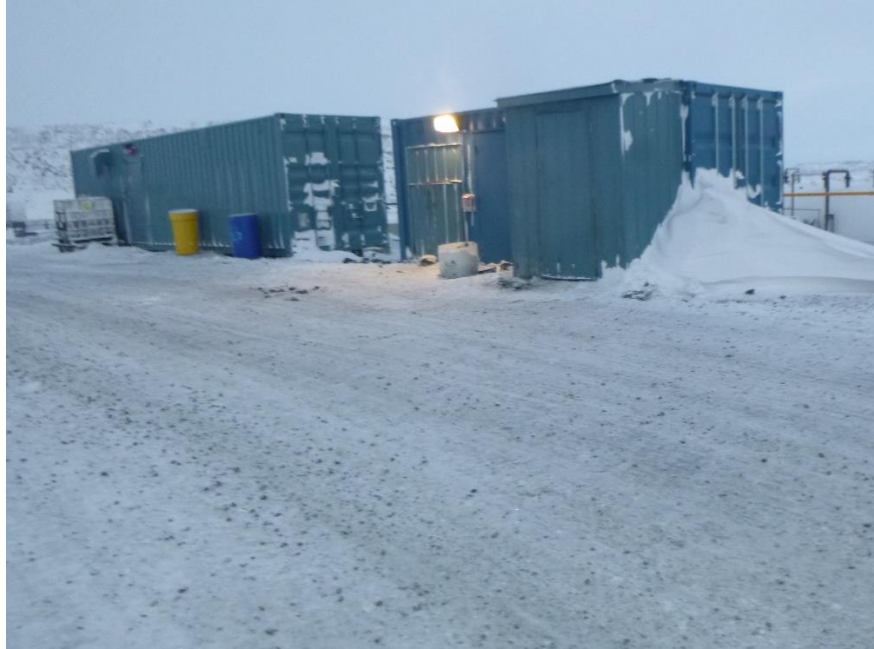
Once noticed, the emergency spill kit was deployed. The contaminated material was collected and brought to the Whale Tail landfarm and the contaminated absorbent material disposed of at the Hazmat.
