GN reference #: 2024-079

Please find the following information as a follow up to the Spill report submitted March 26th, 2024, by Agnico Eagle Meadowbank division. This detailed report is submitted to the Inspector in compliance with the conditions under the Nunavut Water Board License 2AM-WTP1830, Part H, Item 8c.

Spill Description

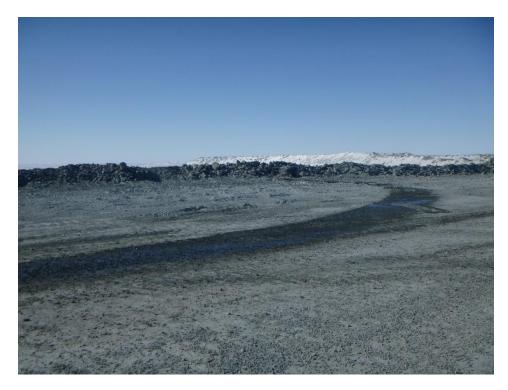
Spill location: 65°24'29" 96°43'12.7"on IOL

During the operations at the Whale Tail Mine, the haul truck's hydraulic system failed while unloading at the Whale Tail Waste Rock Storage Facility. This incident led to the spillage of approximately 200 liters of hydraulic fluid onto the ground of the WRSF. The spill occurred in an active deposition area.

There were no off-site impacts or discharges. Distance to the closest water body is 175 m to Mammoth Lake.
