GN reference #: 2024-120

Please find the following information as a follow up to the Spill report submitted April 23rd, 2024, by Agnico Eagle Meadowbank division. This detailed report is submitted to the Inspector in compliance with the conditions under the Nunavut Water Board License 2AM-WTP1830, Part H, Item 8c.

Spill Description

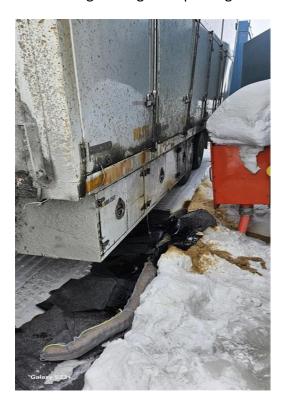
During the operations at the Whale Tail Mine, a lube truck operator noticed a hydraulic oil leak originating from the side compartments of the equipment. Upon further investigation, they found that the hydraulic hose connected to the PTO pump had ruptured at the crimped fitting, leading to the discharge of approximately 150 liters of fluid onto the ground in the underground genset parking.

Spill location: 65°24'22.83" 96°40'54.8"on IOL

There were no off-site impacts or discharges. Distance to the closest water body is 950 m to Whale Tail South Lake

Equipment failure

An investigation was conducted to scrutinize maintenance and operational practices, aiming to uncover any potential issues or gaps. Subsequent to the investigation, a new step was integrated into the task to mitigate the risk of a recurrence of such events. This addition was then communicated and reviewed by the users of the relevant equipment.
