2024-05-11 WTM 2m3 Sewage

GN reference #: 2024-150

Spill Description

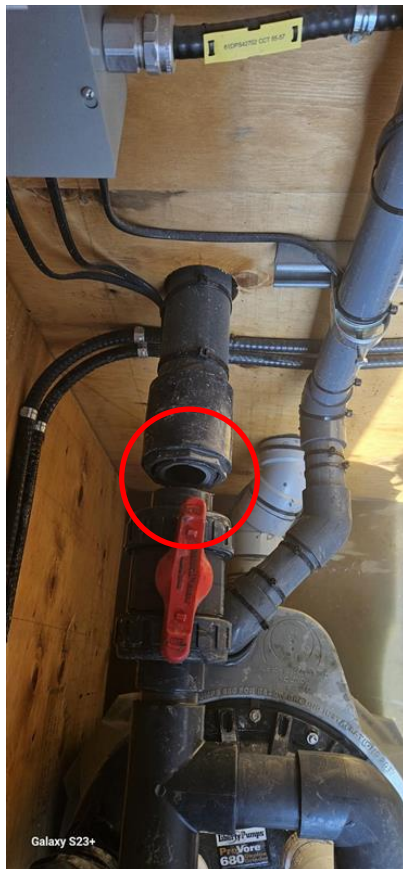
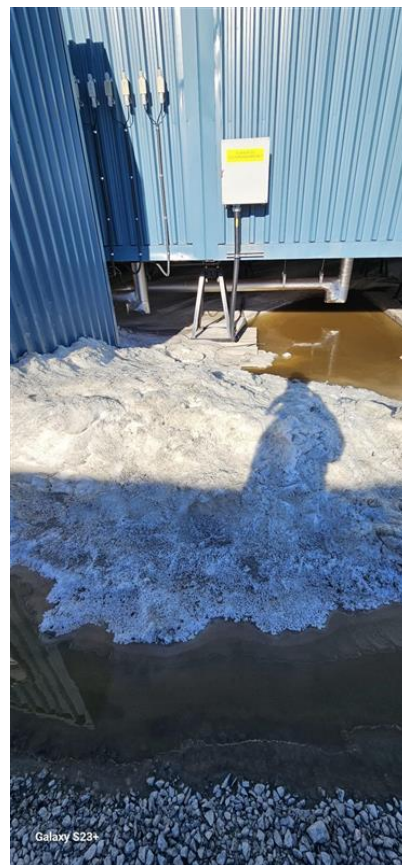
During a regular inspection of the lift station of the underground offices, an employee observed sewage pooling under the building. Upon investigation, it was discovered that the pipe support had failed, leading to the pipe breaking under its weight. Consequently, approximately 2 cubic meters of sewage leaked beneath the building.

Equipment failure

Upon investigation, it was found that the pipe support failed due to improper hardware. A work order has been opened to inspect and replace any deficiencies in the underground office piping. Additionally, an audit of the camp's sewage piping system will be conducted over the summer to identify and replace any faulty parts.
