GN reference #: 2024-513

Please find the following information as a follow up to the Spill report submitted November 4, 2024, by Agnico Eagle Meadowbank division. This detailed report is submitted to the Inspector in compliance with the conditions under the Nunavut Water Board License 2AM-WTP1830, Part H, Item 8c.

Spill Description

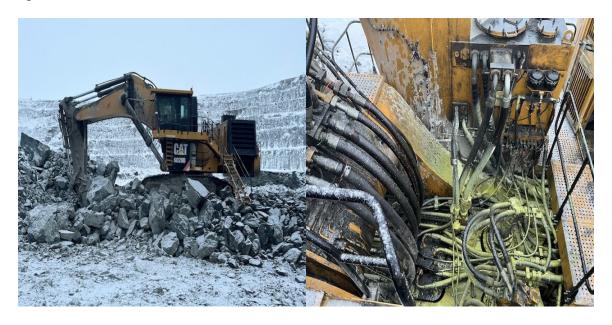
During the operations at the Whale Tail Mine, the excavator was performing work in Whale Tail Pit when it caught fire. This incident led to the spillage of hydraulic fluid onto the ore pattern. The spill occurred in an active mining area.

Upon investigation, a hydraulic hose failure causing an oil leak started a fire within the engine compartment.

A large portion of the spilled oil was burned in the fire. The oil that spilled onto the ground was within an ore pattern. The ore and contaminated material was collected and will be processed through the Milling facilities.

The incident was reviewed with all operators, serving as a reminder of the criticality of conducting equipment walkarounds to prevent avoidable damage or leaks. Furthermore, an investigation was conducted in collaboration with the maintenance department to ensure replacement of all hoses is completed and establish a baseline for service life of hoses on booms.
