2025-01-11 WTM 100L Coolant

GN reference #: 2025-037

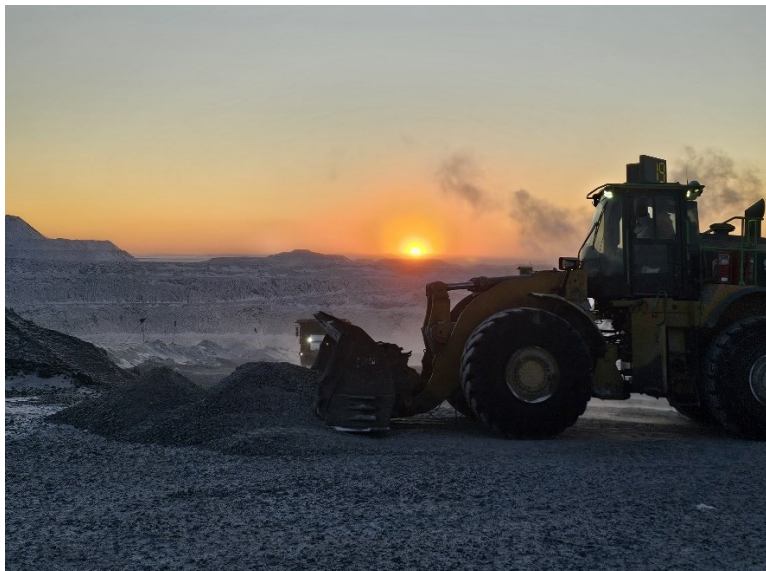
During operations at Whale Tail, a haul truck was exiting the pit on the phase 2 ramp when the coolant hose failed causing coolant to spill on the ground.

The spill was within the active mining area of Whale Tail Pit. There were no off-site impacts or discharges. Distance to the closest water body is 900m to Nemo Lake.

Mechanical Failure.

The equipment was shut down to stop the leak until the hose was repaired. Approximately 8.0 m³ of contaminated snow and material was collected and brought to the Meadowbank Tailings Storage Facility.

Routine visual inspections during pre-op checks and a more thorough preventive maintenance done by the maintenance department will continue as part of AEM's preventative maintenance program.
