AGNICO EAGLE

2025-01-17 WTM 200L Hydraulic Oil

GN reference #: 2025-063

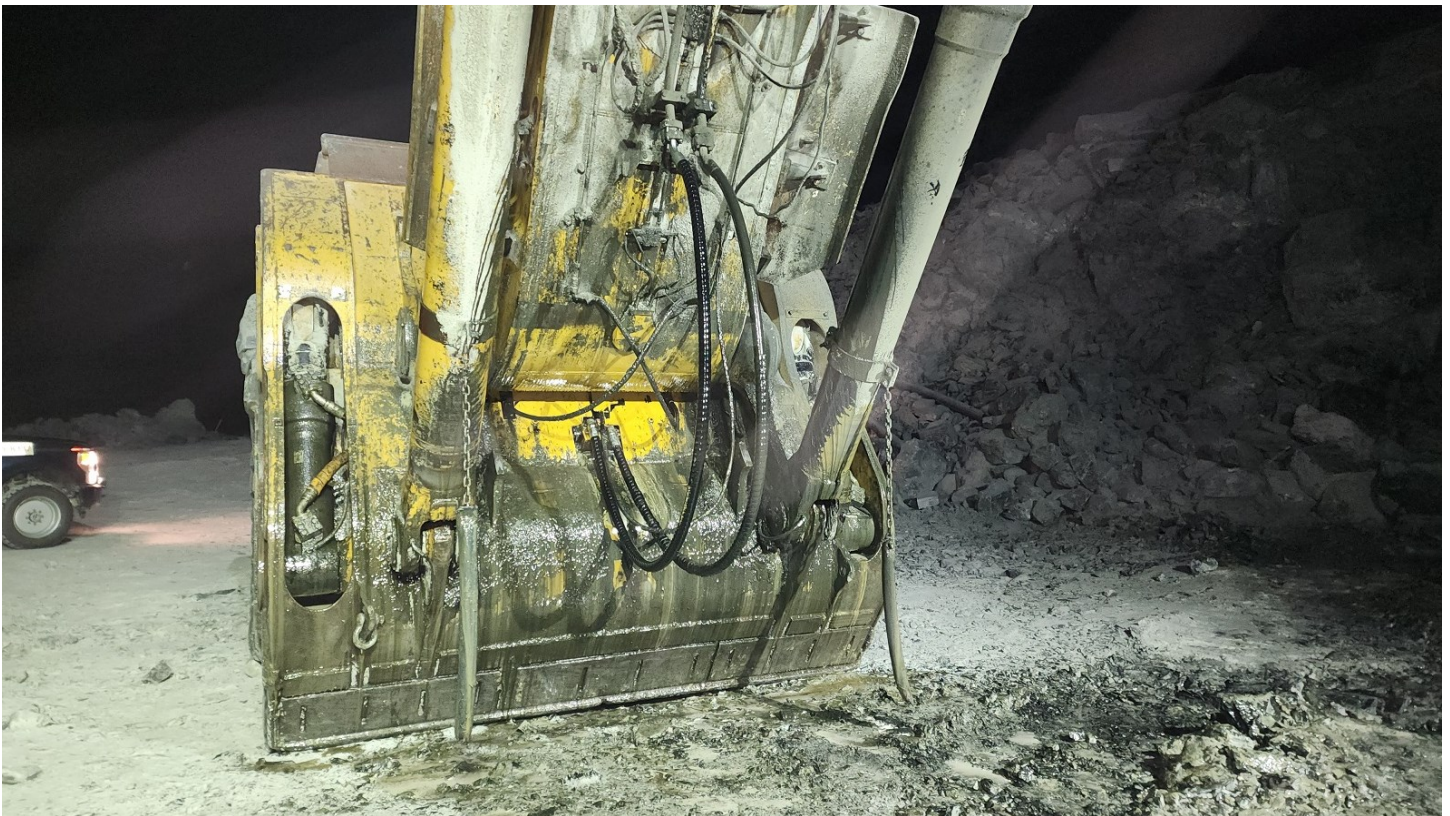
During operations at Whale Tail Mine, a hydraulic hose was pinched between the clamp of an excavator's bucket, resulting on approximately 200 liters of hydraulic oil to spill on the floor of the Whale Tail pit.

Spill location: 65°24'13.90"N, 96°41'50.80"W on IOL

The spill was located within the active mining area of Whale Tail Pit. There were no off-site impacts or discharges. Distance to the closest water body is 820m to Whale Tail South Lake.

Equipment Failure.

The equipment was shut down to stop the leak and promptly taken to maintenance for repair. Approximately 10.0 m³ of contaminated material was collected and brought to the Whale Tail Landfarm.

Routine visual inspections during pre-op checks and a more thorough preventive maintenance done by the maintenance department will continue as part of AEM's preventative maintenance program.
