#### 2025-01-28 WTM 10L Sewage

GN reference #: 2025-088

Please find the following information as a follow up to the Spill report submitted January 29<sup>th</sup>, 2025, by Agnico Eagle Meadowbank division. This detailed report is submitted to the Inspector in compliance with the conditions under the Nunavut Water Board License 2AM-WTP1830, Part H, Item 8c.

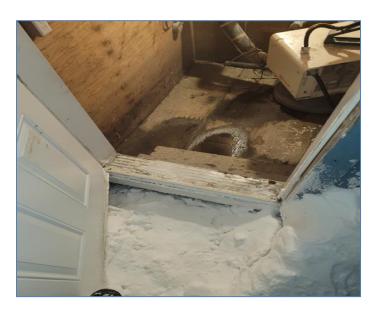
During operations at Whale Tail Mine, a lift station pump became plugged with foreign material (baby wipes). As a result, the lift station containment overflowed into the building and subsequently 10L of sewage left the building and spilled onto the ground.

Spill Location: 65°01'.51"N 96°09'21"W (on IOL)

The spill remained within the mine footprint. There were no off-site impacts or discharges. Distance to the closest water body is ≈360m to lake A-56.

Human Error – Non-Flushable wipes were improperly disposed of into the septic system.

The foreign objects were removed from the septic system. Lids for lift stations to be secured down after inspections.

General site reminder for camp residents of proper hygiene product disposal.
