2025-02-16 WTM 200L Hydraulic Oil

GN reference #: 2025-100

Spill Description

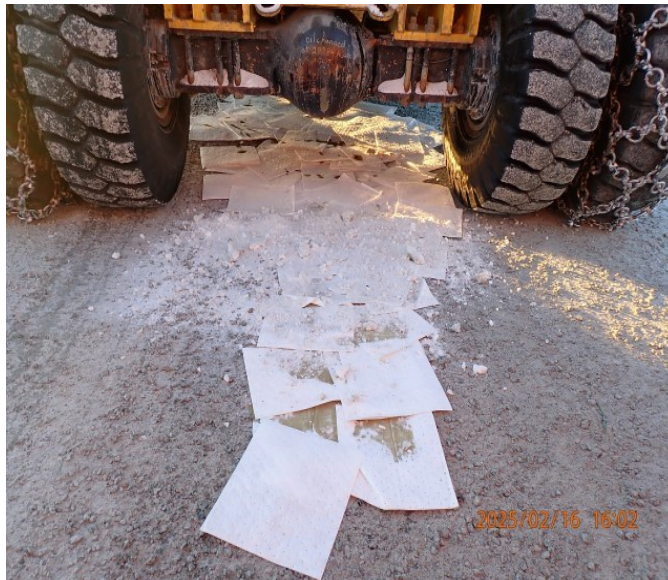
During operations at Whale Tail Mine, the Hyster was traveling through Pad C when the hydraulic hose failed causing a spill of approximately 200L onto the ground.

Mechanical Failure.

Routine visual inspections during pre-op checks and a thorough preventative maintenance done by maintenance department will continue as part of AEM's preventative maintenance program.

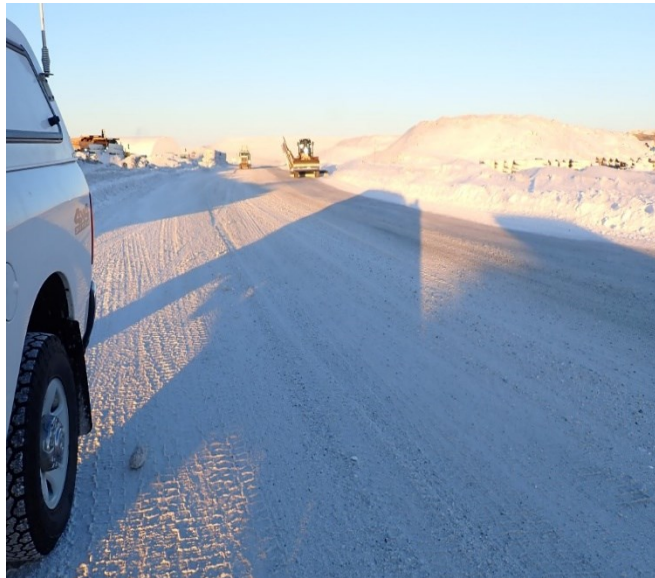
The equipment was stopped and shut down. Absorbents were placed on the ground and a grader was called to scrape the road. Approximately 5m³ of contaminated snow and material was collected and brought to the Whale Tail Landfarm.
