2025-02-21 WTM 500L Contaminated Water

GN reference #: 2025-106

Spill Description

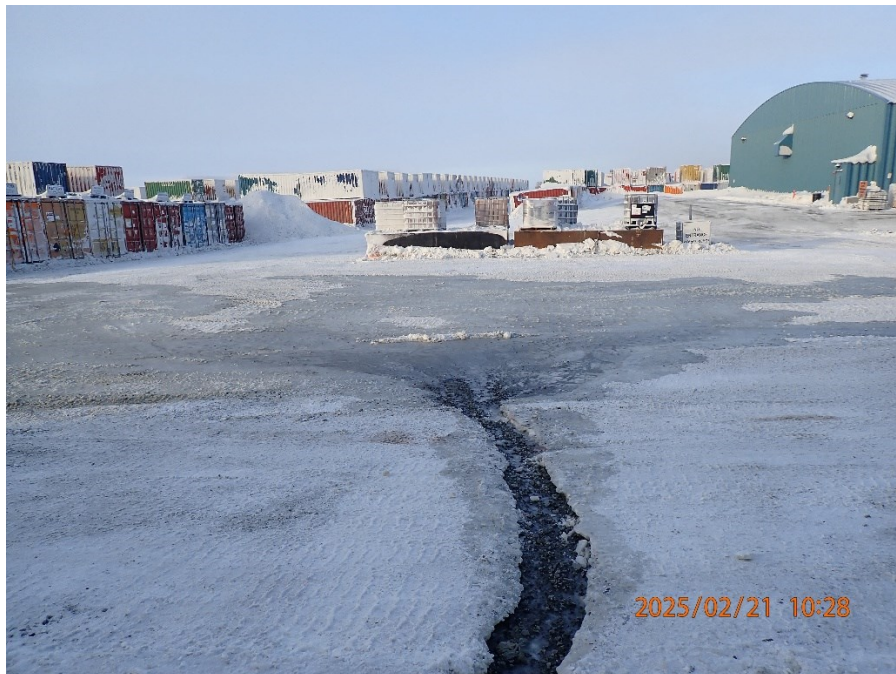
During operations at the Whale Tail Mine, while performing maintenance on the oil and water separator system in the maintenance shop, a miscommunication between two workers led to a spill. A valve was left open while the system was turned on, causing water to leak out of the building.

Spill Location: 65°24'2.82"N 96°40'25.10"W (on IOL)

The spill remained within the mine footprint. There were no off-site impacts or discharges. Distance to the closest water body is 600m to Whale Tail South Lake.

Human Error

The procedure for the task was reviewed with the employee. Agnico eagle will continue to offer environmental awareness and education program to employees through E-learnings and on-site training session.
