## 2025-04-25 WTM 150L Windshield washer fluid

GN reference #:186

Please find the following information as a follow up to the Spill report submitted April 23rd, 2025, by Agnico Eagle Meadowbank division. This detailed report is submitted to the Inspector in compliance with the conditions under the Nunavut Water Board License 2AM-WTP1830, Part H, Item 8c.

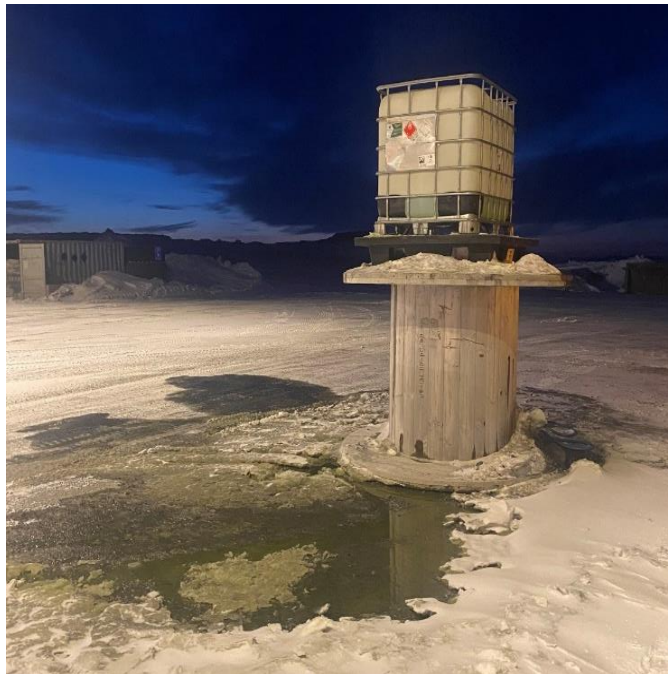
During operations at Whale Tail Mine, a hose connected to a methane-based windshield washer tote failed causing a spill of approximately 150L onto the ground.

Spill Location: 65°24'10.15"N 96°39'59.71"W (on IOL)

The spill remained within the mine operations footprint. There were no off-site impacts or discharges. Distance to the closest water body is approximately 375m to Lake A56.
