## 2025-06-19 WTM 105L Coolant

GN reference #: 2025-265

### Spill Description

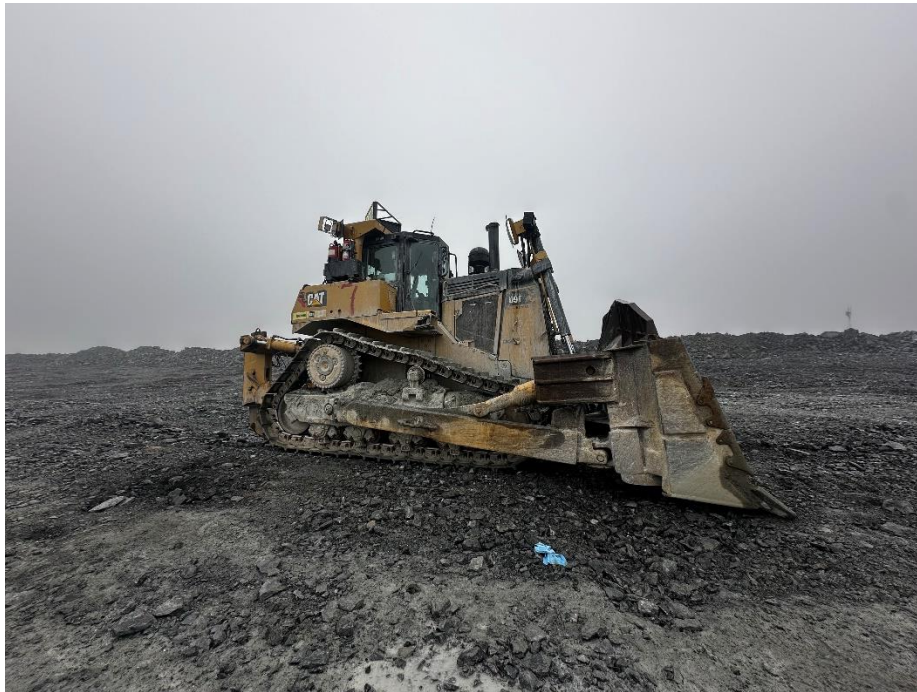
Spill Location: 65°24'50.1"N 96°40'04.1"W (on IOL)

While working on top of the IVR Waste Rock Storage Facility, the coolant tank of Dozer 7 leaked due to mechanical failure. This caused 105L of coolant to leak onto the ground. The spill occurred in an active material deposition area.

The spill remained within the mine operations footprint. There were no offsite impacts or discharges. Distance to the closest water body is 1000m to Lake A113.
