2025-07-30 WTM 200L Hydraulic Oil

GN reference #: 2025-308

Please find the following information as a follow up to the Spill report submitted July 30th, 2025, by Agnico Eagle Meadowbank division. This detailed report is submitted to the Inspector in compliance with the conditions under the Nunavut Water Board License 2AM-WTP1830, Part H, Item 8c.

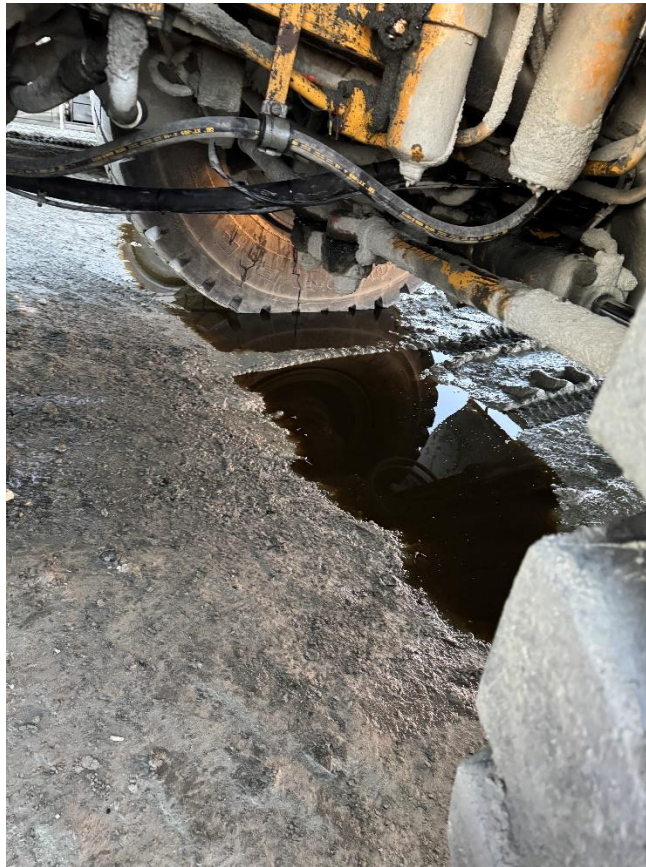
Spill Location: 65°24'41.78"N 96°40'55.52"W (on IOL)

During operations at Whale Tail Mine a haul truck was parked at the IVR parking when the hydraulic line failed. As a result, ~200L of hydraulic oil to leak onto the ground. The haul truck was shut down to stop the leaking. The spill did not occur in an active excavation or deposition area.

The spill remained within the mine operations footprint. There were no off-site impacts or discharges. Distance to the closest water body is 700m to Lake A113.

Mechanical Failure.
