2025-11-14 WTM 350L Hydraulic Oil IVR Pit

GN reference #: 2025-438

Spill Description

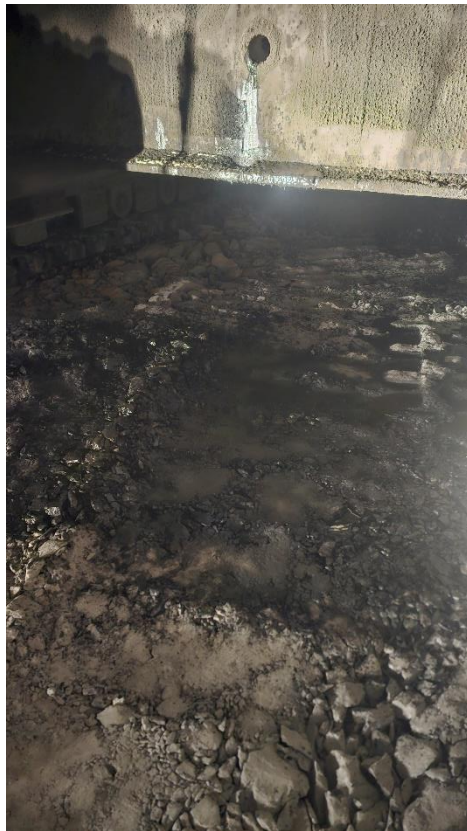
During operations at Whale Tail Mine, an excavator's hydraulic hose failed inside of the pump compartment room resulting in a spill of 350L onto the floor of the IVR Pit Extension within an area of active excavation.

Mechanical Failure – wear and tear

An extensive mechanical assessment of the unit was conducted. Routine visual inspections during pre-op checks and a thorough preventative maintenance done by maintenance department will continue as part of AEM's preventative maintenance program.
