2025-11-14 WTM 350L Hydraulic Oil -Whale Tail Pit

GN reference #: 2025-439

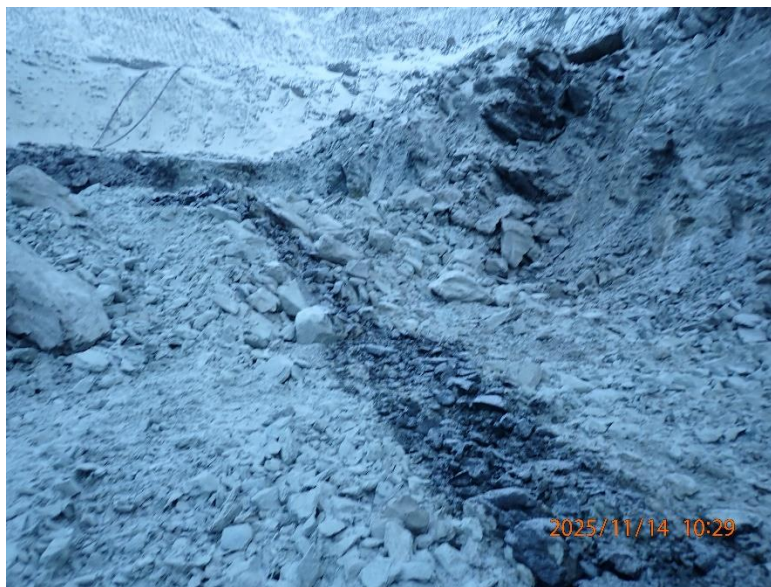
During operations at Whale Tail Mine a hydraulic hose on an excavator failed, resulting approximately 350L of hydraulic oil leaking onto a muck pile in Whale Tail pit within an area of active excavation.

Mechanical Failure – wear and tear
