## 2025-11-29 WTM 200L Hydraulic Oil

GN reference #: 2025-447

Please find the following information as a follow up to the Spill report submitted November 29<sup>th</sup>, 2025, by Agnico Eagle Meadowbank division. This detailed report is submitted to the Inspector in compliance with the conditions under the Nunavut Water Board License 2AM-WTP1830, Part H, Item 8c.

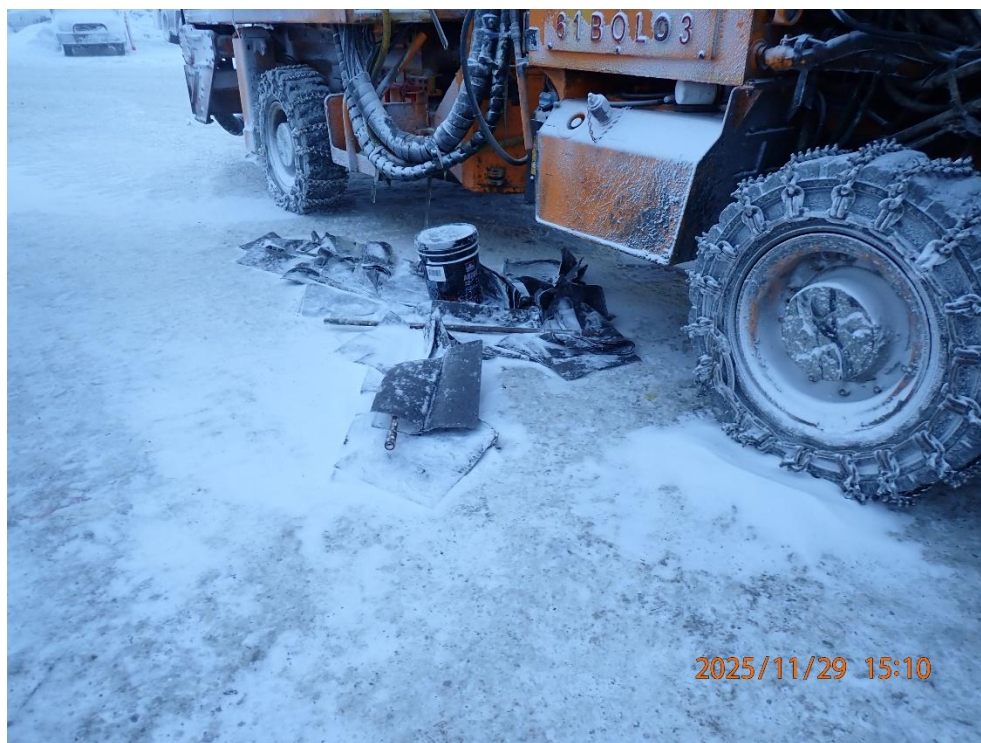
During operations at Whale Tail Mine a hydraulic hose failed while a bolter was parked at the Underground Maintenance Shop Parking.

The spill remained within the mine operations footprint. There were no off-site impacts or discharges. Distance to the closest water body is ~925m to Whale Tail South Lake.

Mechanical Failure – wear and tear

An extensive mechanical assessment of the unit was conducted. Routine visual inspections during pre-op checks and a thorough preventative maintenance done by maintenance department will continue as part of AEM's preventative maintenance program.
