2026-02-06 WTM 500L Sewage Effluent Water

GN reference #: 2026-032

Spill Description

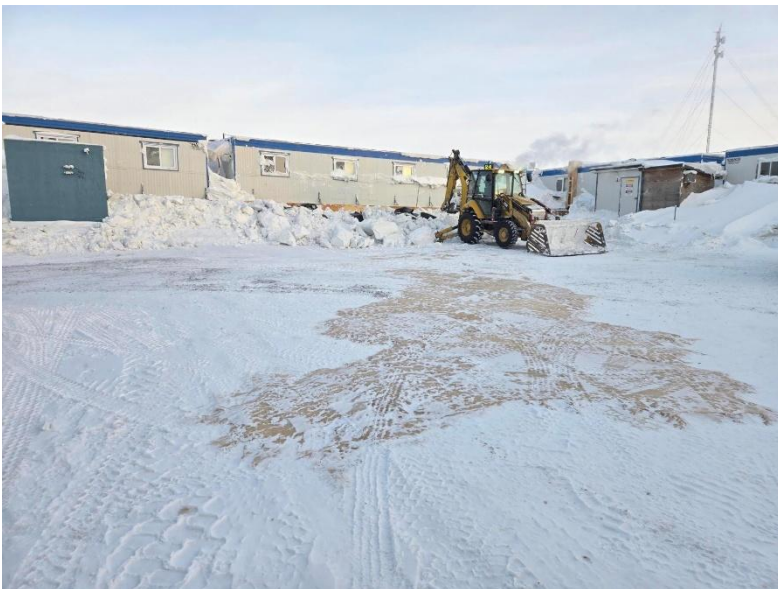
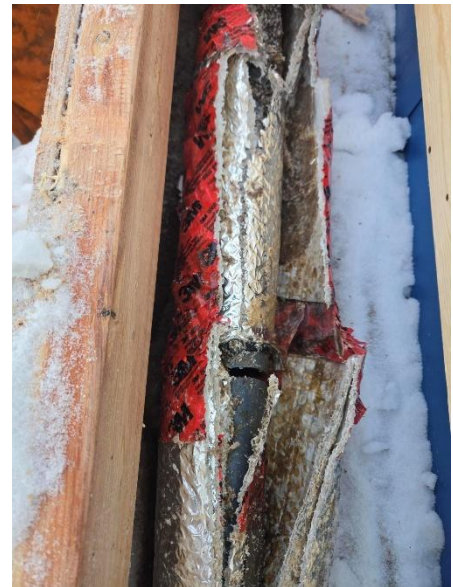
During operations at Whale Tail Mine, a sewage spill was found coming from under wing 28 by the site plumber. Upon investigation the sewer line that runs along wing 28 was found to be broken and leaking onto the ground.

Equipment Malfunction/Human Error – Heat trace was installed but set to the wrong voltage

The piping and insulation were repaired, and the heat trace voltage was adjusted to the correct requirements. All other heat trace were inspected and confirmed to be functioning correctly.

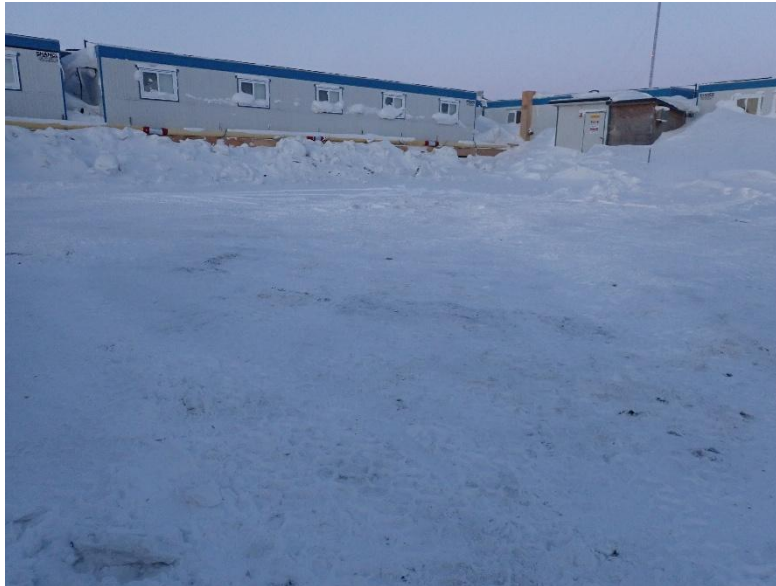
A loader was deployed to remove snow to access the broken pipe and contain the spill. ~2m³ contaminated snow and ice were collected and placed in a roll-off bin for transport to the Meadowbank Tailing Storage Facility for disposal.
