WHALE TAIL PROJECT

Monitoring Program Summary Report

December 2019

Type A Water License 2AM-WTP1826

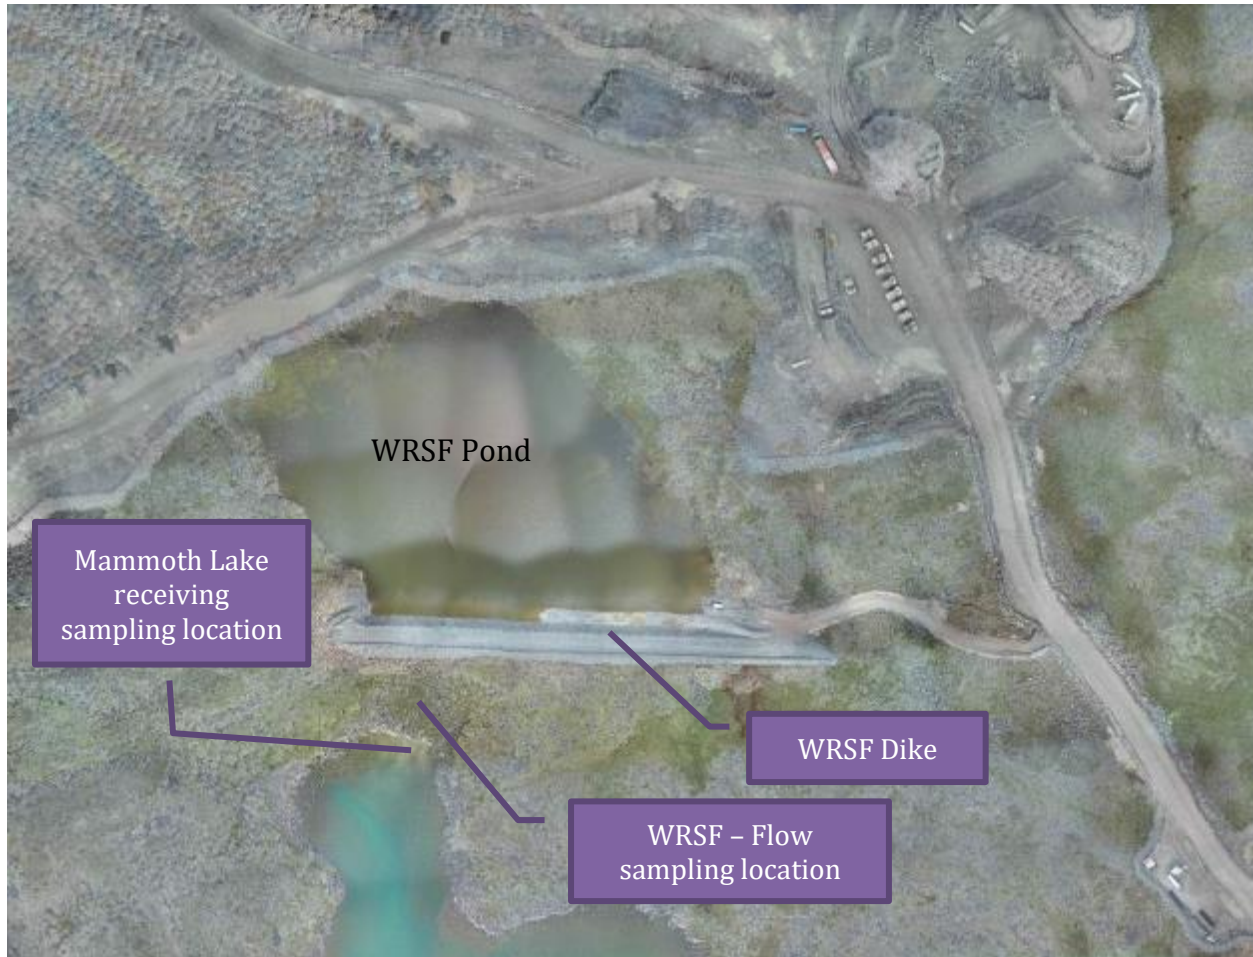
Figure 1: WRSF Flow and Receiving Environment Location

Agnico Eagle Mines Limited – Meadowbank Division (Agnico Eagle) informed you via email on August 25, 2019, that during a routine inspection of the Whale Tail WRSF Dike carried out on August 24, 2019 at 10:30 am, a water flow was observed at the toe of the dike flowing toward Mammoth Lake (UTM 14W 0605380 7255454) (see Figure 1).

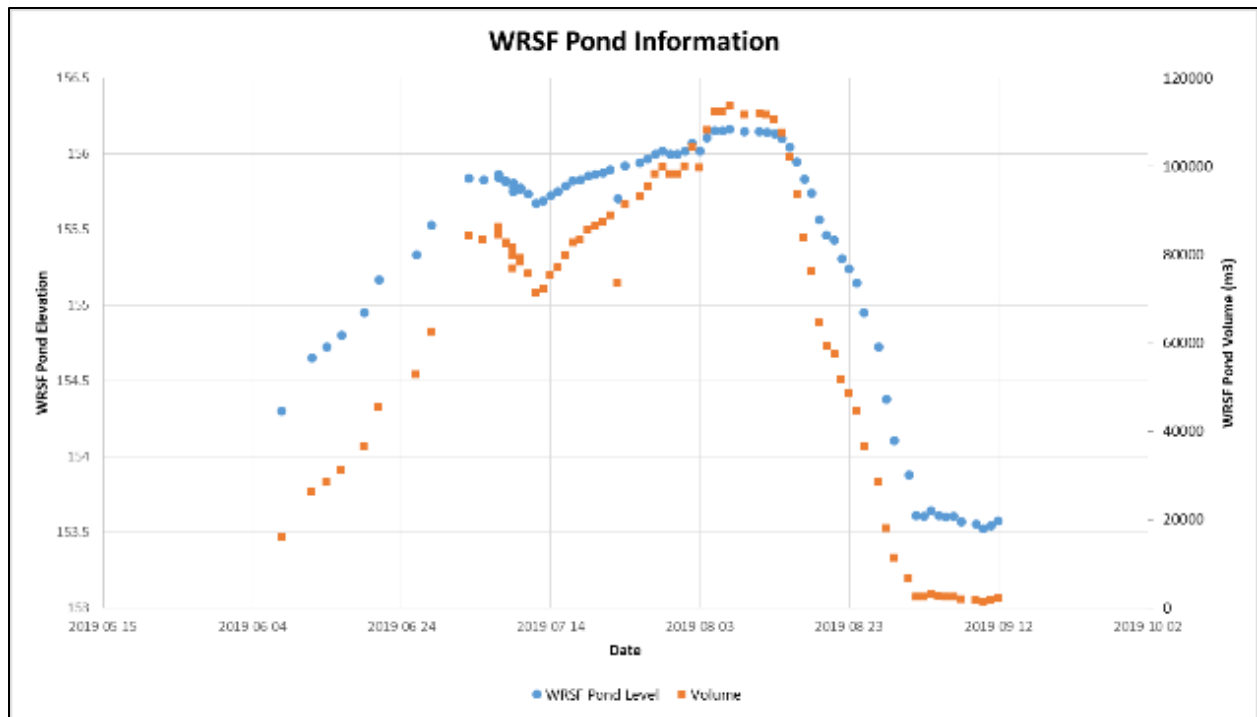
Figure 2: WRSF pond water elevation and associated volume

The initial estimate provided of the quantity of water released from the flow through the WRSF pond dike between August 15 and September 1 was approximately 15,000 m³. Verification of pumping rates, along with bathymetry of the WRSF pond and the water elevation, have enabled us to refine this estimate. As shown on Figure 2, on August 15, the volume of water in the pond was estimated at 99,657m³. From that volume, 38,135m³ was pumped to Quarry 1 to empty the pond. This meant that the rest of the water, or approximately 61,500m³, had seeped through the dike. This estimate is intended to be conservative.

At peak conditions, the flow has been estimated to be approximately 172 m³/hour. These estimates have been done by comparing the actual rate of decrease of the pond level compared to the expected rate of decrease of the pond resulting only from the pumping activities.

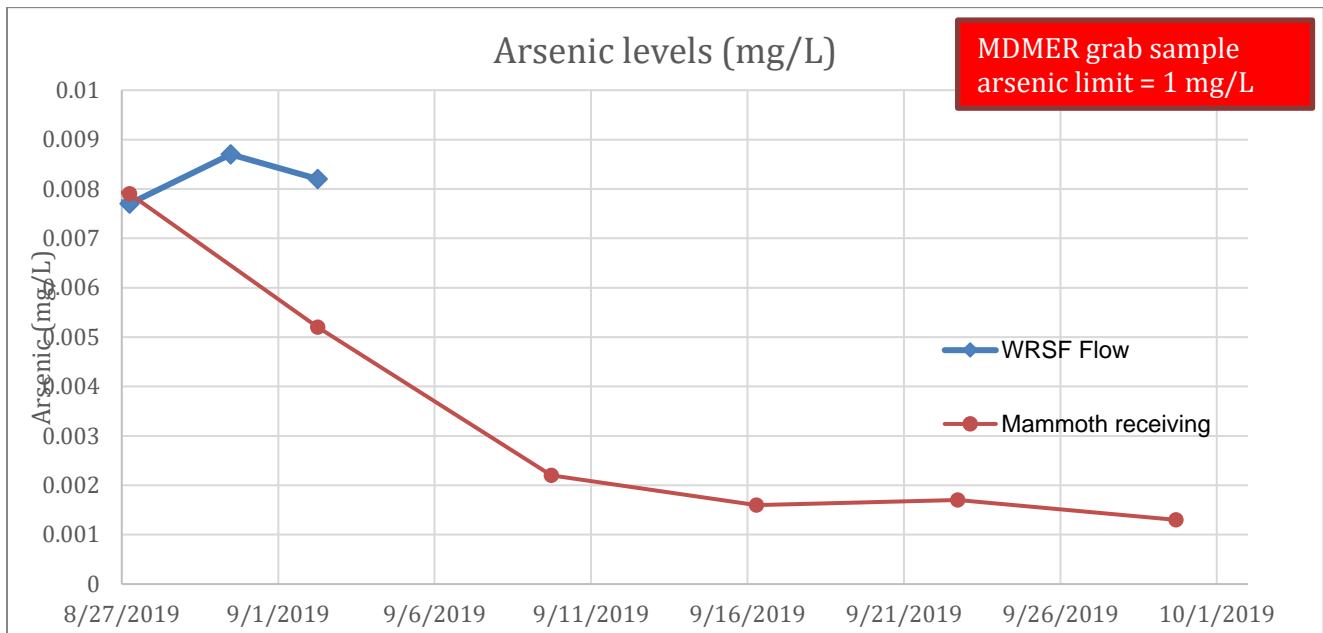
Figure 3: Arsenic Concentrations in Water of Mammoth North

As shown in Table 1, the prescribed deleterious substances regulated pursuant to MDMER were below the prescribed limits in the receiving water of Mammoth Lake and were decreasing over time, which coincides with the reduction in water flow through the

dike as the water in the WRSF pond was pumped out (pond empty by September 1st). Arsenic concentrations, the main parameter of concern identified during the Environmental Assessment process of the Whale Tail Project, are shown in Figure 3 below in both the seepage flow and in the receiving water, as an example to show the low concentrations of arsenic relative to the MDMER limit for discharge.

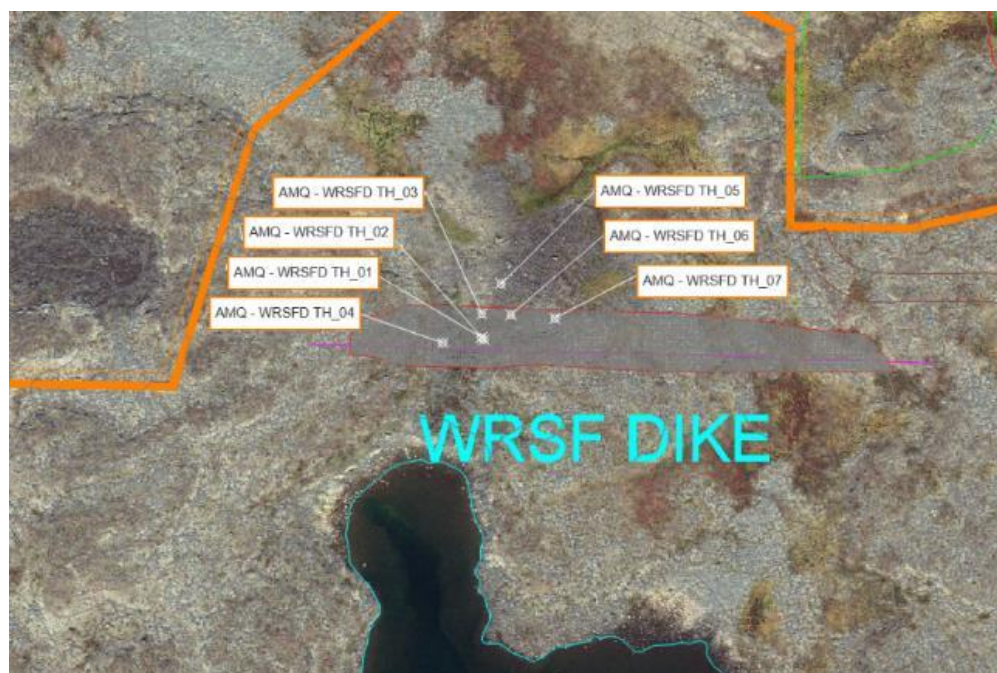
Figure 4: WRSF Thermistor locations

Installation of additional thermal monitoring instrumentation was completed in October 2019 in response to the seepage event. In addition to the existing 3 thermistors (TH-01, TH-02, TH-03), 4 new vertical instruments were installed (TH-04, TH-05, TH-06, TH-07). Locations are detailed in Figures 4 and 5 below. Figures 6 to 12 show collected data for the thermistors along with a short explanation of each instrument configuration and an interpretation of each thermistor data set. All data are logged into an existing data collection system.

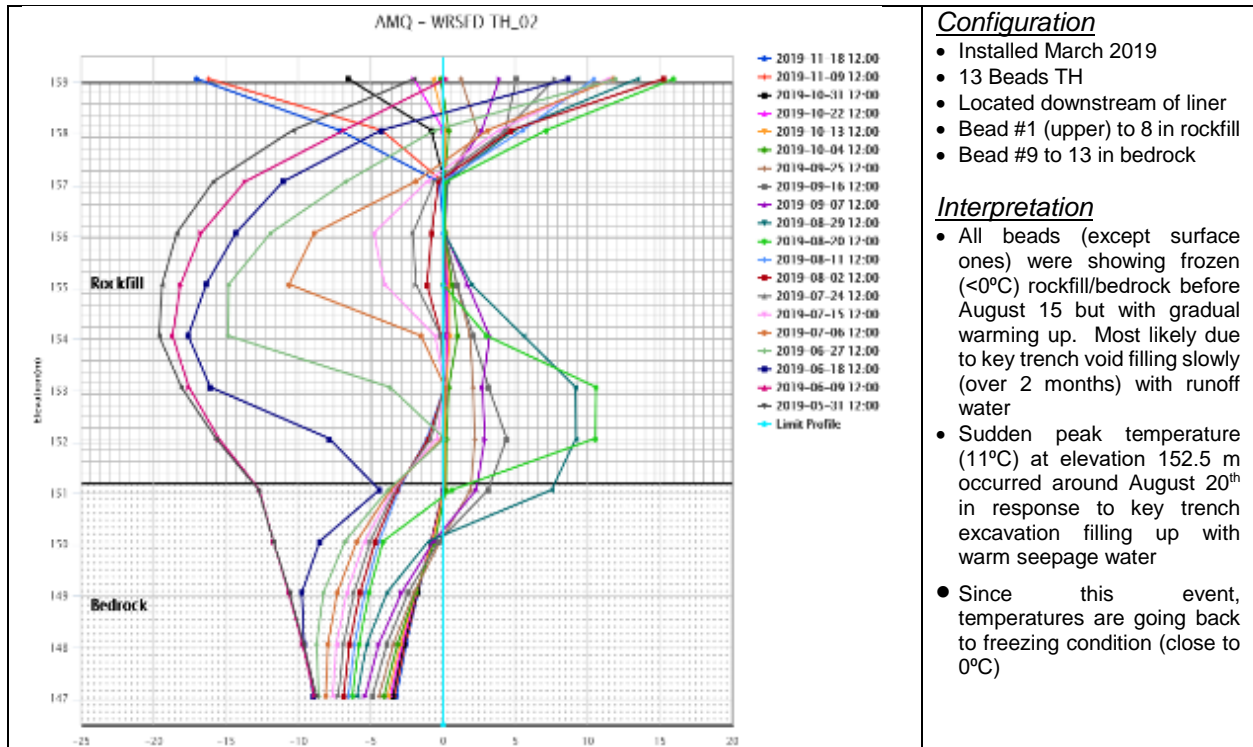
Figure 7: WRSF Temperature profile of thermistor TH-02

Thermal monitoring results suggest that thawing of the dike foundation occurred, resulting in an increase of its hydraulic conductivity that led to the seepage. Thawing of the foundation has probably been induced by the higher than anticipated accumulation of water in the pond coupled with an insufficient thermal protection on the upstream toe of the dike.
