Meadowbank and Whale Tail 2024 Annual Geotechnical Inspection

2024 Annual Geotechnical Inspection

Meadowbank Complex, NU

Reference No. CA0038946.6657-1630-R-Rev0

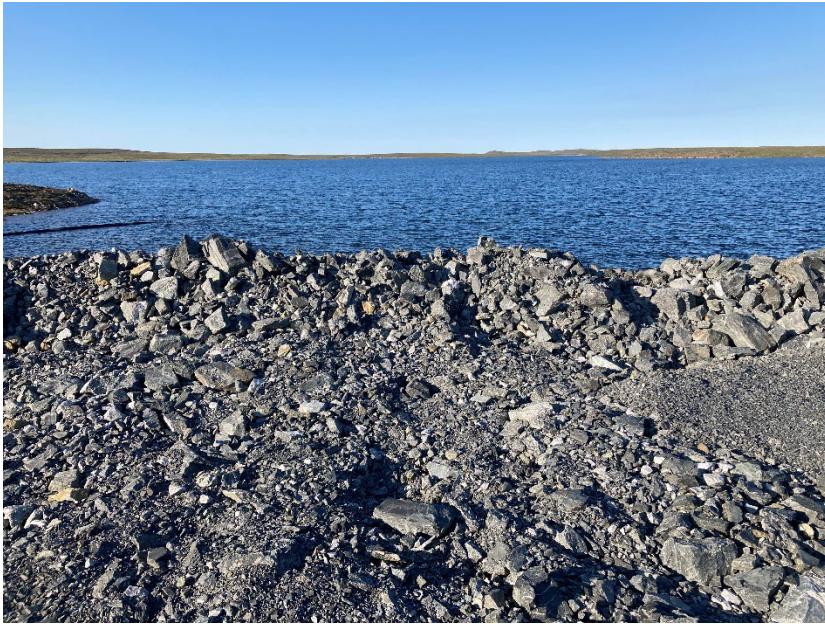
Photograph A5-17 Whale Tail Dike

Description: From approx. Sta. 0+775 upstream, looking southwest at the capping. Uneven surface is observed, but no visible deformation.

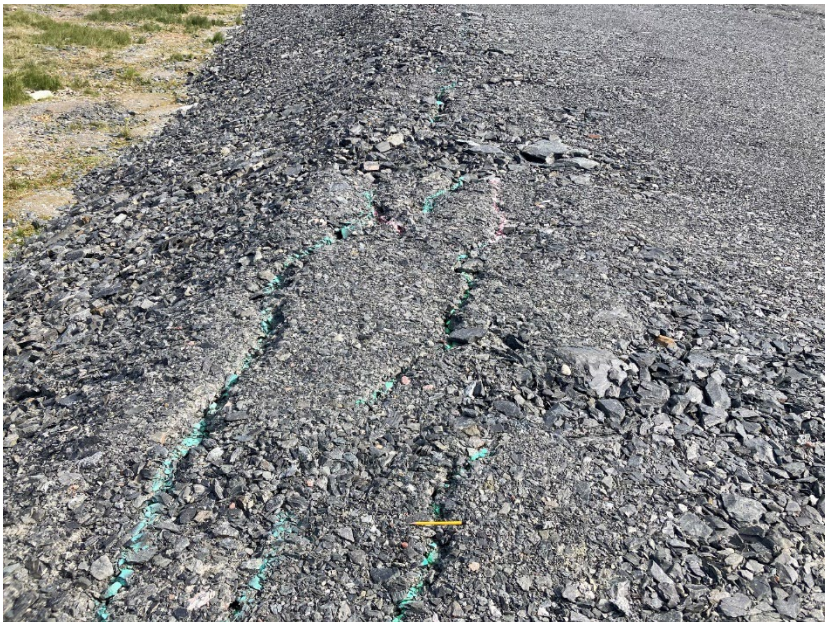
Photograph A6-8 IVR Dike D-1

Description: From approx. Sta. 0+300, looking east at the crest and upstream slope. Presence of tension cracks (inactive).

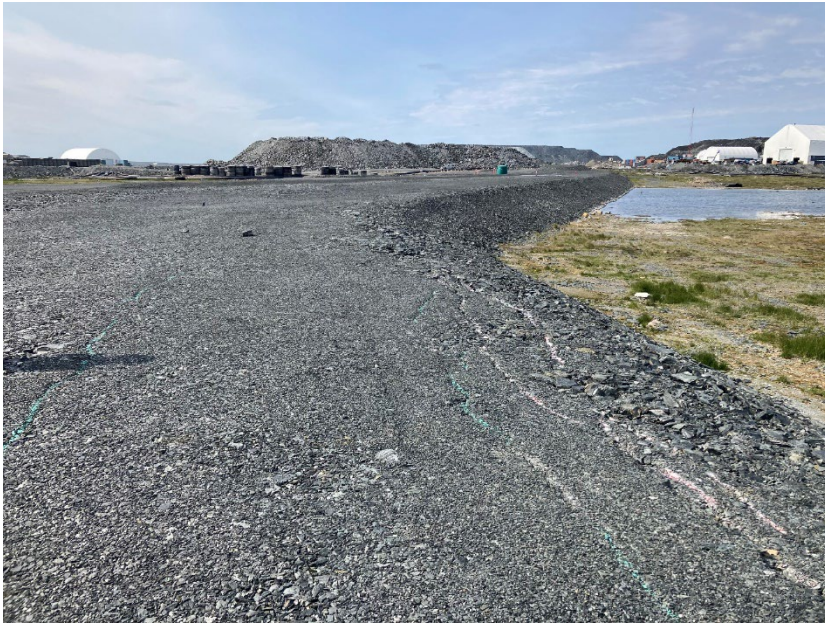
Photograph A6-9 IVR Dike D-1

Description: From approx. Sta. 0+350, looking west at the crest and upstream slope. Presence of tension cracks (inactive).

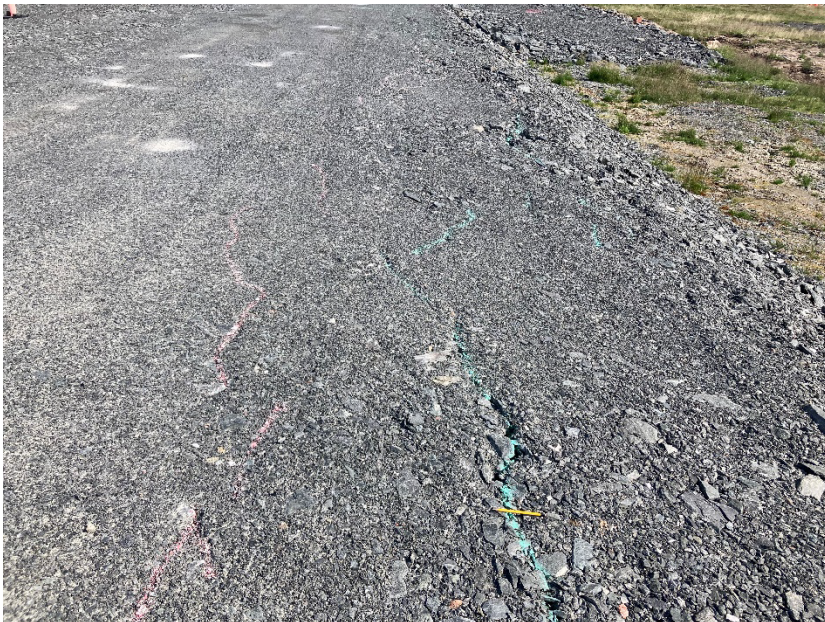
Photograph A6-14 IVR Dike D-1

Description: From approx. Sta. 0+350, looking east at the crest and downstream slope. Presence of tension cracks (5-6 m long, inactive).

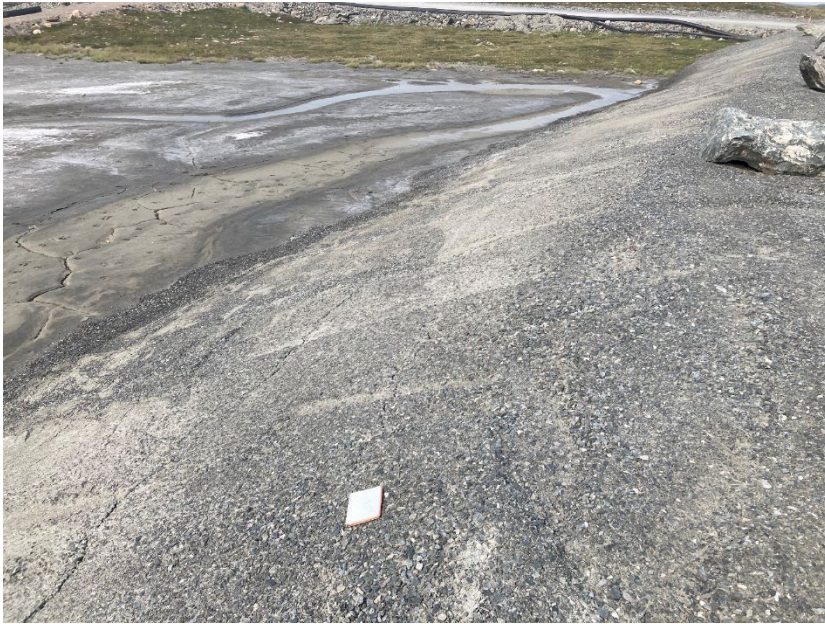
Photograph B1-01 Tailings Storage Facility

Description: From the North Cell Internal Structure, looking west at upstream slope. Tension cracks in fine filter slope (~ 0- 20 mm wide).

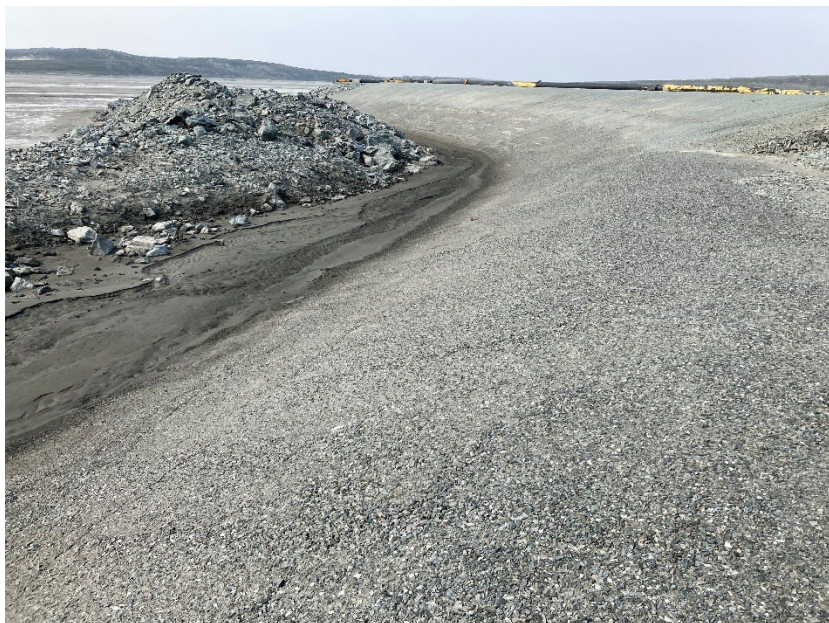
Photograph B1-11 Tailings Storage Facility

Description: From the North Cell Internal Structure, looking northwest at the upstream slope. Presence of tension crack on upstream slope (approx. 10-20 mm wide).

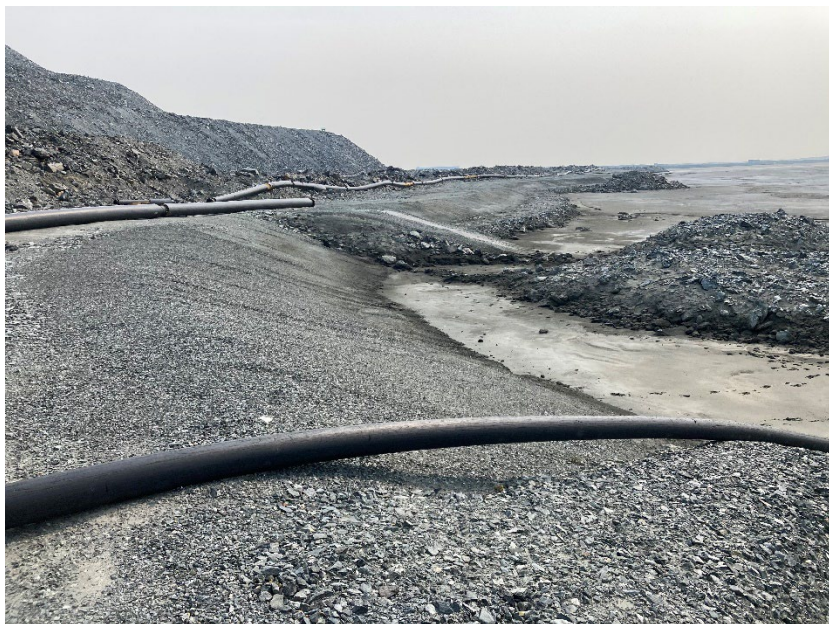
Photograph B1-12 Tailings Storage Facility

Description: From the North Cell Internal Structure, looking south at the upstream slope. Presence of tension crack on upstream slope (approx. 10-20 mm wide), water channeling at the toe.

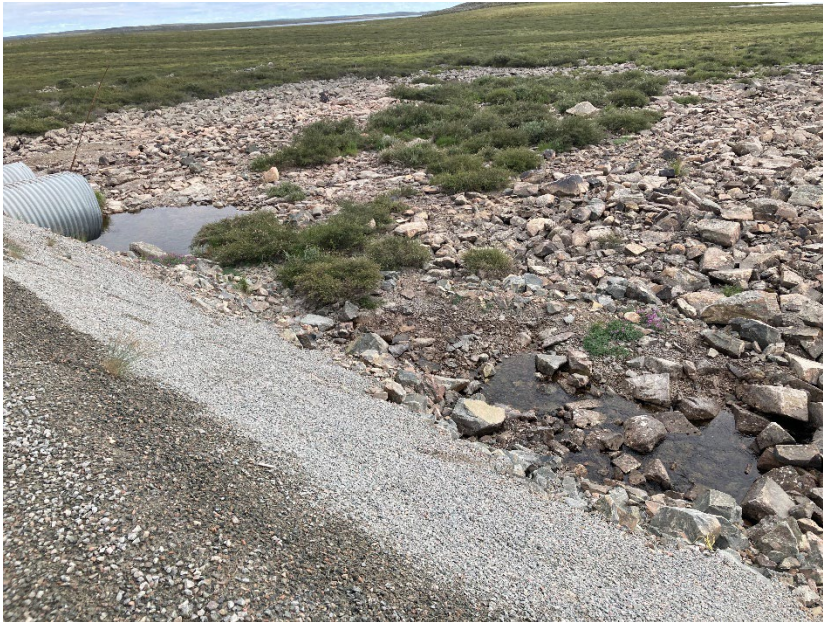
Photograph D2-01: PC-17A km 8+830

Description: View of the culverts. No sign of degradation and the flow is stable south of the culverts (5-10 m away).

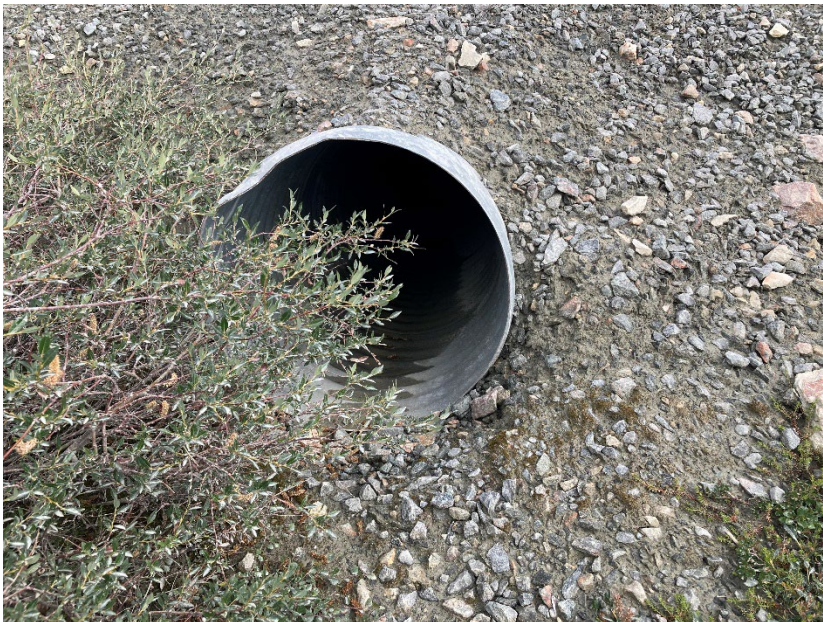
Photograph D2-02: PC-11 km 39+552

Description: View of the culvert inlet. Installed high but in good condition.

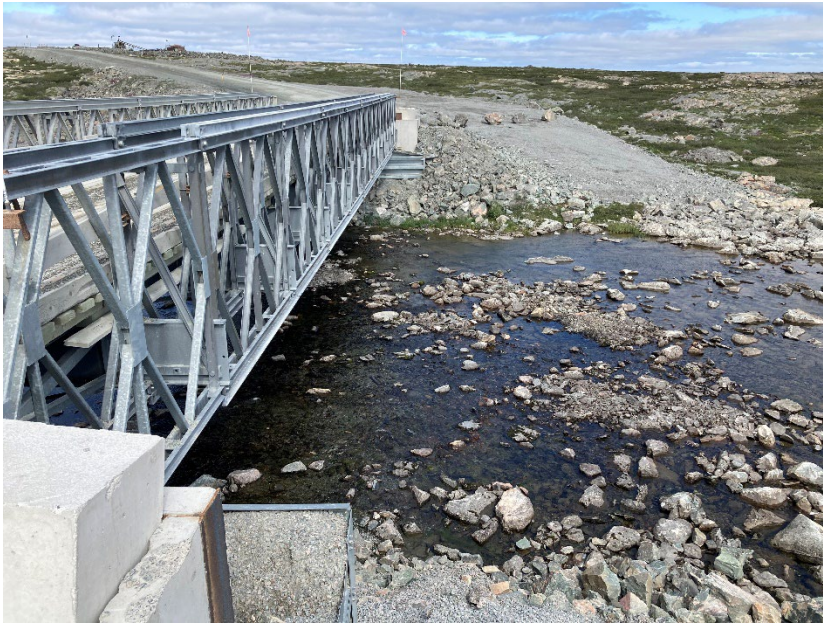
Photograph D3-5 Bridges 3 – R06 km 23+100

Description: Looking at the north abutment. Some tension cracks in granular material on abutments.
