WATER LICENCE INSPECTION FORM

Licensee	Licensee Representative
TMAC Resources	Sarah Warnock
Licence No. / Expiry	Representative's Title
2BB-BOS1727	Environment Supervisor
Land / Other Authorizations	Land / Other Authorizations
Date of Inspection	Inspector
14/08/2019	Candice Pedersen
Activities Inspected	
<input type="checkbox"/> Camp	<input type="checkbox"/> Drilling
<input type="checkbox"/> Roads/Hauling	<input type="checkbox"/> Mining
	<input type="checkbox"/> Construction
	<input type="checkbox"/> Reclamation
	<input checked="" type="checkbox"/> Fuel Storage
	<input type="checkbox"/> Other:

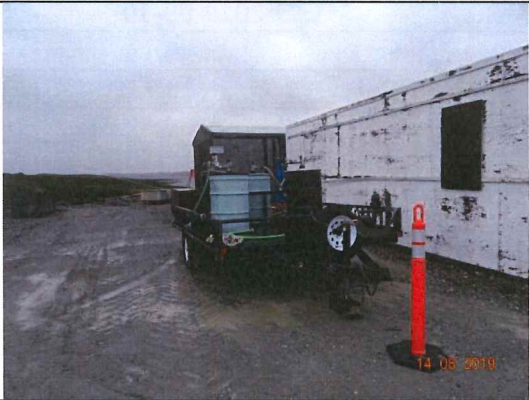
Photo Log # 3	Location (NAD 83 DD MM SS.SS)		
Photo #3	N	W

Oil Water Separator System: this is a new system of four 45 gallon drums and one pump (see photo log #3) that treats the water that builds up in the berms. The product ‘Metsorb’ is used to treat the water, the water then meets criteria to discharge onto tundra. No concerns where noted with this system.

Description: Oil Water Separator System

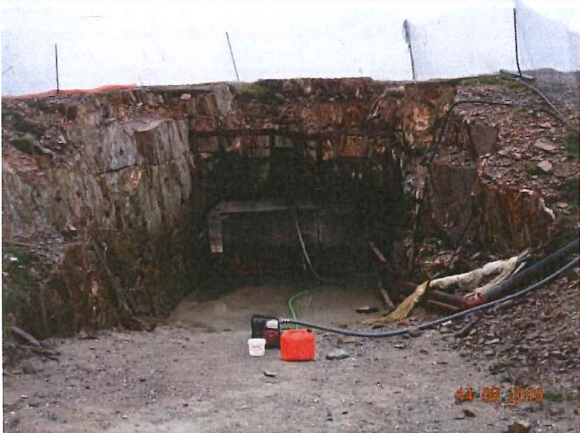
Photo Log # 4

BOS-9: Bos-9 used to be the portal to access the underground mining from the previous proponents (see photo log #4). This location collects rainwater and meets criteria to discharge, TMAC has been discharging the water over the outcrop. No concerns where noted with his facility.

Description: BOS-9

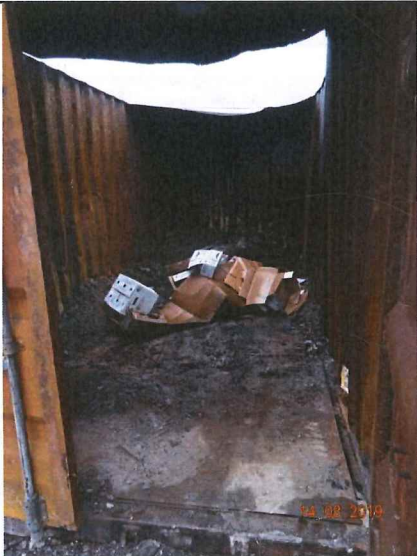
Photo Log # 5

Burn Pan: The Burn Pan is a recycled sea can that has a portion of the top cut off to allow smoke to come out (see photo log #5). Clean wood and cardboard are burnt at this facility. Inspector notes a few cardboard boxes inside and a bit of ash that has been shoveled to the back of the sea can. No concerns where noted with this facility.

Description: Burn Pan

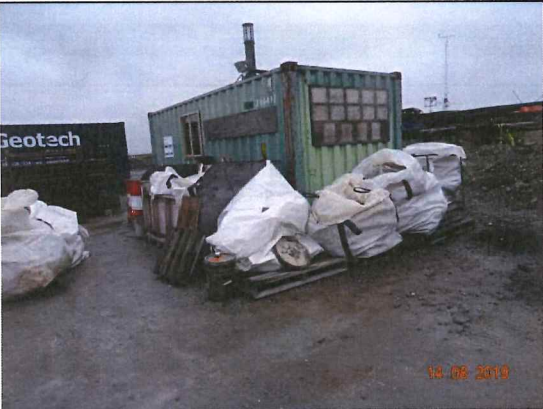
Photo Log # 6

Waste Management Area: During the inspection it was noted that waste is being segregated and disposed of as required by the licence. Such as aerosols, oily rags, paint, oil filters and more (see photo log #6). All to be disposed of at Doris Camp, the waste will get hauled in winter of 2020 at the Doris Waste Management Facility and eventually off site. Before that time, they will store them on Boston site.

Description: Waste Management Area, segregation

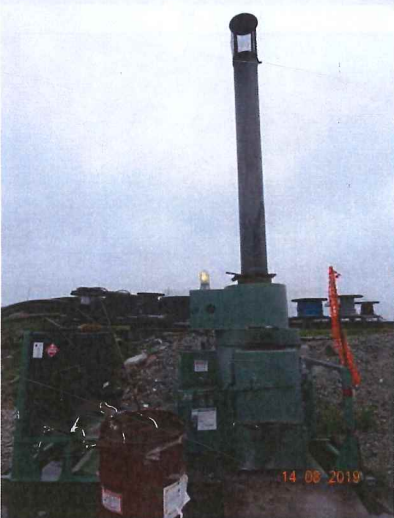
Photo Log # 7		Location (NAD 83 DD MM SS.SS)	
Photo #7		N	W

Description: Incinerator

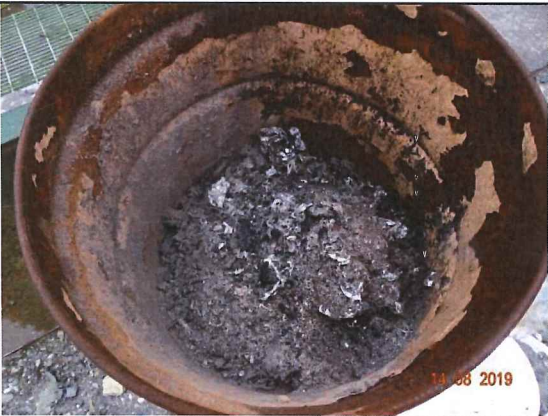
Photo Log # 8		Location (NAD 83 DD MM SS.SS)	
Photo #8		N	W

Incinerator: The Incinerator appears to be operating as intended (see photo log #7), no debris is seen around the incinerator. A 45 gallon drum is seen in front of the incinerator uncovered filled about one third of burnt ash (see photo log #8). Inspector is concerned this drum is uncovered.

Description: Uncovered incinerator ash

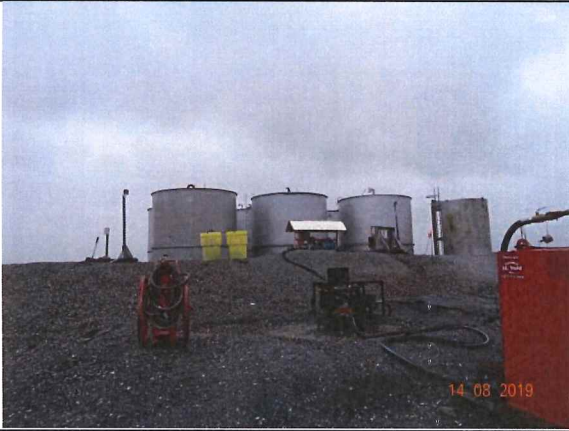
Photo Log # 9		Location (NAD 83 DD MM SS.SS)	
Photo #9		N	W

Bulk Fuel Storage (BOS-5): The Bulk Fuel Storage is comprised of 7 tanks (see photo log #9), Inspector is informed the fuel is old so they have a filter that pumps fuel from the tanks into the filter then to a double walled holding tank (see photo log #10). The pump is in a lined area and spill kits are seen in the vicinity. A bag of absorbent pads it seen near the

holding tank. The tank farm itself has some water collection, the last pump out of this facility was during freshed. Inspector is informed that they will be conducting another test before freeze up to discharge the remaining water. The bottom of the tanks are starting to rust. No concerns where noted with this facility.

Description: Bulk Fuel Storage

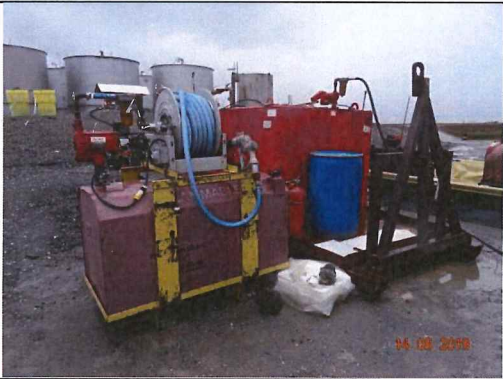
Photo Log # 10		Location (NAD 83 DD MM SS.SS)	
Photo #10		N	W

Description: Doubled walled fuel holding tank

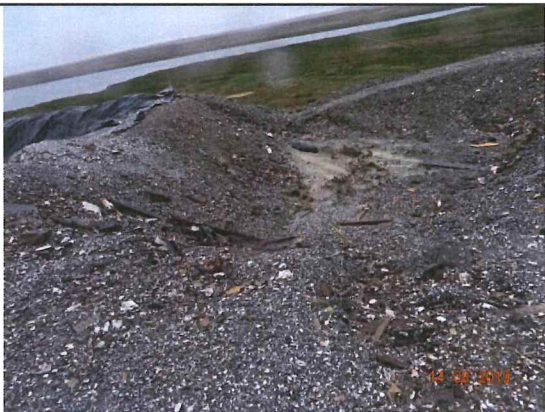
Photo Log # 11

BOS-7: This Facility used to be the burn pit from the previous proponent. It has no liner, and because of that it is not being used by TMAC. Inspector notes some debris such as wood and a bit of scrap liner in this facility (*see photo log #11*). Inspector was informed that this facility is having run off issues as it has no liner, however, the runoff is just rainwater. No concerns where noted with this facility.

Description: BOS-7

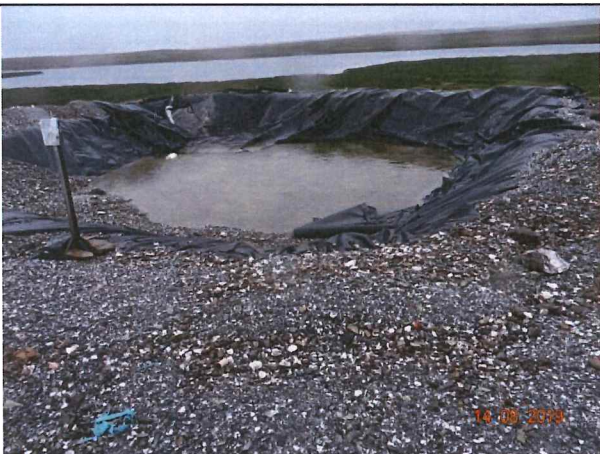
Photo Log # 12

BOS-2: This Facility used to be the Contaminated Pond. Because the liner is compromised (*see photo log #12*) TMAC has not been using it and plans to decommission it. Inspector notes some water has built up in the berm. No concerns were noted.

Description: BOS-2

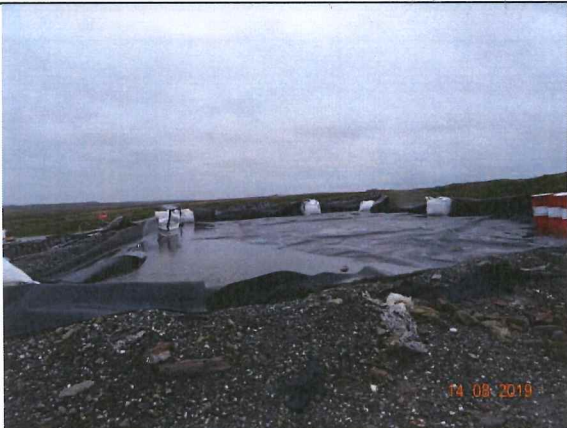
Photo Log # 13

Old Land farm: Inspector sees what used to be the land farm (*see photo log #13*), the Old Land Farm was remediated in 2017 and everything was hauled to the Doris Camp for proper disposal in 2019 via ice road. A new berm was placed by the contractors and TMAC is currently using it to temporary store empty Jet A fuel drums.

Description: Old Land Farm

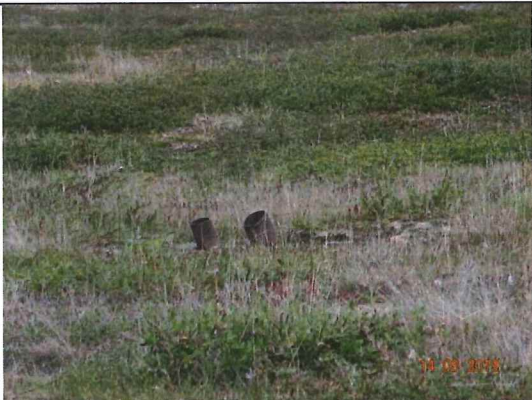
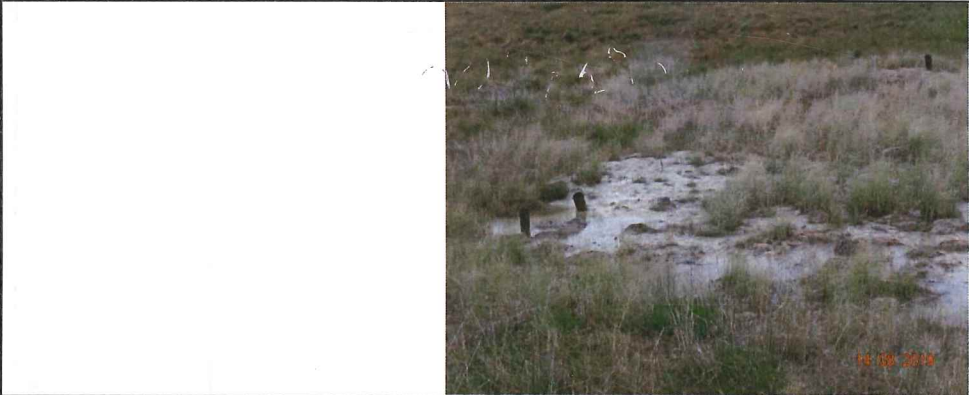
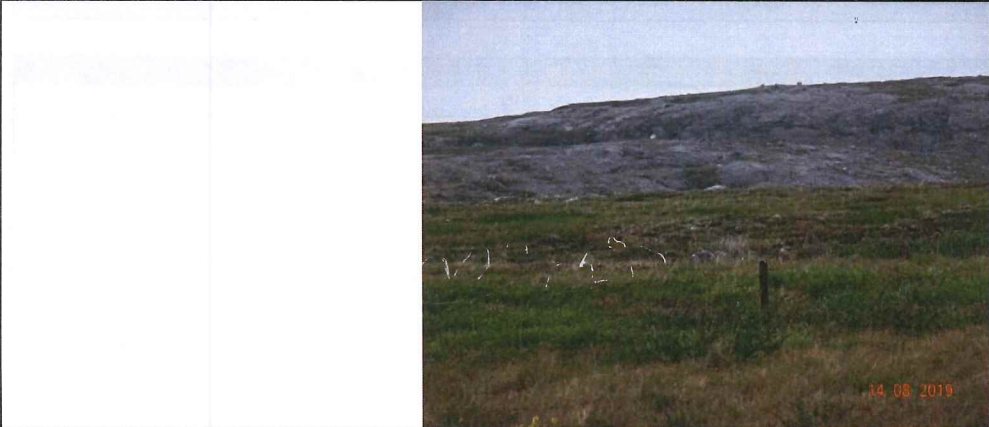
On the way to the runway Inspector notes a few drill casings sticking out of the ground (*see photo log #14-16*) varying from one foot to about three feet. When questioned about the drill casings Inspector is informed, they are historic drill casings from the previous proponent, TMAC has plans to cap and shorten them, Inspector was not given a date as to when this is planned to occur.

Description: Old Drill Casings

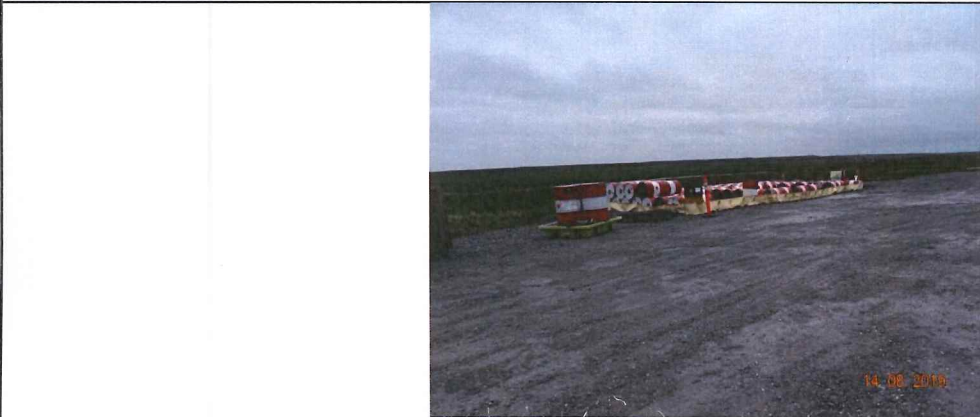
Photo Log # 17

Fuel Storage at the Runway: Inspector notes many 45-gallon barrels in a yellow berm on the side of the runway used to fuel planes (*see photo log #17*). A spill kit is noted near a pump. Three drums are on a "spill tray" that can be used as hold and transport up to four drums closer to the planes when filling. Inspector asks if a spill tray is used and informed that the transportable spill tray can be used as a spill tray. No concerns where noted with this facility.

Description: Fuel storage at the Runway

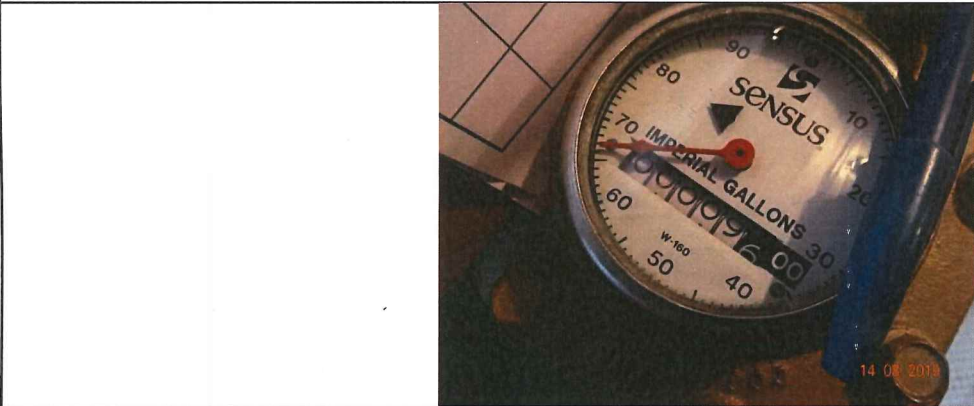
Photo Log # 18

Water Treatment Plant: the flow meter at the Water Treatment Plant is at 9600 square meters (*see photo log #18*), Inspector is informed that the old water meter broke this spring, and that this is the replacement. No concerns where noted with his facility.

Description: New Flow Meter at the Water Treatment Facility

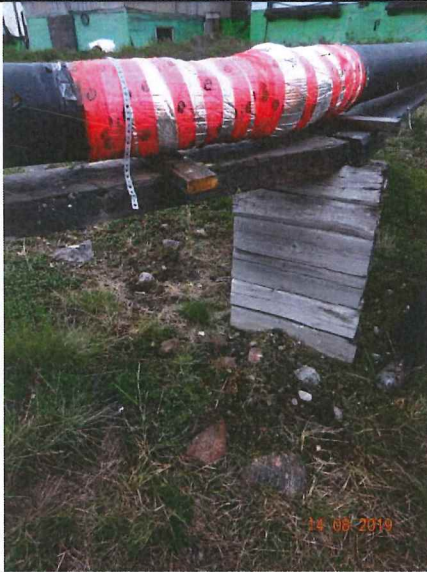
Photo Log # 19

19-252: 100L of grey water spilled when a pipe lift station dropped causing this pipe to separate at the connectors. The camp just opened leading to a smaller spill. Inspector checks area and doesn't notice any impacts to the environment (*see photo log #19*). Post-incident water quality samples where conducted at the shoreline of Aimaokatalok Lake approximately 80 m downstream and compared them to samples taken on July 17, 2019 and found no impacts or changes.

Description: Spill 19-252

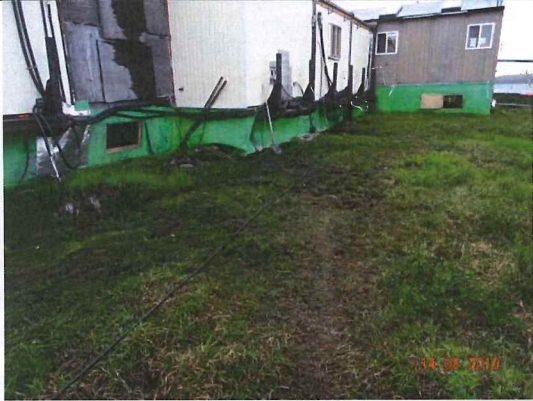
Photo Log # 20

19-301: Approximately 7000L of sewage spilled when the spill was discovered, it was discovered that a Fernco fitting on the main sewage line had disconnected at some point, possibly from improper installation and from the freeze/thaw movement. A small pump was used to recover pooled waste under the building and on the tundra and placed into plastic totes and sent for treatment at the Sewage Treatment Plant. Lime was placed under the building. The proponent didn't want to place too much line on the tundra as it may kill the plants. The sewage is thought to have been absorbed into the tundra and dried up before it can reach the lake. The proponent did not want to remediate the site with heavy equipment as that would cause more damage. (*see photo log #20*) Inspector sees no visible damage to the tundra and considers the spill closed.

Description: Spill 19-301
