Hugh Wilson  
Manager, Environmental Affairs  
Miramar Hope Bay Ltd., Hope Bay Joint Venture  
311 West First Street  
North Vancouver, BC V7M 1B5

re: October 18, 2000 reply to Water Licence Inspection Report

NWB1BOS9801

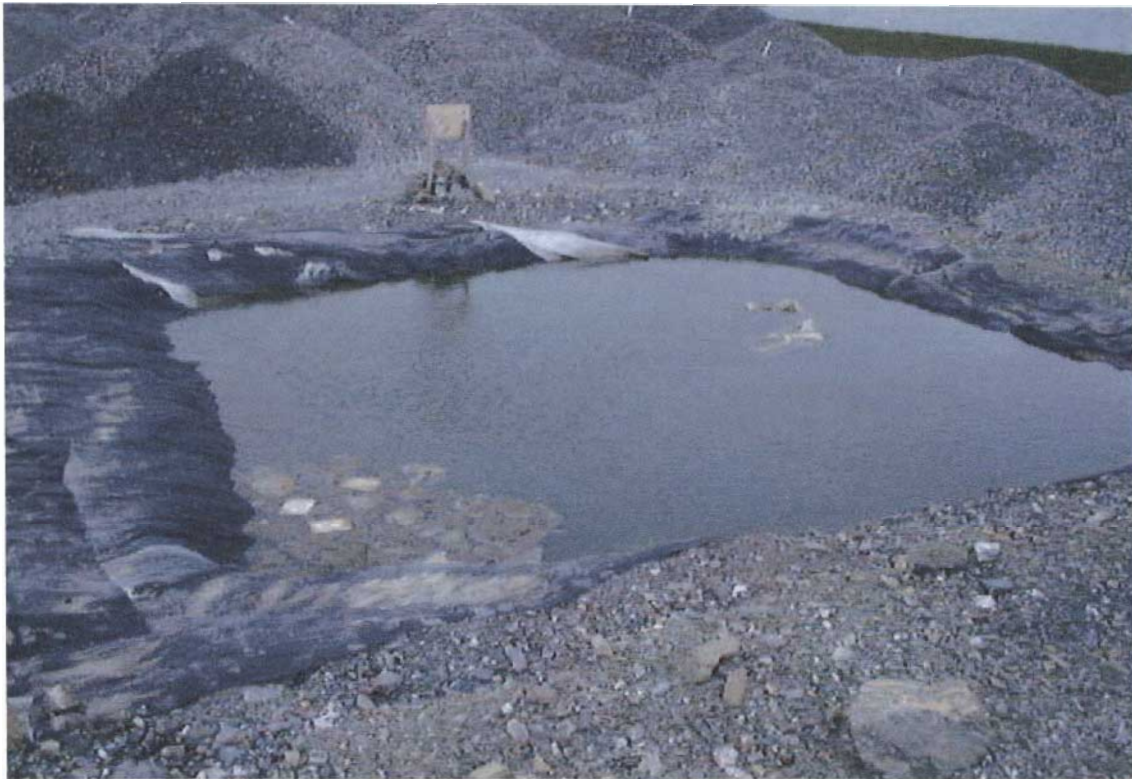
- **Lined sump within the ore storage pad:** As was indicated in the Licensee's October 18, 2000 correspondence, the content of the innermost sump (figure 1) was emptied shortly after the inspection (figure 2). However, analytical results from the sampling of the contents prior to discharge, as alluded to during the inspection, have yet to be submitted.

**figure 1.** Lined sump within the ore storage pad; 2000/07/11.

Considering the unknown nature of the solids within the sump, and the general location of the sump within the ore storage pad, the Inspector directs the Licensee to:

- provide the analytical results of relevant sampling, if taken.
- ensure, through sampling prior to discharge, that all future releases from the sump meet the effluent quality standards contained under part D of the Water licence.
- indicate the path of discharge from the sump.
- determine the disposal location of the sludges from the sewage treatment facility.

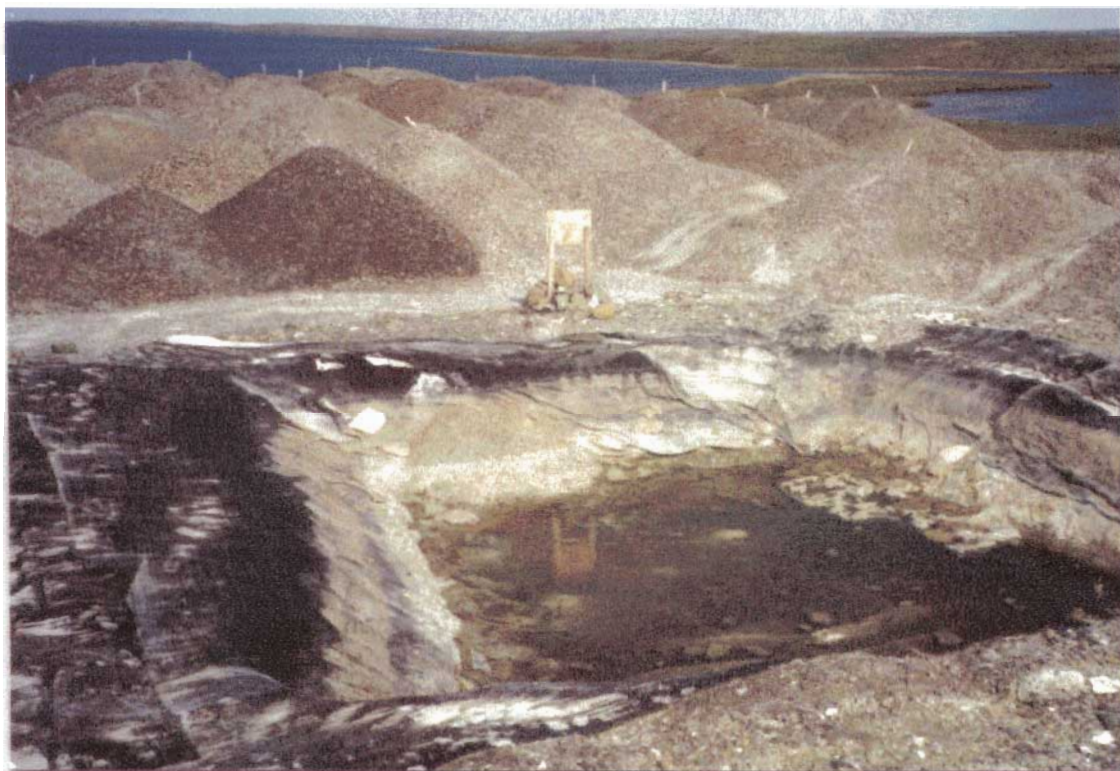
**figure 2.** Lined sump within the ore storage pad; 2000/07/20. (courtesy of NWB)

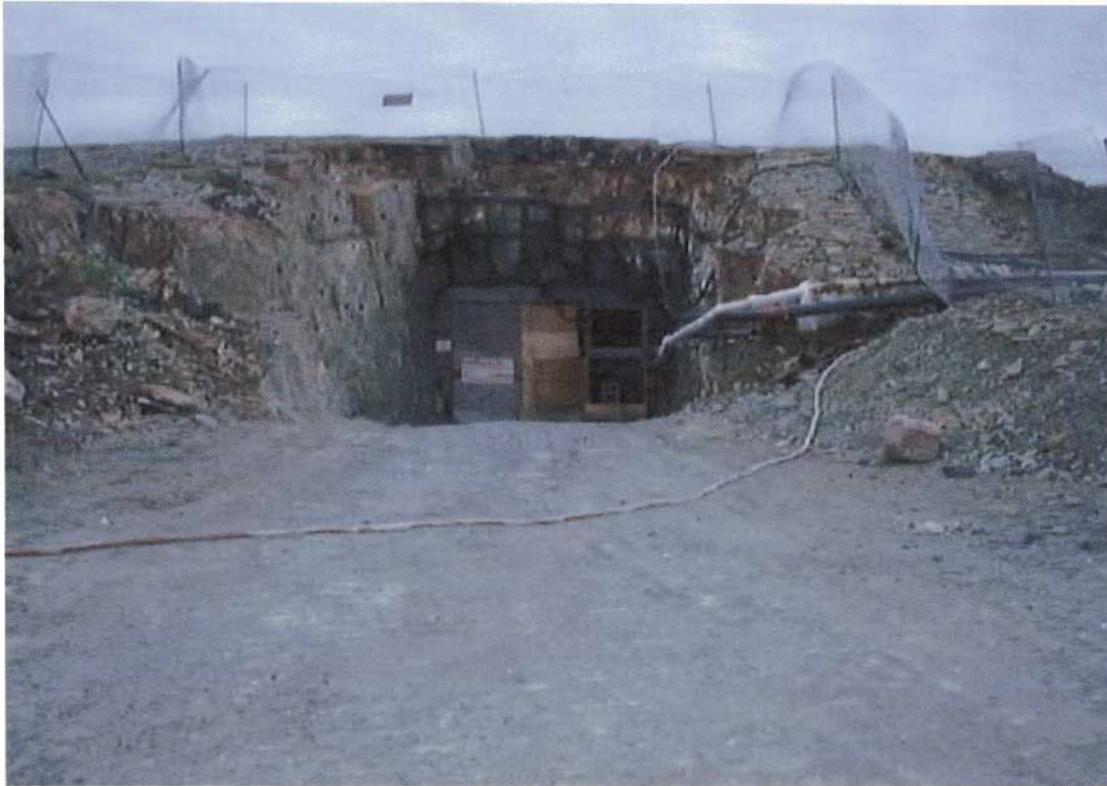
- **Lined sump in periphery of the ore storage pad:** At the time of the inspection, an uncharged line ran from the portal area (figure 3) to the sump (figure 4). However, very little, if any, additional settling material could be observed within the sump in subsequent site visits (figure 5). Nonetheless, the Inspector again points out that maintenance work ought to be carried out on the liner should the sump be utilized as a holding/settling pond of any kind.

**figure 3.** Underground portal area; 2000/07/11.

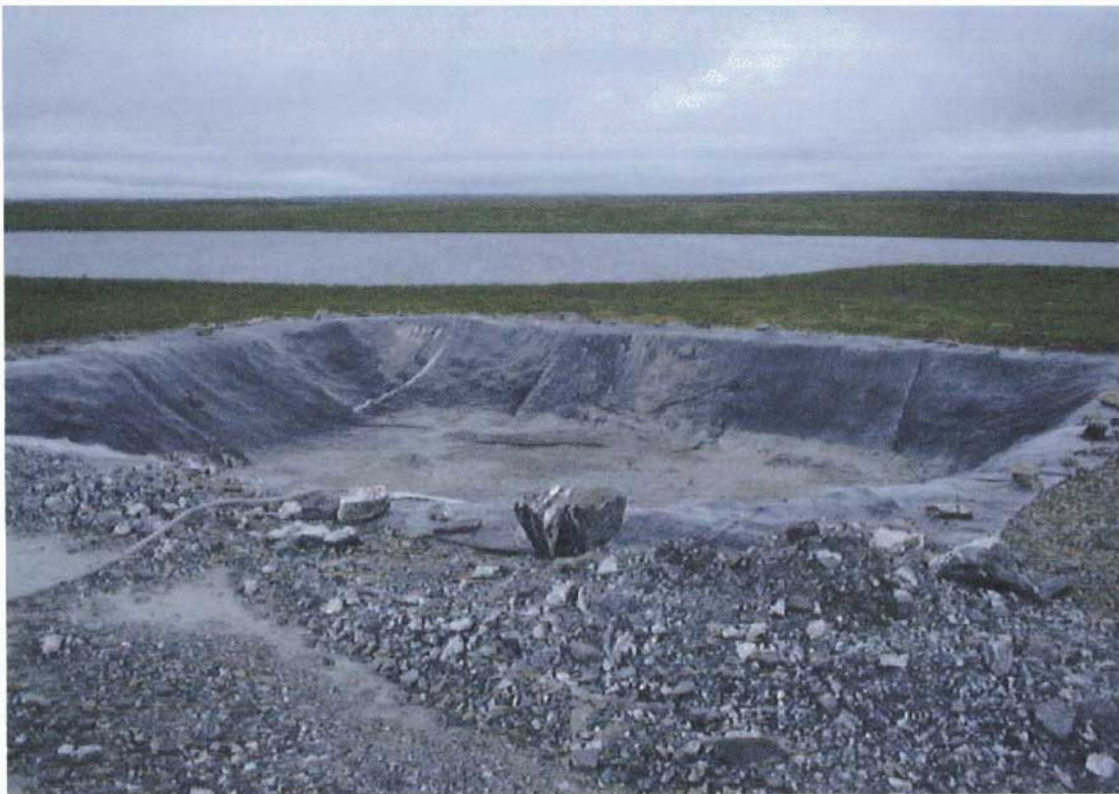
**figure 4.** Lined sump in periphery of the ore storage pad; 2000/07/11.

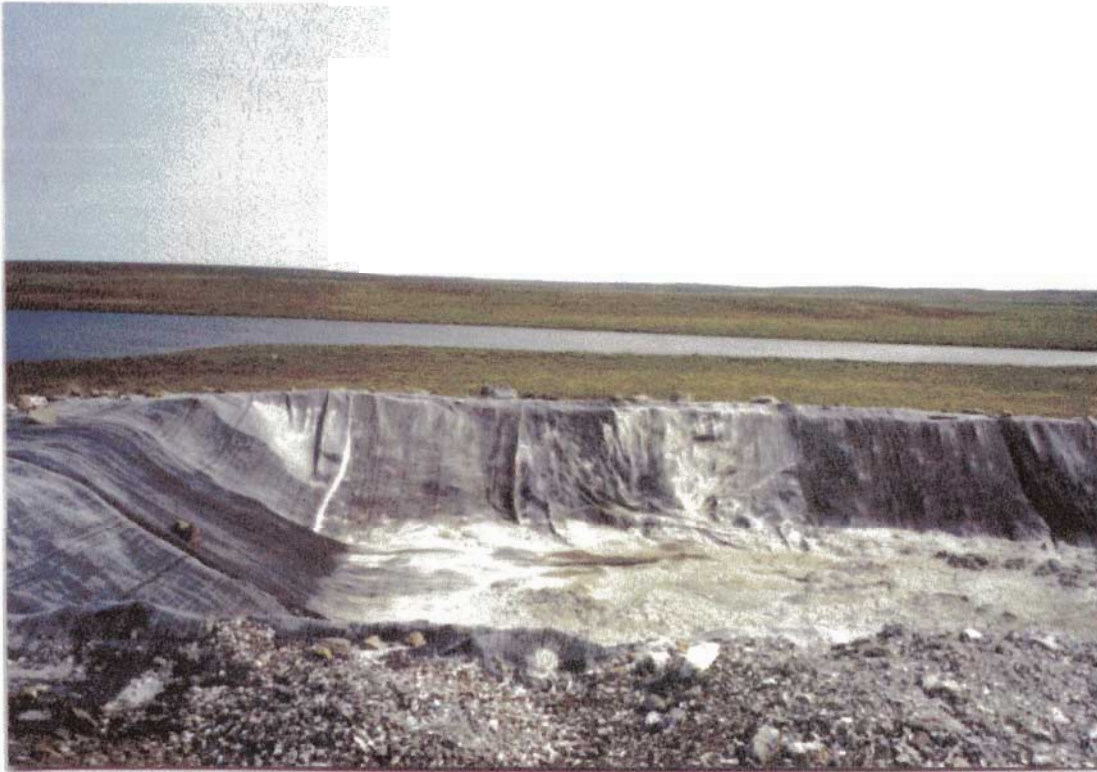
**figure 5.** Lined sump in periphery of the ore pad; 2000/07/20. (courtesy of NWB)

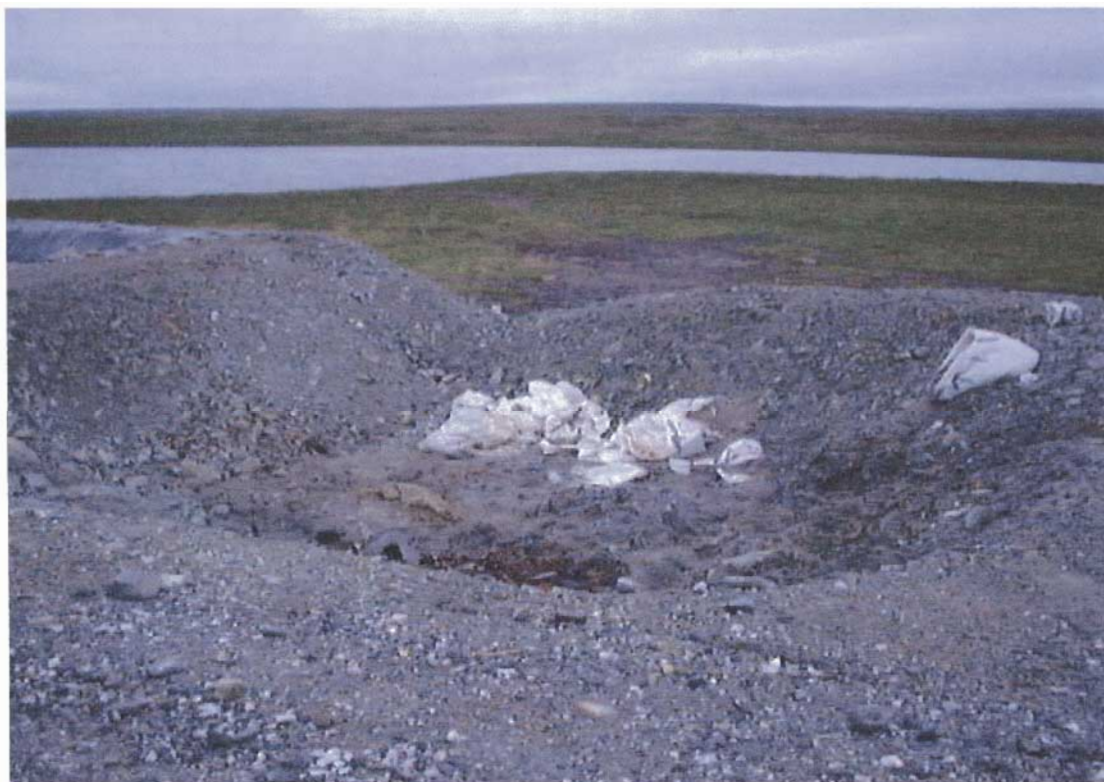
- **Unlined sump in periphery of the ore storage pad:** At the time of the inspection, the sump contained approximately a dozen tattered bags of drill cuttings (figure 6). However, subsequent observations reveal the disposal of solid waste at the site (figure 7). In this regards, the Inspector reminds the Licensee that part F of the Water licence defines the need for prior notice relating to modifications of undertakings. Moreover, the notch in the berm (figure 8), as well as the base of the sump (figure 9), seem saturated. Further, what appears like a channel in the berm of the adjacent lined sump is noticeable (figure 7), while an uncharged line sits atop the sump's berm (figure 9), next to an area where pooled water can be observed (figure 10). In addition, signs of notable runoff are apparent downslope of the ore pad sumps (figures 11-12). Accordingly, the Inspector directs the Licensee to:

**figure 6.** Unlined sump in periphery of the ore storage pad; 2000/07/11.

- halt all disposal of solid waste in the ore storage pad area before the planned modification is submitted to, and duly approved by, the NWB.
- confirm that at no time this summer was the sump included in the path of a discharge.
- indicate, in the contrary, the nature of the discharged substance(s).

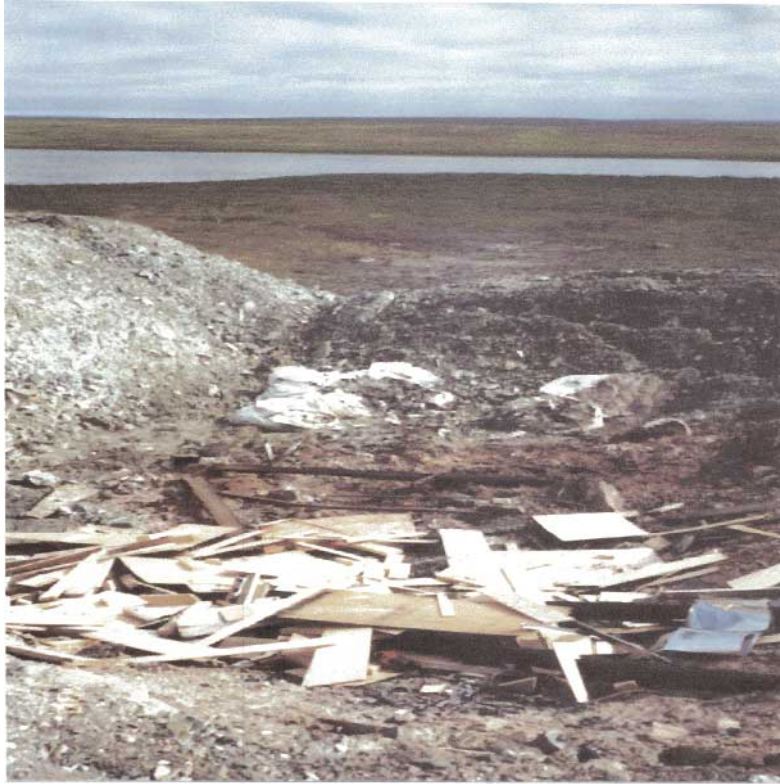
**figure 7.** Unlined sump in periphery of the ore pad; 2000/08/02. (courtesy of DFO)

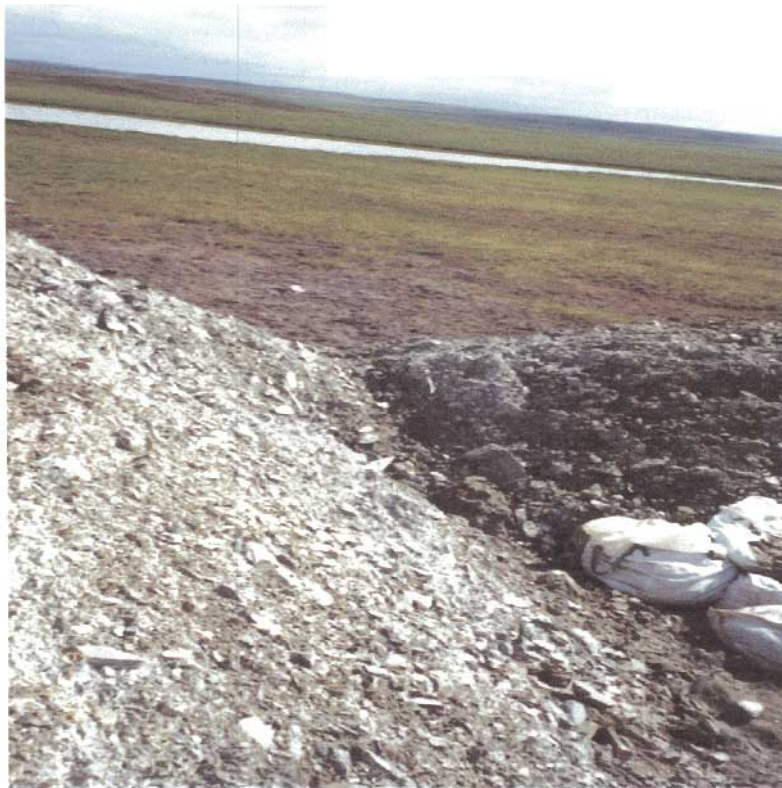
**figure 8.** Unlined sump in periphery of the ore pad; 2000/08/02. (courtesy of DFO)

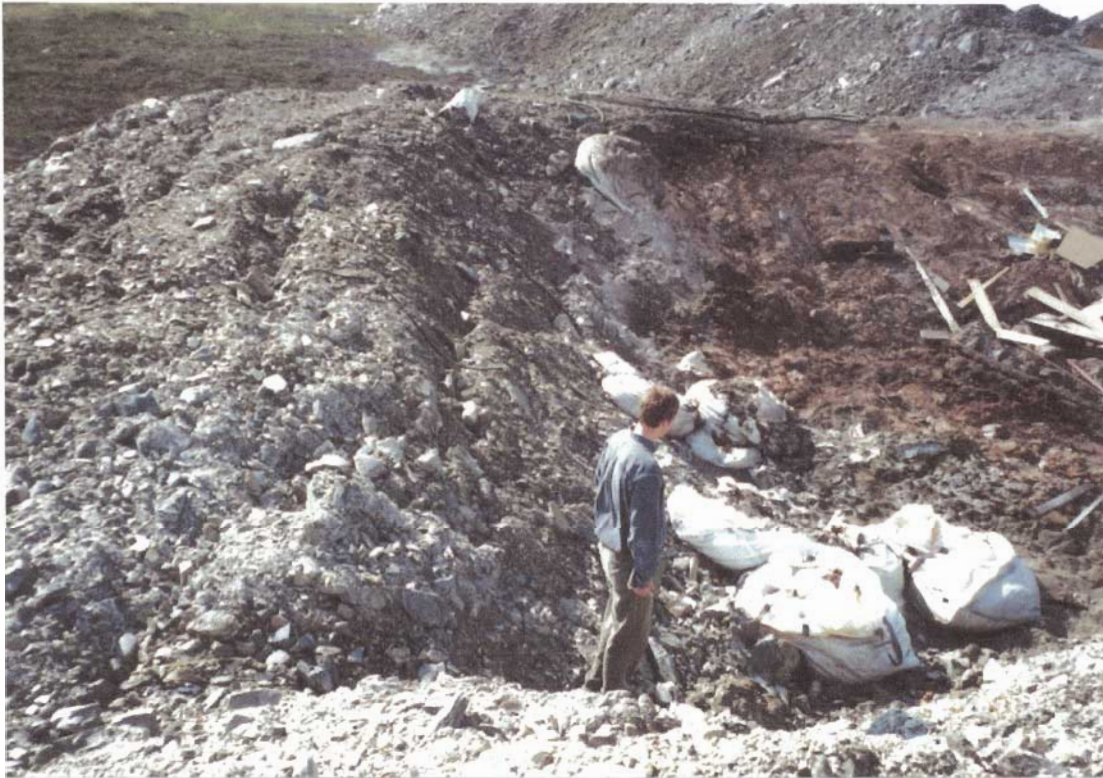
**figure 9.** Unlined sump in periphery of the ore pad; 2000/08/02. (courtesy of DFO)

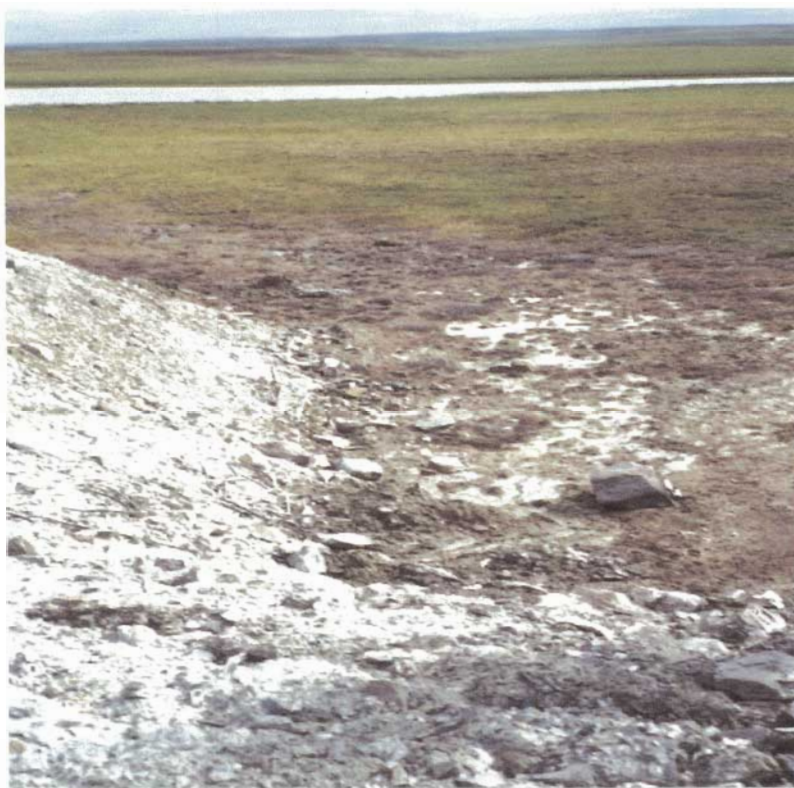
**figure 10.** Area next to the ore pad's unlined sump; 2000/08/02. (courtesy of DFO)

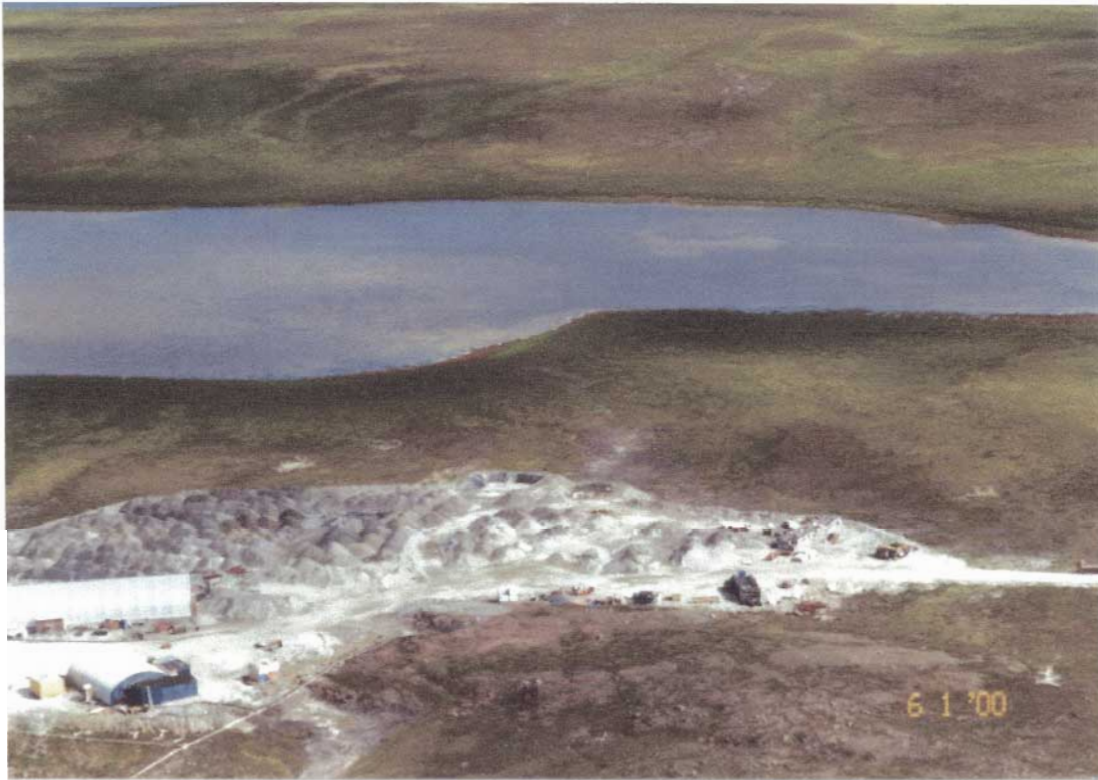
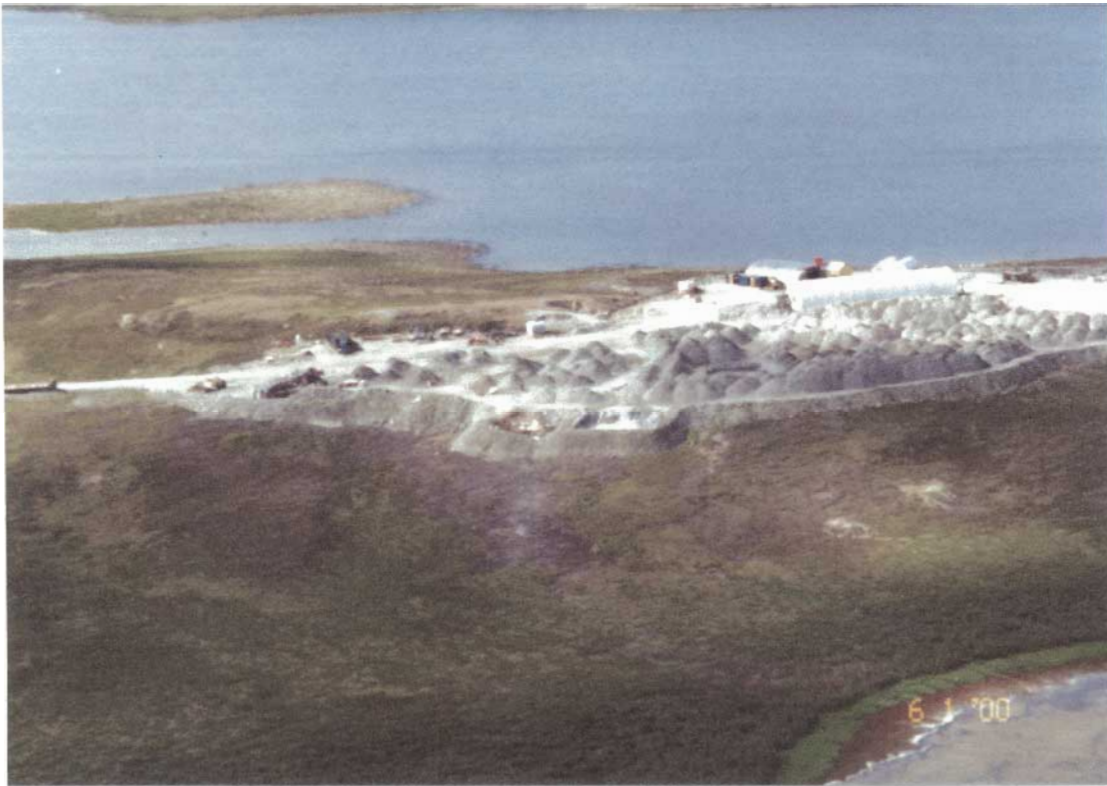
**figure 11.** Ore storage pad and sumps from air; 2000/08/02. (courtesy of DFO)

**figure 12.** Ore storage pad and sumps from air; 2000/08/02. (courtesy of DFO)
