February 12, 2019
Project No: 1CT022.028

RE: Boston Advanced Exploration Project: 2018 Annual Geotechnical Inspection

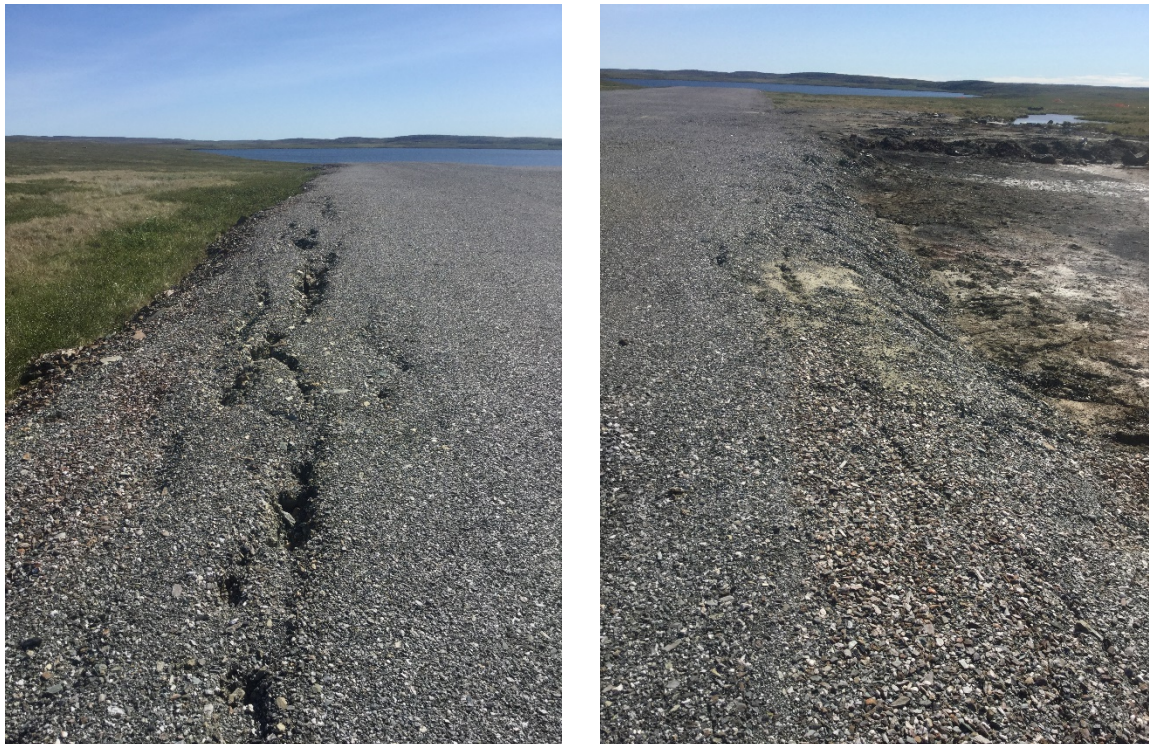
The airstrip does have more pronounced shoulder tension cracks as illustrated in Photos 1 and 2 below, with some extending up to 3 m onto the runway. Some cracks are up to 100 mm wide at surface; however, their rounded surface edge suggest they are not new but are continuously progressing, which is supported by the fact that the cracks are associated with localized depressions, some extending 3 m from the shoulders onto the runway. There are also new smaller cracks, also extending a few meters onto the shoulder. Both old and new cracks are prevalent along most of the runway shoulders but are more pronounced in areas where seasonal ponding is experienced (see right-hand photo below).

These cracks and depressions are normal and form because of permafrost thaw associated with the airstrip rockfill placed directly onto the tundra, thereby deepening the active layer along the shoulder where the fill is thin. This has always occurred but is more visible now because airstrip regrading and maintenance has not been carried out for several years. Beyond the affected airstrip shoulders, the central part of the runway appears relatively smooth with no major depressions. The condition of the runway is likely sufficiently compromised that aircraft operators should conduct an inspection of the runway prior to using it to satisfy themselves that they can operate aircraft safely. Based on recommendations by the aircraft operators, TMAC may have to carry out some airstrip maintenance, likely in the form of regrading of the runway surface.

Photos 1 and 2: The left-hand photo shows some of the more extensive and wider shoulder tension cracks along the airstrip shoulder. The right-hand shoulder depicts some of the newer, but still extensive shoulder cracking.

Observation	Recommendation
Extensive shoulder tension cracks and depressions along most of the runway shoulders caused by permafrost thaw of underlying foundation.	<ul style="list-style-type: none">• Prior to landing any aircraft on the runway, the aircraft operators should conduct their own assessment of the runway conditions and make recommendations for maintenance.
Ongoing progressive thermal erosion of existing erosion gulley west of the camp, upstream of Aimaokatalok Lake.	<ul style="list-style-type: none">• Install silt fencing downstream of the erosion gulley to minimise risk of sediment release to Aimaokalaok Lake.• Continue to monitor area carefully and implement permanent remediation if damage becomes excessive. Remediation may be deferred until Phase 2 Boston mining commences.

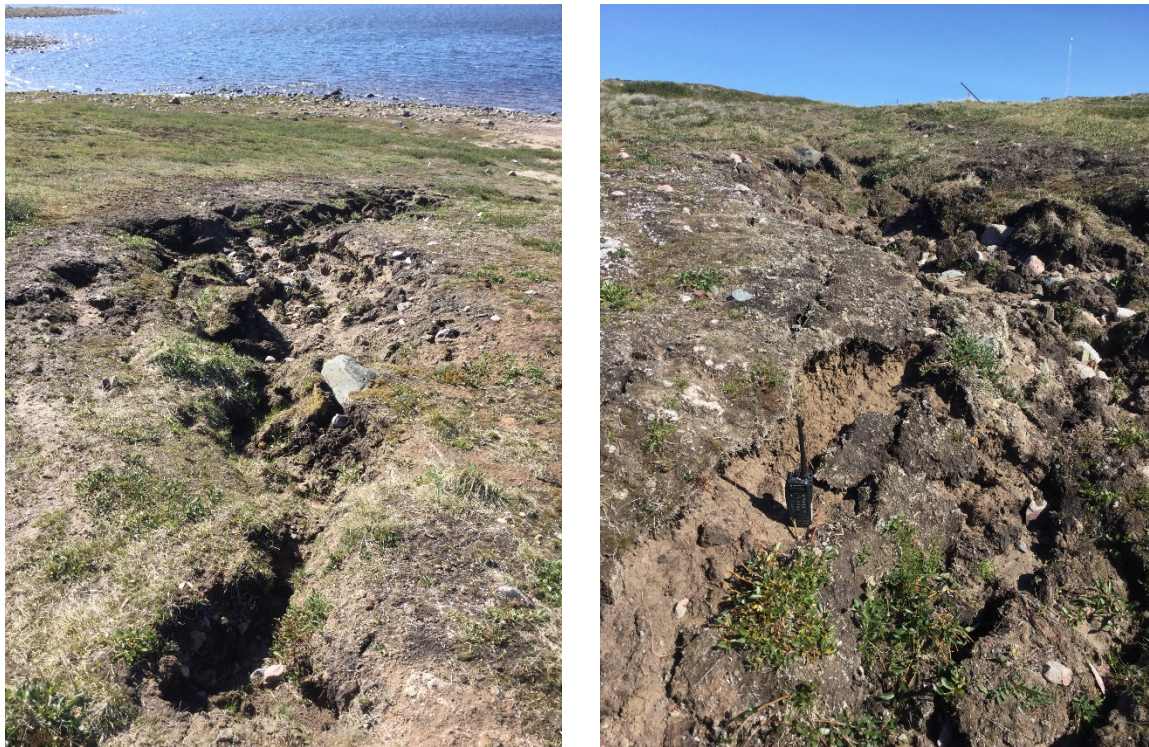
Photos 3 and 4 below shows an erosion gulley along the western slope of the camp leading towards Aimaokatalok Lake. Historically, water has been discharged in this area causing the original gulley. It is however apparent that this gulley is increasing because of thermal erosion as evidenced from the fresh scarp cuts, which were not present in 2017, along the gulley perimeter as shown on the photos. Multiple tension cracks extend beyond the exposed scarps, which confirm that this thermal erosion is progressing rapidly.

Photos 3 and 4: The left-hand photo is looking downstream from the camp towards Aimaokatalok Lake showing the extent of the erosion feature. The right-hand photo shows a close-up depicting some fresh scarps suggesting thermal erosion progression during the 2018 summer season.

TMAC will have to remediate this area; however, considering the fact that there are no suitable construction material or equipment at the site to readily do this, SRK recommends that as a minimum TMAC install silt fencing downstream of the area to avoid sediment loads from entering Aimaokatalok Lake. When construction of the Phase 2 Boston mine commences, this area will however have to be permanently remediated. Meanwhile the area must be monitored carefully (visually), and if the erosion progresses extensively alternate remediation plans may be required.
