Re: 2020 Annual Geotechnical Inspection for the Boston Exploration Site

2020 Annual Geotechnical Inspection Letter for Boston (SRK, 2021)

Subject **Boston Advanced Exploration Project – 2020 Annual Geotechnical Inspection**

Project 1CT022.057

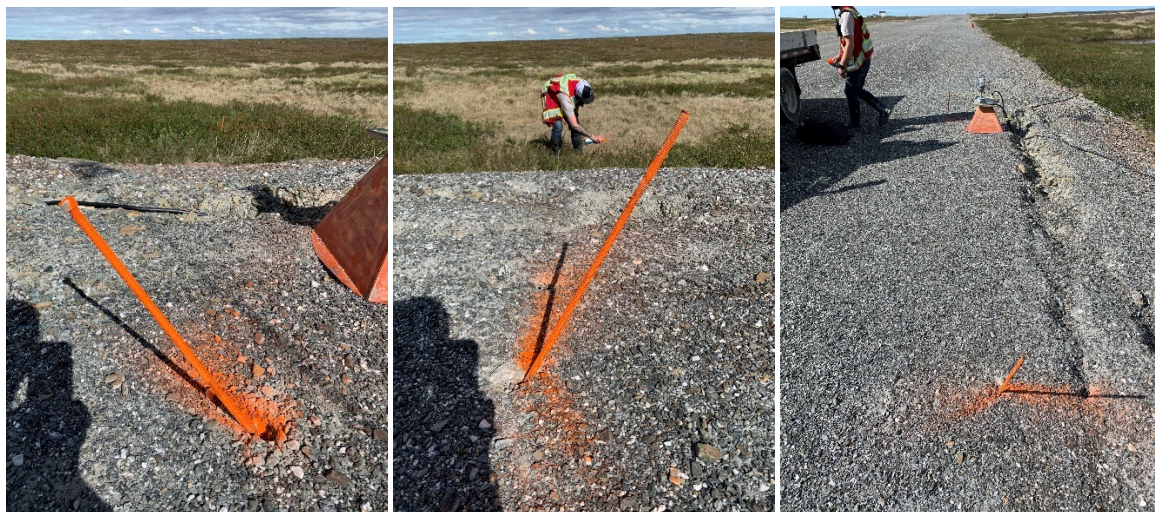
- Aerial imagery (taken by UAV /drone) are in the summer months.
 - This information is summarized in Figure 1 and 2 and will be used to assist to better evaluate changes related to permafrost degradation over time.
 - In the summer of 2021, an addition set of drone images should be taken so that these can be compared to the 2020 images.
- In the worse area where extensive cracking has been noted by the shoulders of the runway, steel rebar pins (painted orange) were installed / driven into the ground by hand. This was done to set up reference points for measuring the lateral impact of permafrost degradation on the airstrip surface.
 - The staked positions located off the airstrip serve as reference points for measuring the lateral impact of permafrost degradation on the airstrip surface.
 - Photographs 1 to 3 below show these installed fixed survey monitoring pins

Photographs 1, 2 and 3: Fix survey monitoring pins installed in June 2020.

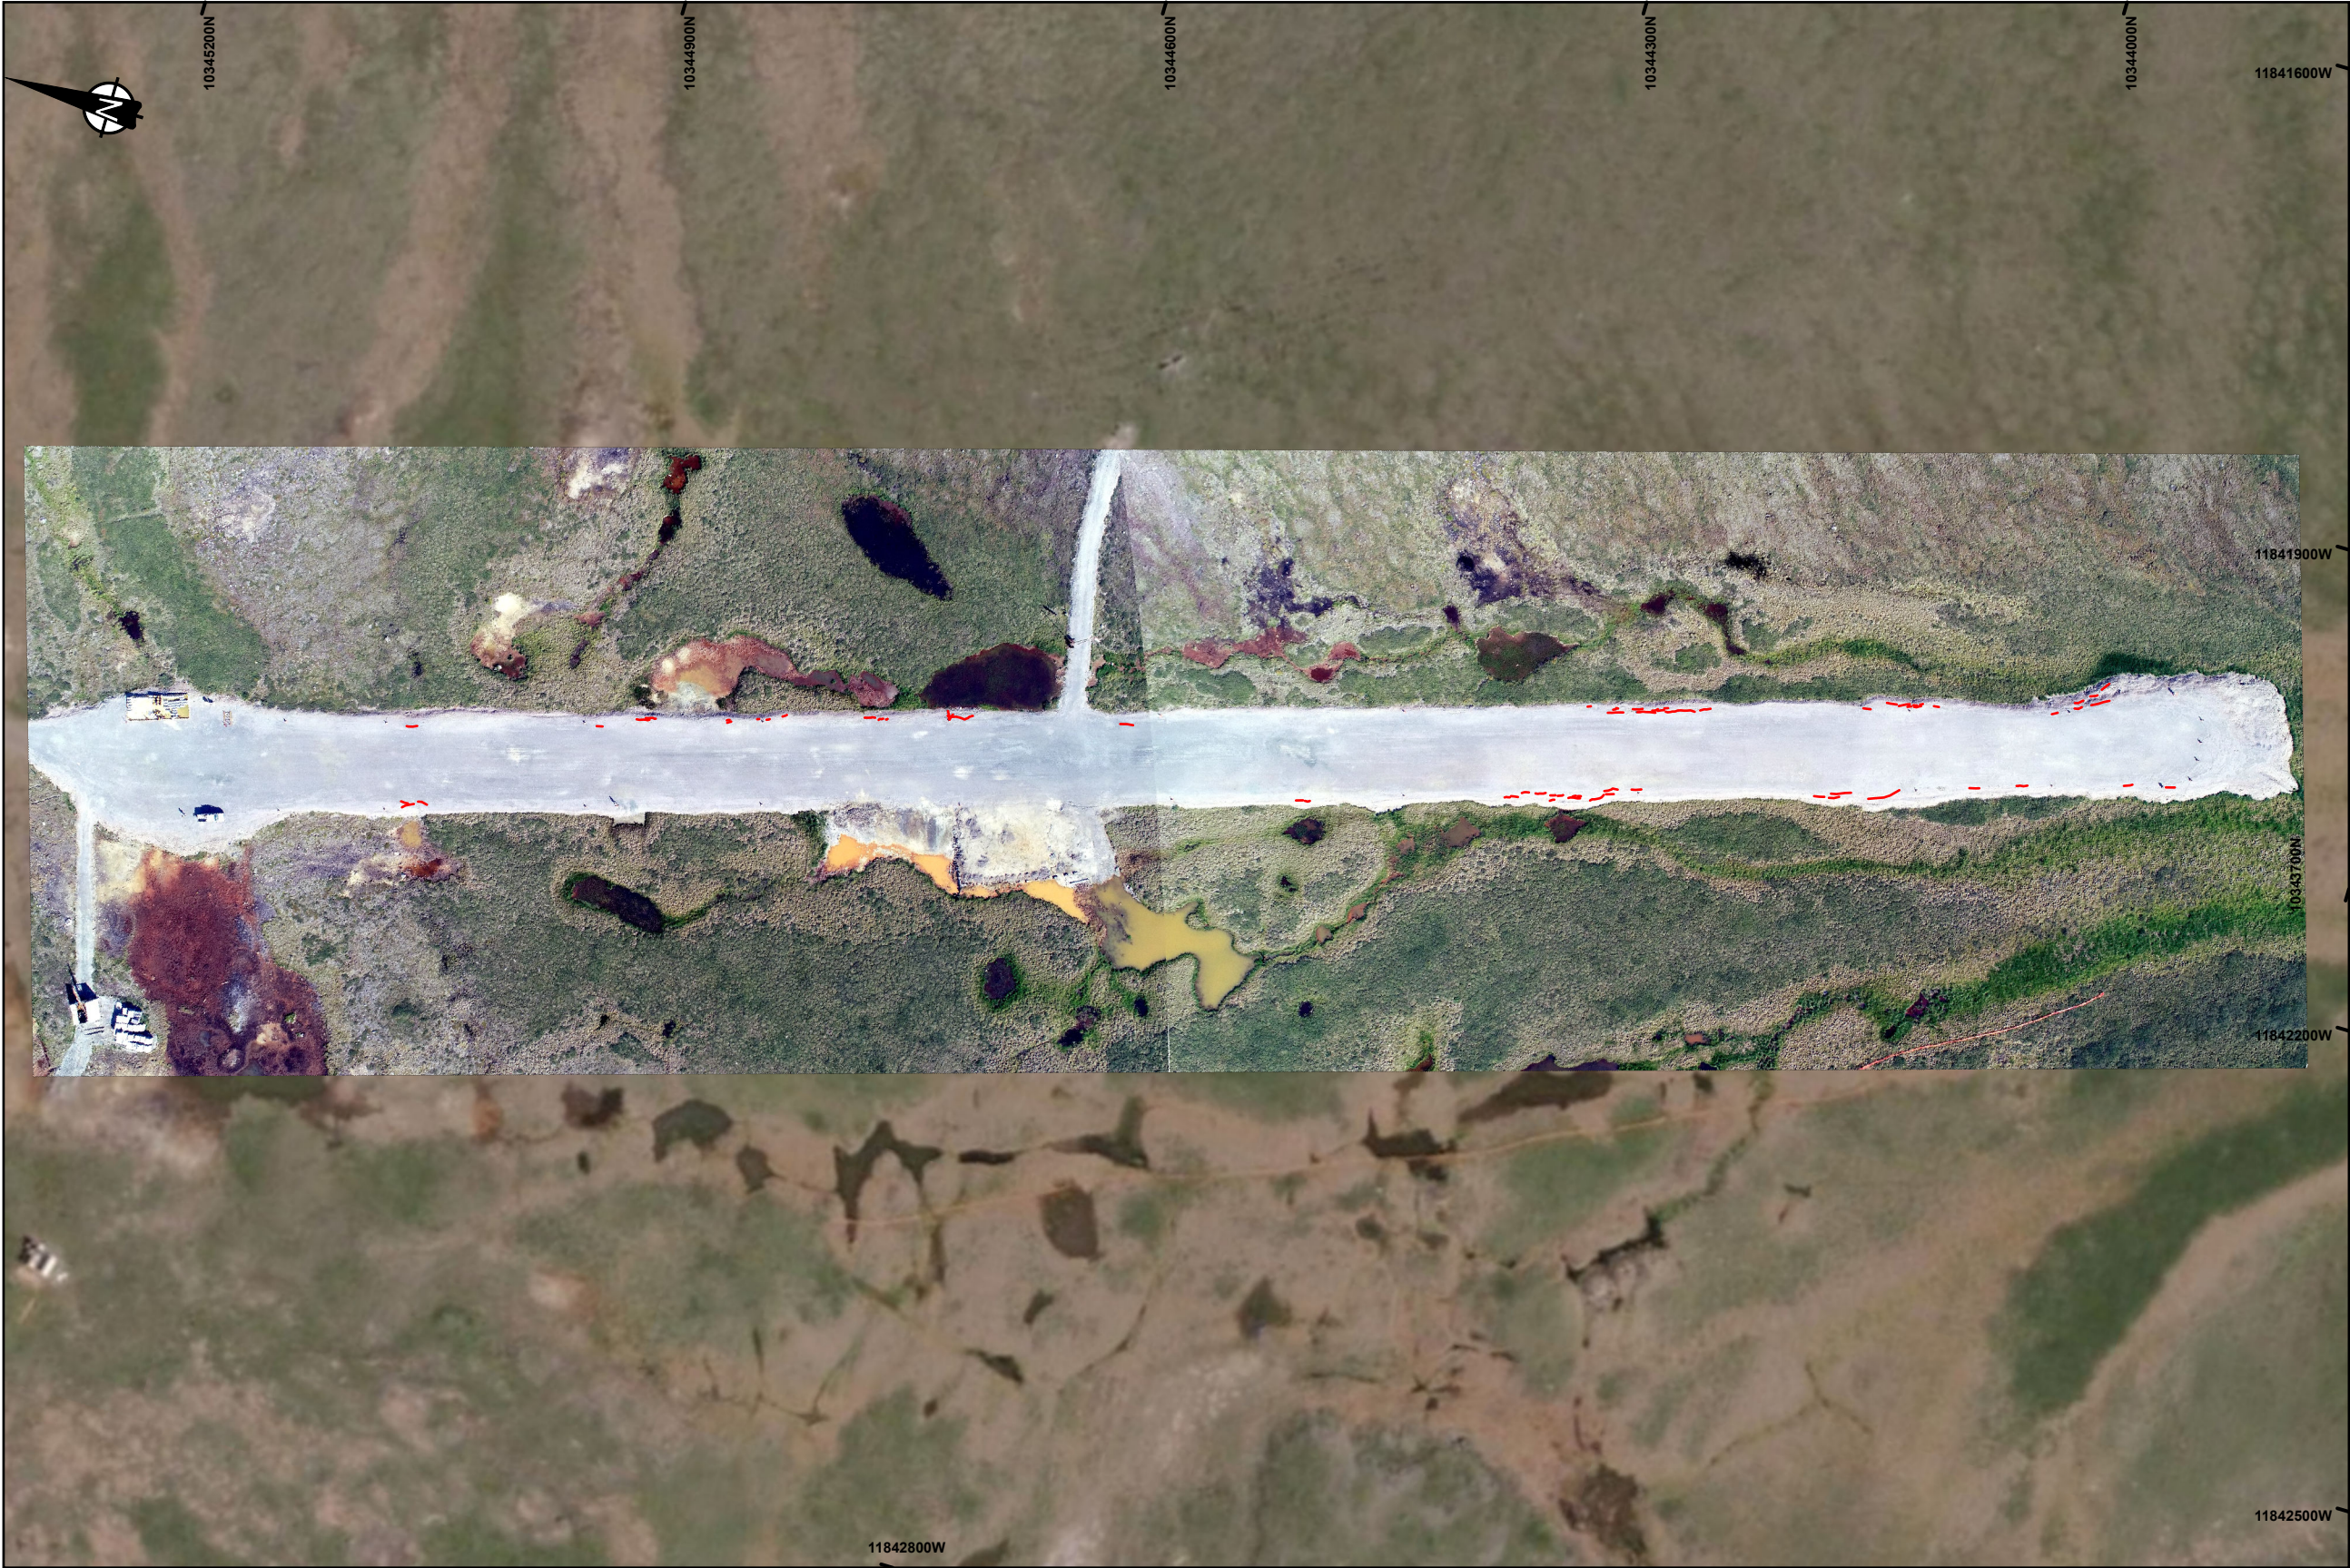
<div>  SRK JOB NO: 1CT022.057 FILENAME: 1CT022_057_Boston_Airstrip_Monitoring</div>	<div>  AGNICO EAGLE Hope Bay</div>	Boston Airstrip Monitoring		
		Boston Airstrip Aerial Image & 2020 Monitoring		
		Date: Feb 2021	Approved: CS/JBK	Figure: 01

Pronounced shoulder tension cracking at the airstrip is a historic and ongoing observation that has been noted in previous years' inspections (example 2018 and 2019 inspections). Due to the lack of availability of equipment and material at Boston, ongoing observation and monitoring of the airstrip has been recommended previously and is suggested to continue. TMAC did implement additional monitoring in 2020 and new monitoring tracking figures have been generated as part of this 2020 AGI (presented as Figures 1 and 2).

The shoulder tension cracking in areas extends 3+ m inwards / onto the runway. At the surface some of these cracks are on the order of approximately 120+ mm wide at surface. Based on inspection of the surrounding area many of these cracks can be seen to be associated with permafrost disturbance from historic drilling activities or associated with seasonal surface water flow ponding against the airstrip edges. Based on the layout of the airstrip and prior exploration history, these cracks and depressions are expected. These cracks form because of permafrost thaw associated with the airstrip rockfill placed directly onto the tundra, thereby deepening the active layer along the shoulder where the fill is thin. An additional cause of these tension cracking, and as noted above, include surface water annually ponding in the summer months against the airstrip. Some of this ponding can be associated with areas where historic exploration drilling has disturbed the permafrost. Based on visual observation around the Boston site, massive ice is expected around this area. In some cases, over 20 years of thermal degradation has led to slight topographic lows which allows for additional surface water to pond and have resulted in some settlement at the airstrip shoulders. The finer crush material placed on the top airstrip running surface (finer as in higher percentage of finer gradation material than the bulk rockfill base) helps to further accentuate this cracking.

Observation	Recommendation
<p>Extensive shoulder tension cracks and depressions along most of the runway shoulders caused by permafrost thaw of underlying foundation.</p> <p><i>Note: This is a historic and ongoing observation that has also been noted in previous years' inspections. Due to the lack of availability of equipment and material at Boston, ongoing observation has been recommended. In 2020 more formal monitoring protocols were implemented on site.</i></p>	<ul style="list-style-type: none"> ■ Prior to landing any aircraft on the runway, the aircraft operators should conduct their own assessment of the runway conditions (in terms of functionality) and make recommendations for maintenance. ■ Permafrost degradation at the Boston airstrip is suggested to continue to be visually monitored each year during the annual geotechnical inspection. Ground level photographs, measurements, and aerial drone imagery should again be collected in 2021 to assist with ongoing monitoring. <ul style="list-style-type: none"> – Note that in 2020 the following positive monitoring improvements were completed: <ul style="list-style-type: none"> – Ground level photographs collected from similar locations and view directions for comparison with the observations made in 2019. – Steel rebar pins (painted orange) were installed in a couple locations along the shoulders of the airstrip and initial measurements taken. Reference points used to help with measuring the lateral impact of permafrost degradation on the airstrip surface. – Aerial imagery taken by UAV (drone) were completed in 2020. Observations of the main areas of ongoing tension cracking (associated primary with permafrost degradation) are presented in Figure 1 and 2. Images will be used to assist better evaluation of changes related to permafrost degradation over time. – Overall based on 2020 inspection permafrost thaw is ongoing but at a slow rate, with similar size cracking and depressions noted in 2019. The above monitoring will allow for more accurate monitoring of these cracks and permafrost degradation in the coming year.
