HOPE BAY MINING LIMITED

2008 Annual Geotechnical Inspection, Boston Advanced Exploration Project, Hope Bay, Nunavut

Project No. 1CM008.006

March 2009

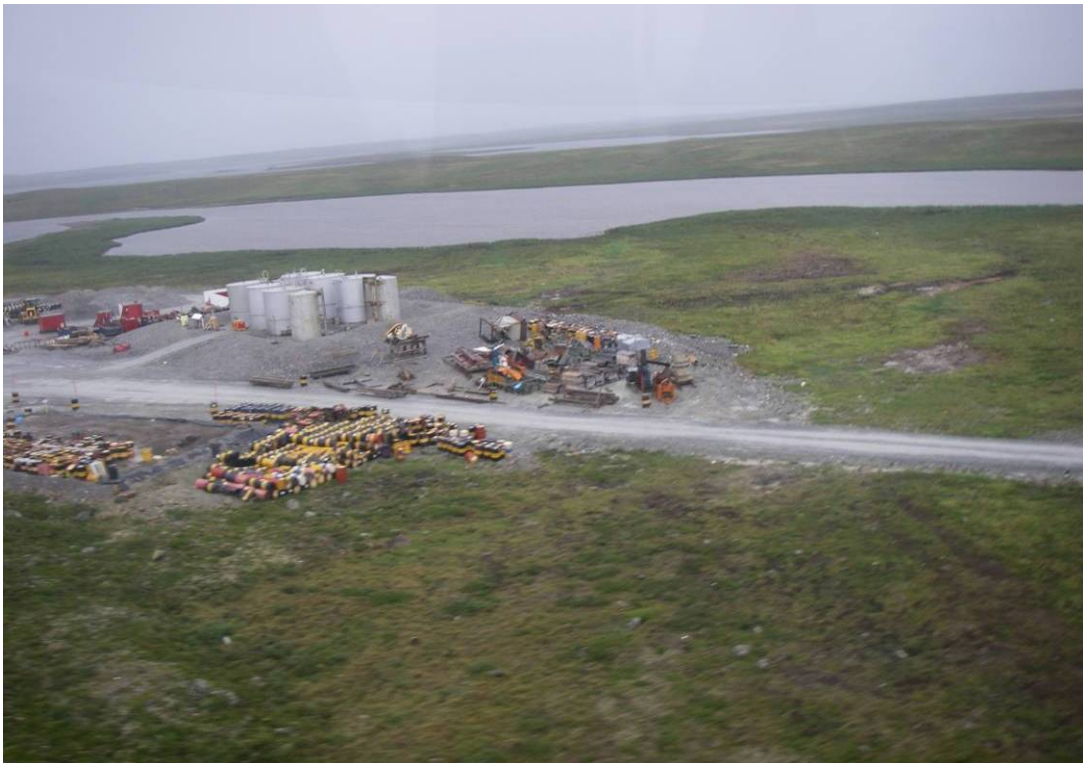
Photo 8: View of scrap metal, old fuel drums and other garbage stockpiled for off-site removal as backhaul opportunities present themselves.

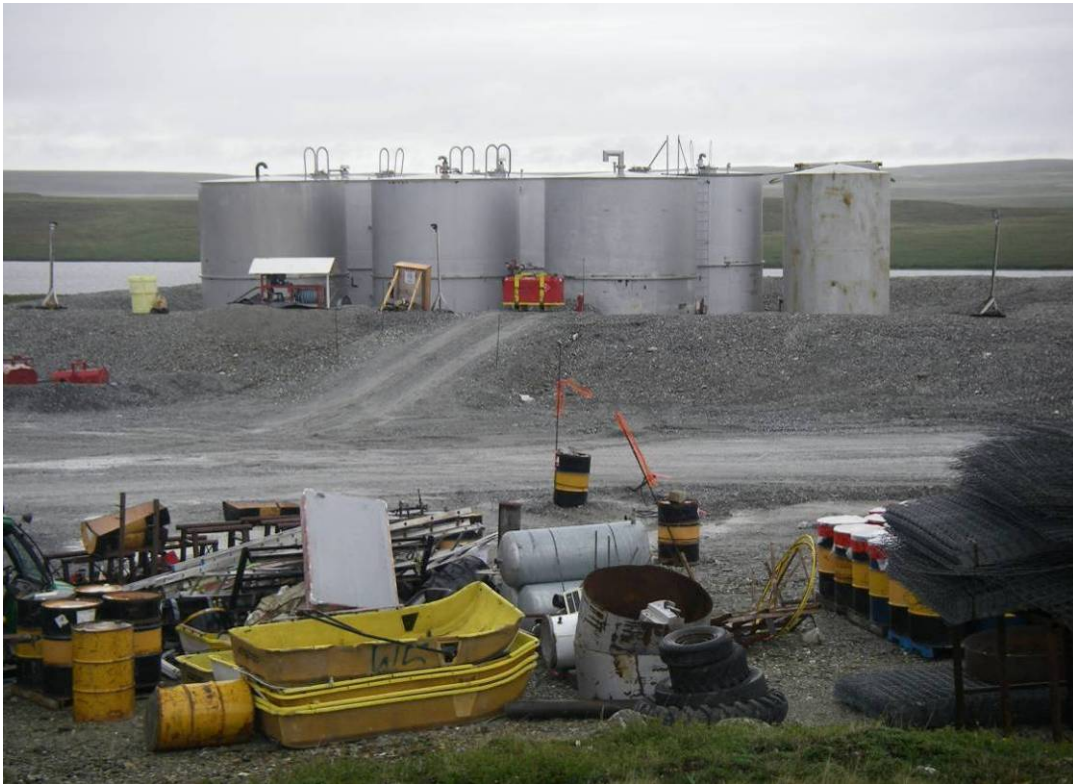
Photo 9: Primary fuel tank farm.

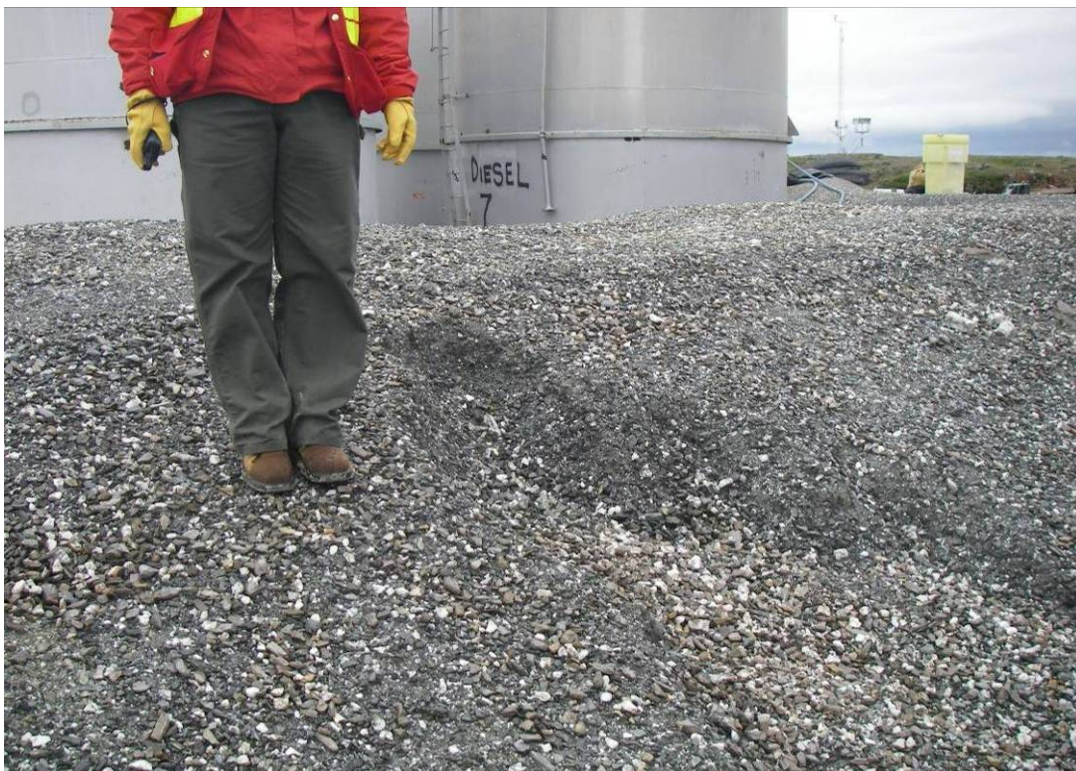
Visual inspection of the secondary containment facility showed several signs of surficial slip surfaces on the containment side slopes, as well as small tension cracks along the berm crest. These were not observed during the 2007 inspection and should be monitored closely. These slip surfaces could be an early indication of settlement, or may simply be due to the oversteepened nature of the gravel berm. The liner is not exposed anywhere, and the containment berms for both the main containment facility and the fuel transfer areas are intact. There were no visible signs of fuel spills outside of the respective containment areas. HBML has rigorous protocols in place for fuel transfer, and provided those are followed, the facility design appears adequate to ensure environmental protection.

Photo 10: Surficial slip surfaces on the west face of the primary tank farm berm.

1. The appearance of surficial slip surfaces and tension cracks on the containment berms should be closely monitored. Remedial measures should be put in place if there are any signs of these progressing. Should excessive deformation of these berms occur (the probability of which is likely low), the tank integrity is not at risk. It is simply the secondary containment that will no longer be in place.
2. The tank settlement monitoring program that has been put in place is good. Quarterly monitoring (or as close to this schedule as the camp operating window allows) of tank

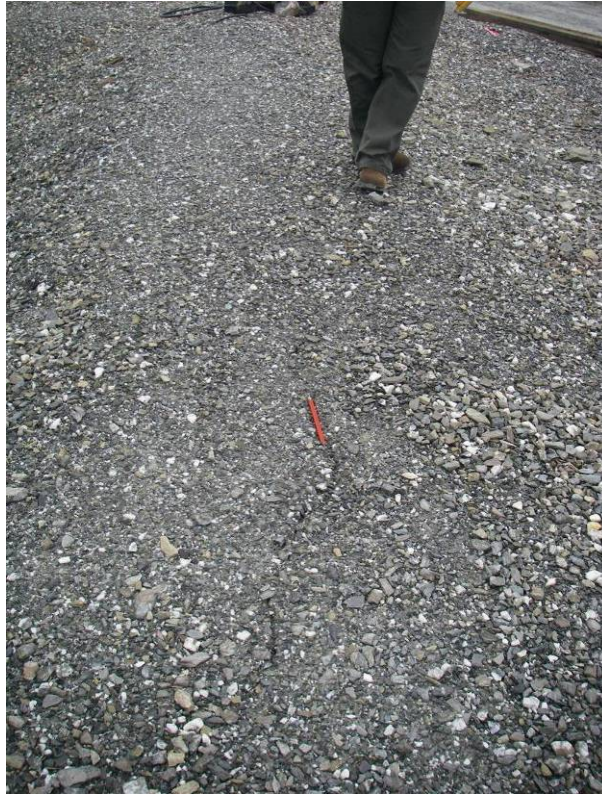
Photo 11: Tension cracks on the primary tank farm berm crest.

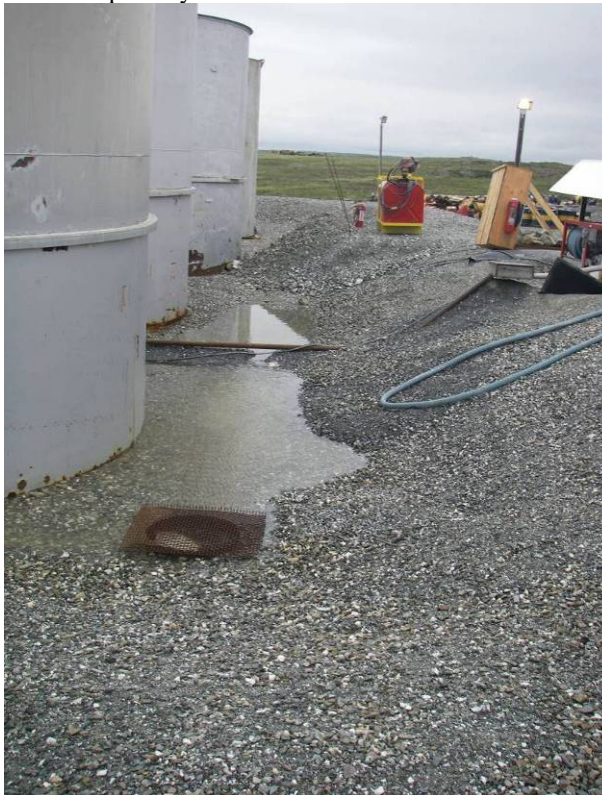
Photo 12: Ponded water in the primary tank farm. This suggests that the liner is performing as intended.

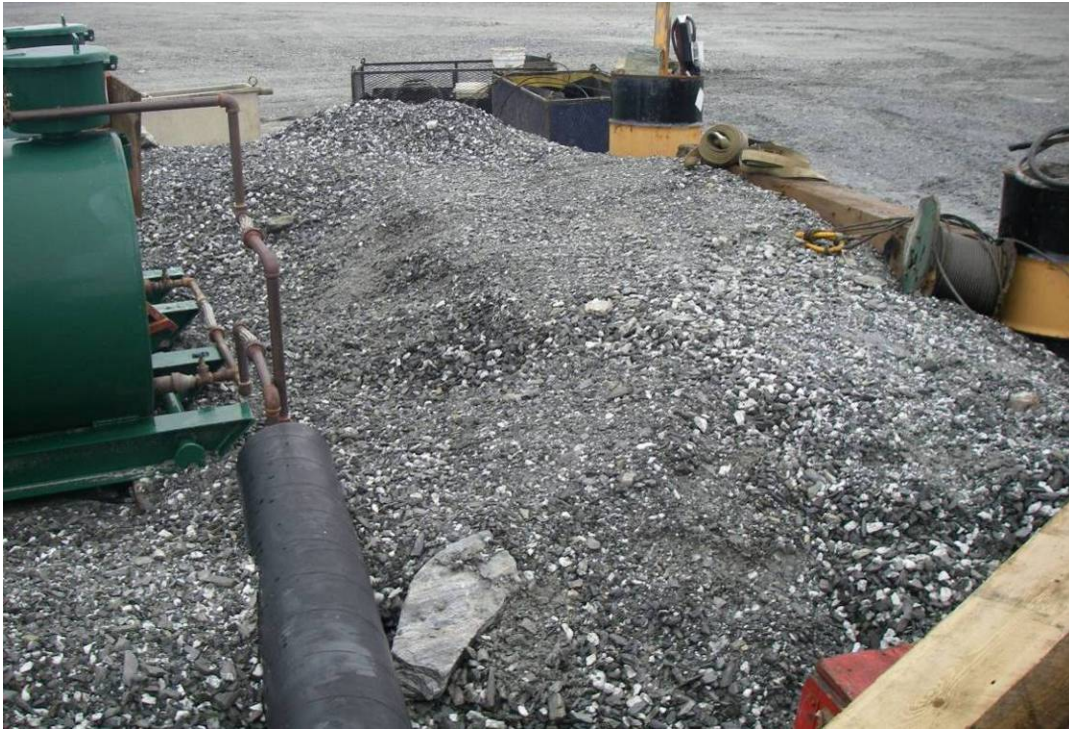
Two double-wall fuel tanks servicing the power plant are located in a secondary containment facility (rockfill berm) immediately west of the maintenance shop. Construction details for this secondary containment are not available; however, visual inspection in 2007 suggested that there was no secondary containment liner. It was further noted during the 2007 inspection that this berm was breached in two locations to accommodate service piping to the facility. These breaches have been repaired to the extent practical, without relocating the feeder pipes, and HBML staff confirms that a liner was installed in 2008.

Photo 13: Diesel fuel tank supply to the camp powerhouse. Containment dike breaches have been repaired.

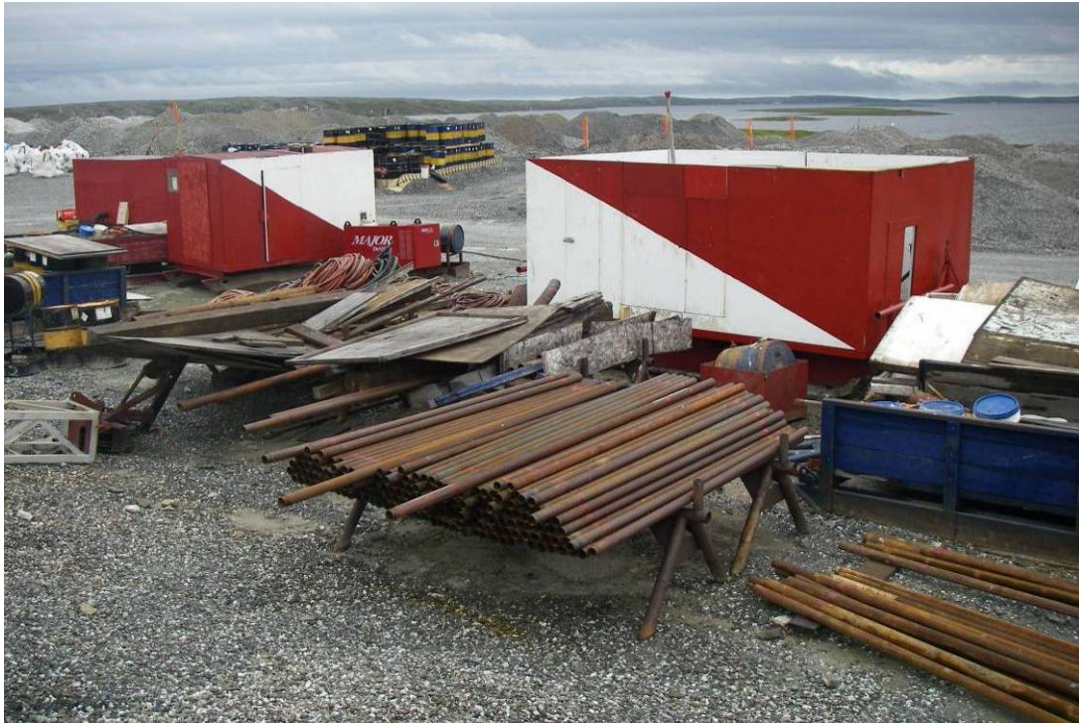
During the 2008 inspection, SRK noted that this facility was no longer being used to store jet fuel, but rather was only used for Tidy Tanks. Jet fuel is stored in drums grouped together on wooden pallets, stacked two high, in an area of the rockfill pad northeast of the primary fuel tank farm. A portable pollution control berm is used to provide secondary containment.

Photo 14: Drill supplies in foreground and jet fuel stored in drums on pallets in the background. No secondary containment.

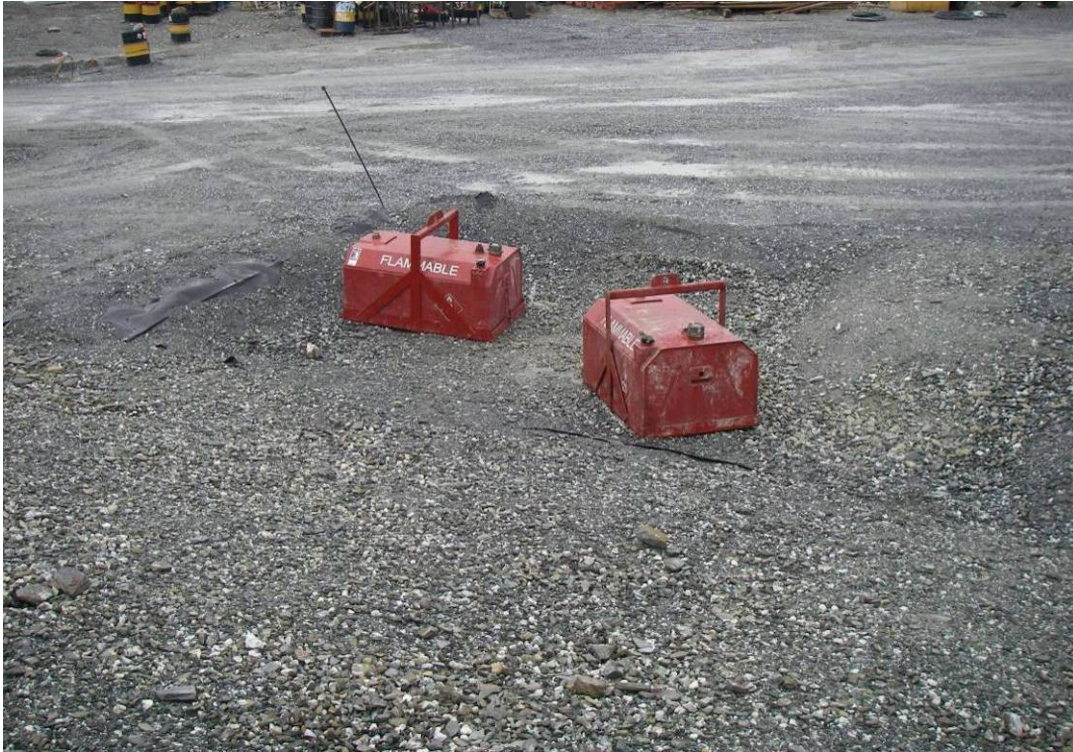
Photo 15: Tidy tanks refueling area in lined facility.

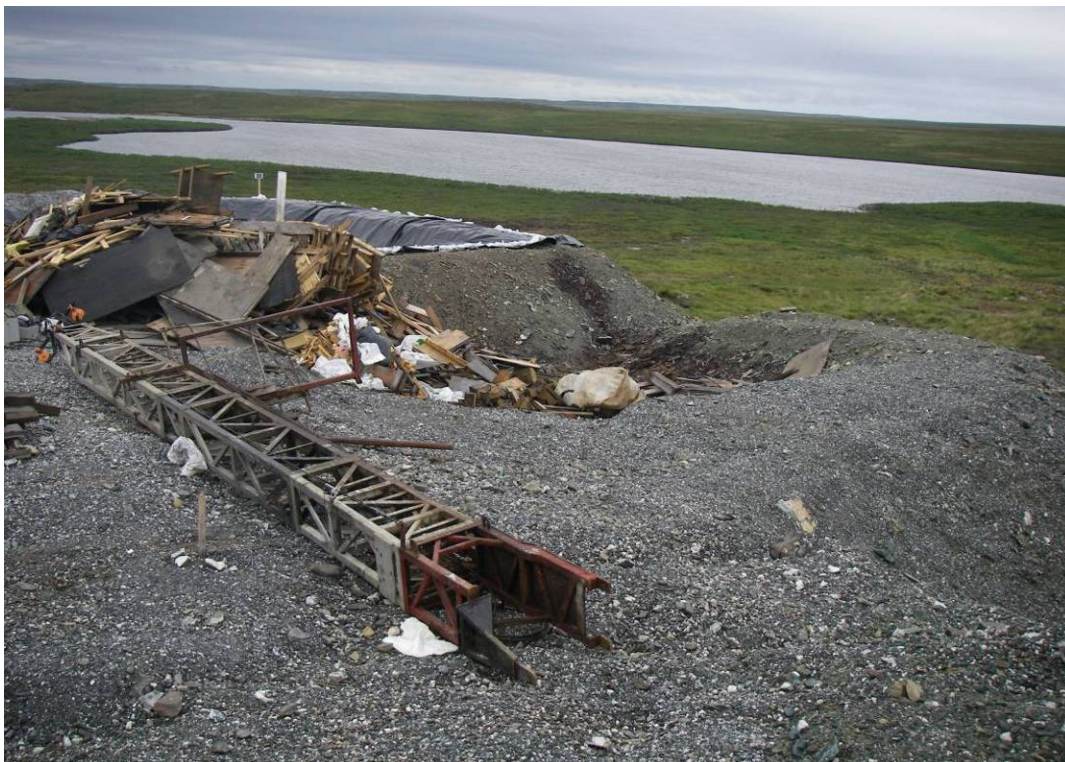
At one time, all wood waste was burned in a burn pit (a converted sedimentation pond) located immediately south of the active sedimentation pond; however, this practice has been discontinued and all non-combustible materials was removed from the pit. The reason for discontinuing this practice is not clear. The burn pit itself is still used to contain unburned wood waste and ash, until such time as HBML adopts an alternate strategy to dispose of these elements.

Photo 16: Wood debris in burn pit.

1. Confirm through an appropriate waste inventory that there are no waste that require environmental containment.
2. Since the burn pit no longer serves its original design intent, it should be cleaned out by removing all the wood waste and ash and relocating it to an appropriate disposal site.
3. If the burn pit could be used to perform another functional use it should be so designated, otherwise HBML should prepare a plan to completely decommission this facility. SRK understands that HBML has commissioned a project to develop a closure plan for the Boston Camp, and addressing the burn pit will be part of that scope of work.

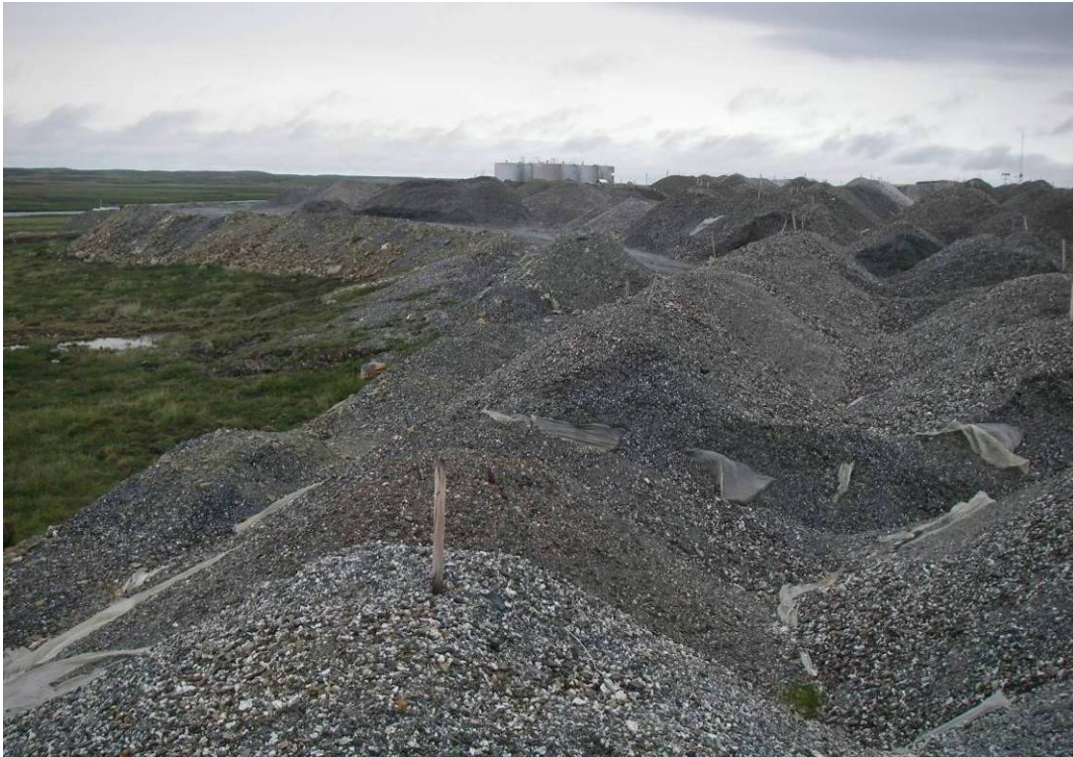
A large number of crushed ore stockpiles are located on the north-western portion of the camp complex foundation pad. This ore comes from the 27,000 ton bulk sampling program carried out between 1996 and 1997. These stockpiles are individual uncompacted end-dump piles. Surface water drainage from this part of the foundation pile is not specifically separated from the rest of the foundation fill pad, and is not contained, but allowed to flow directly onto the tundra.

Photo 17: Crushed ore stockpiles.

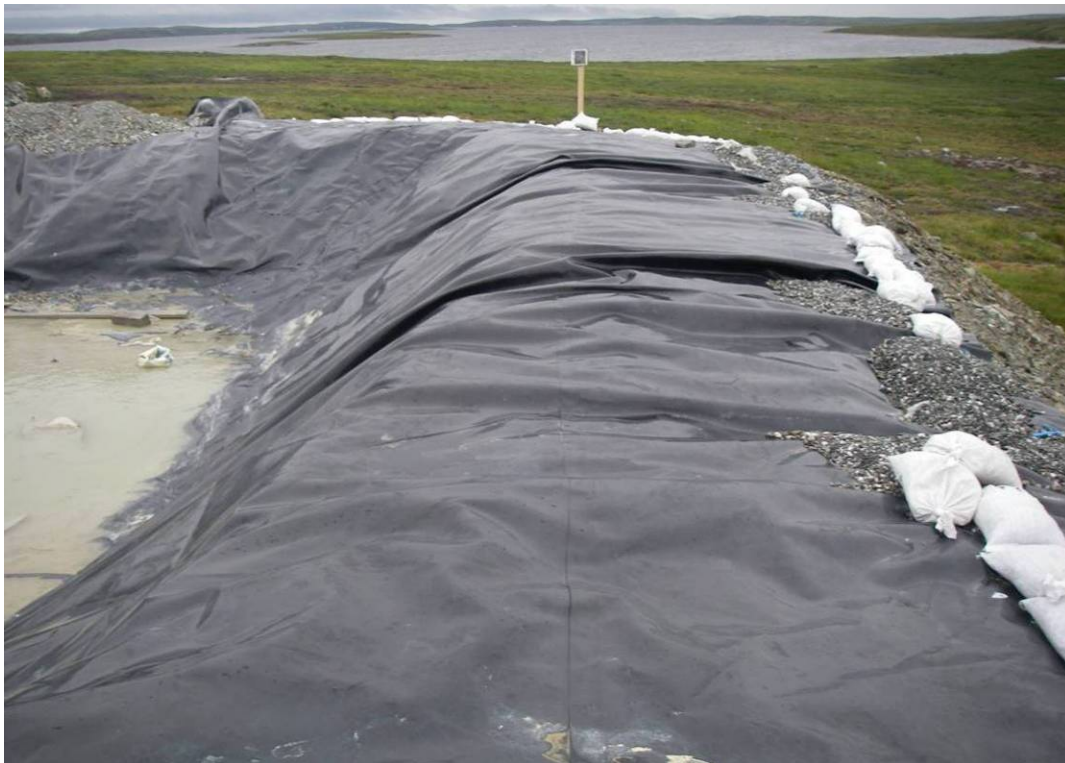
During the 2007 inspection it was noted that the pond was in extremely poor condition, and SRK recommended that the pond either be decommissioned or repaired. The 2008 inspection revealed that HBML had done some remedial work on the liner. HBML confirmed that a contractor was brought in to repair and reset the liner, and the top of the liner was repositioned and re-bedded with sand bags. The pond still has a small amount of water in it, likely from rainwater and/or snowmelt. The pond also contained various amounts of gravel (crushed ore) and wood debris which would compromise the liner integrity.

Photo 18: Sedimentation pond liner repositioned and repacked with sand bags.

3. If the pond is to be used to retain water for any length of time, a suitable leak detection monitoring system should be implemented. As a minimum, a protocol involving frequent visual inspections would have to be put in place for the pond. Excessive and prolonged leaking will lead to permafrost degradation, which in turn will result in differential settlement that may cause the liner in the pond to fail.

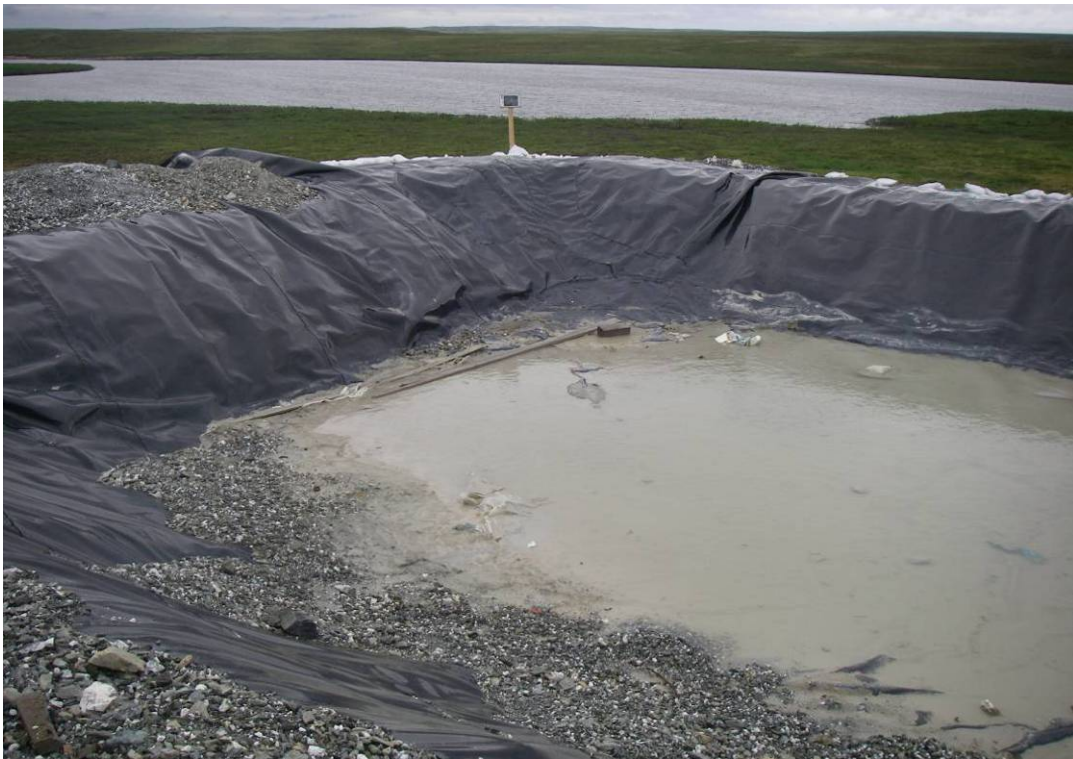
Photo 19: Note: wood debris, gravel and other sediment in base of sedimentation pond.

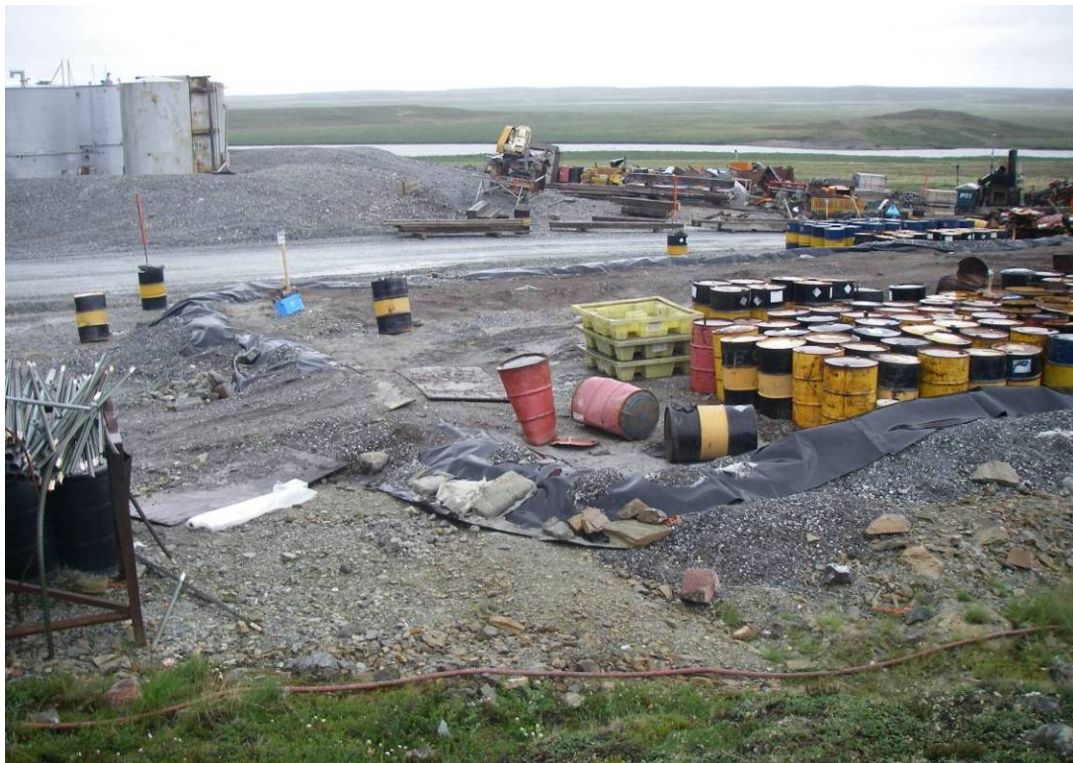
Photo 20: North end of landfarm. Note: ramp into landfarm.

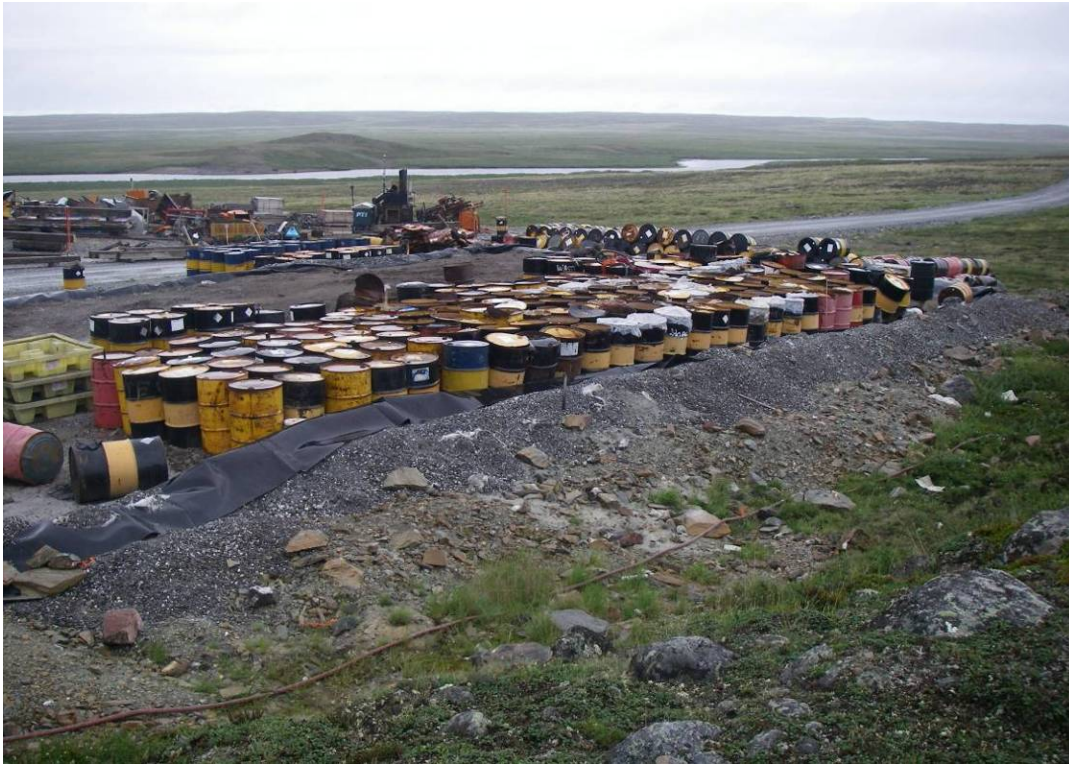
Photo 21: Fuel drums filled with contaminated soil stored on top of the soil filled landfarm.

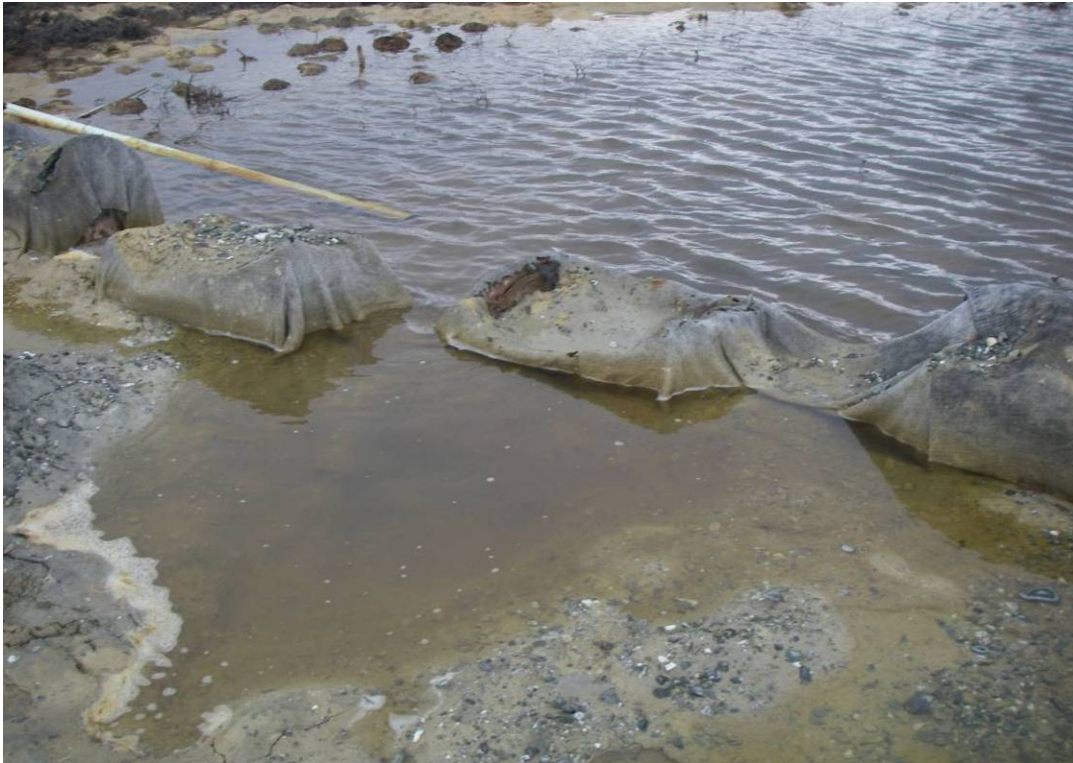
Photo 23: Drill cutting sedimentation pond outlet with geotextile filter cloth wrapped around old fuel drums. Water however by-passes this system which is in disrepair.

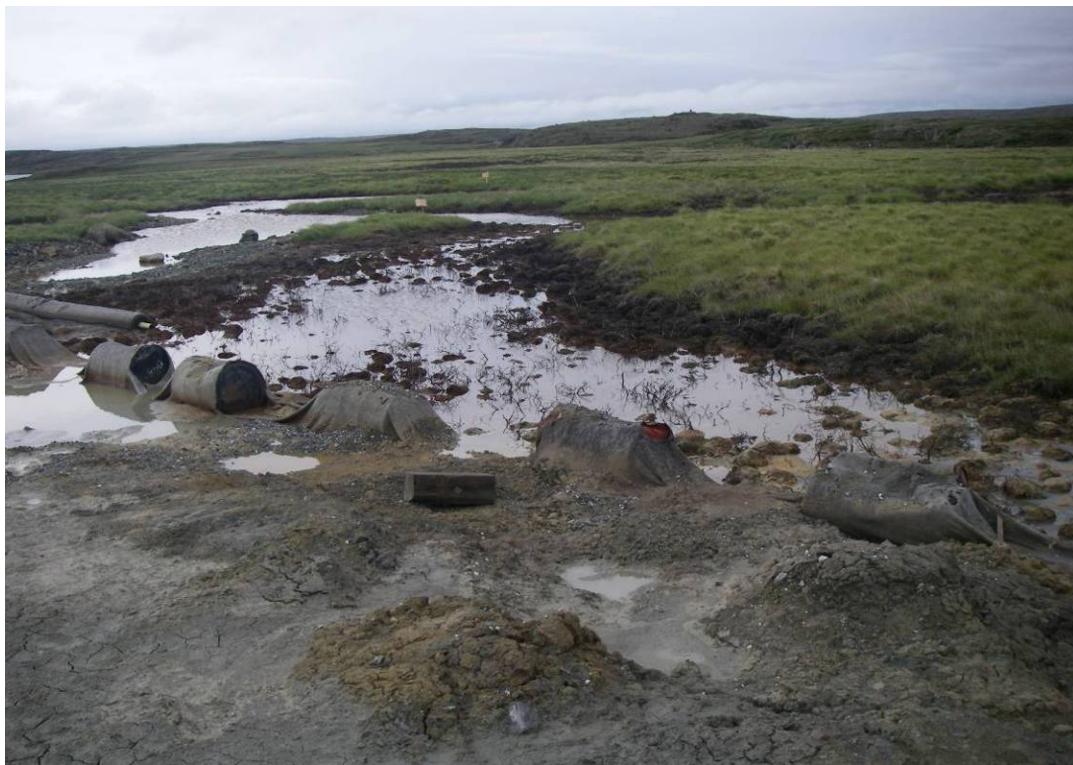
Photo 24: Drill cutting sedimentation pond outlet. Note: filter cloth is no longer functional.

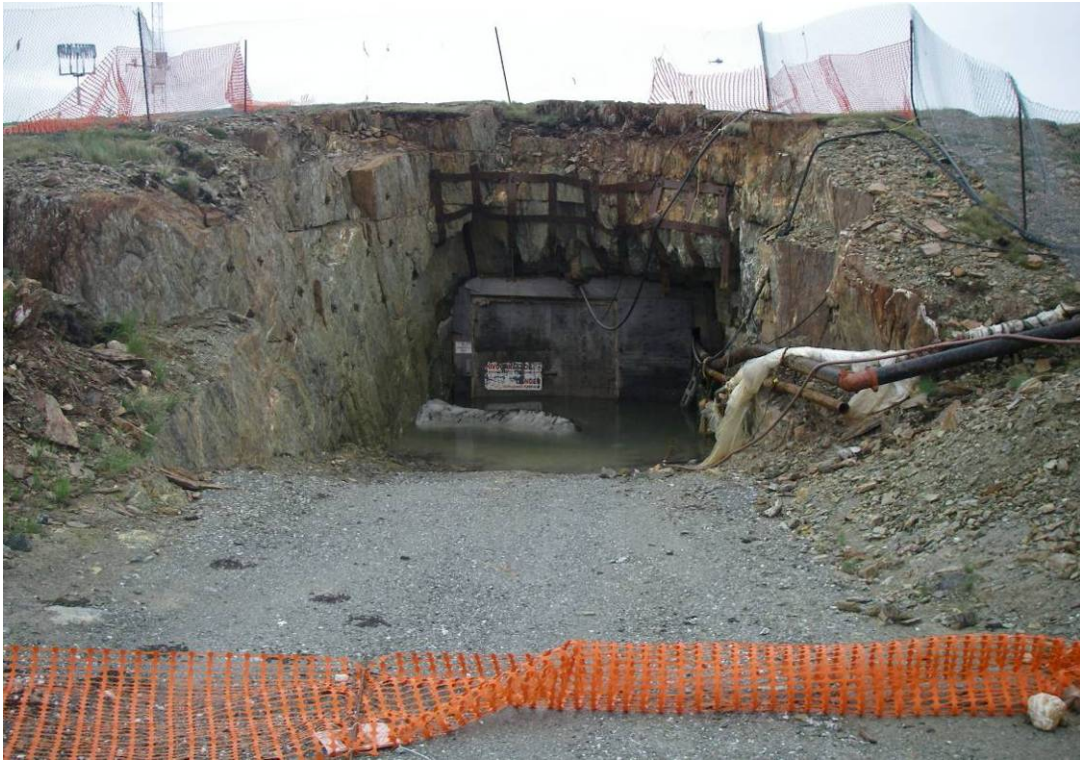
Photo 25: Portal entrance. Note: upper barricade needs to be repaired.

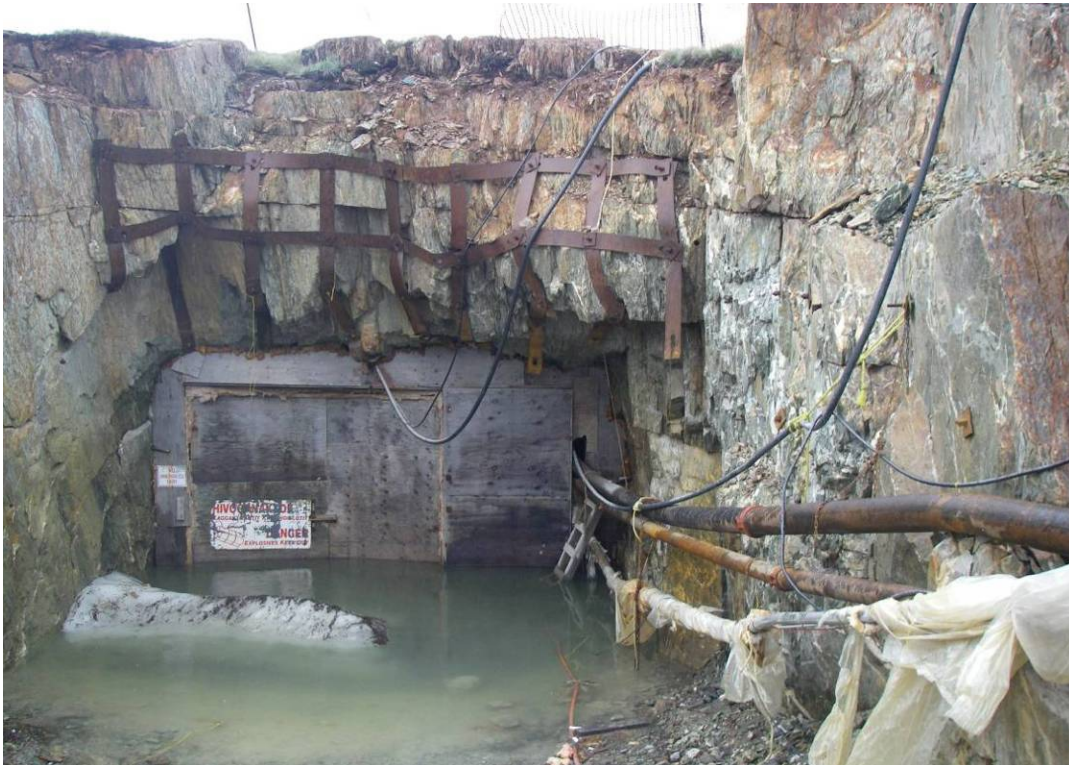
Photo 26: Portal entrance. Note: access warning sign is faded and the area is flooded at time of inspection.

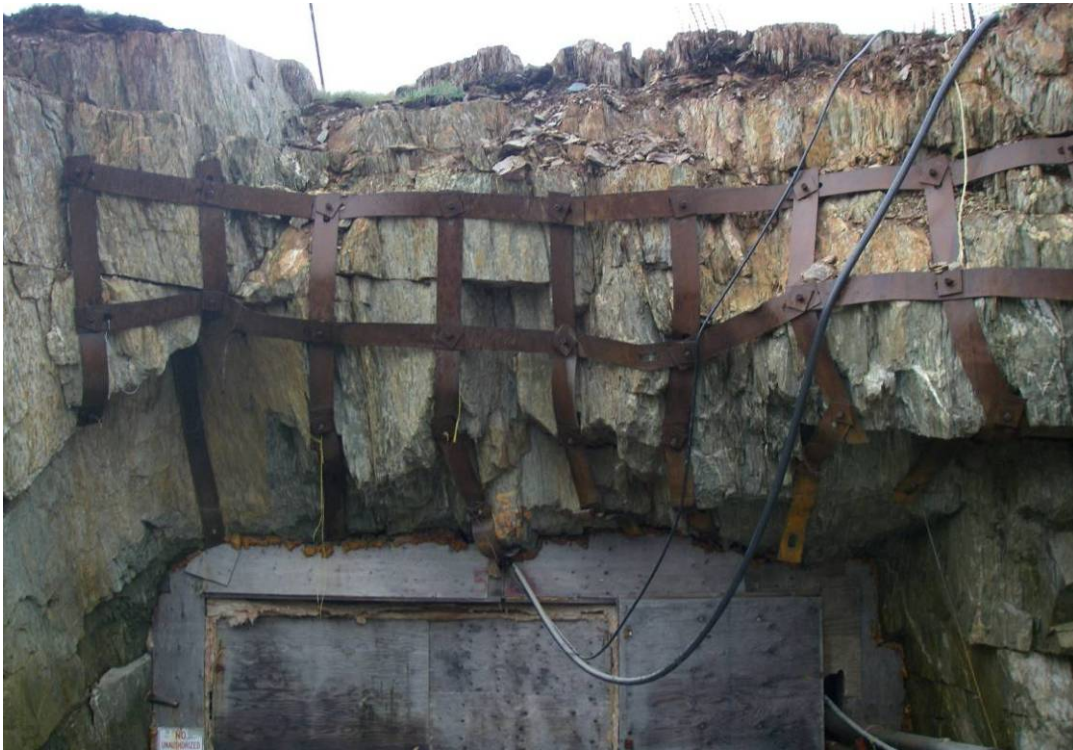
Photo 27: Steel mesh band and rock bolts supporting the portal access roof. Note: spalding rock will be a hazard should the roof support collapse.

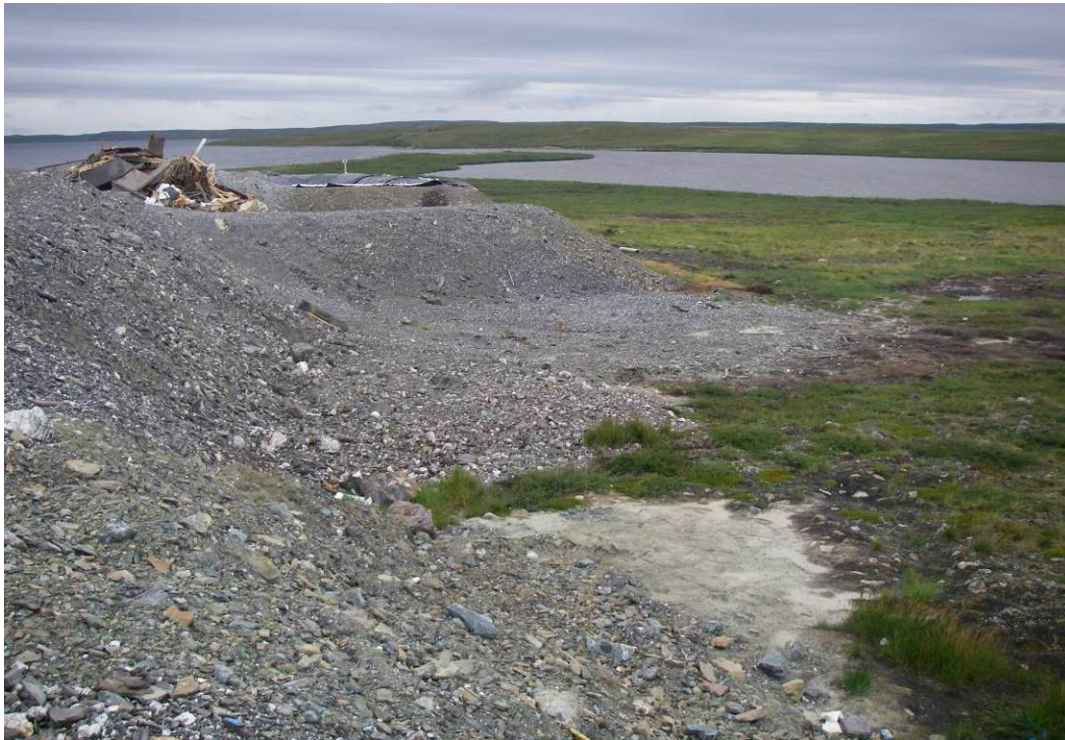
Photo 30: Looking north across the eastern edge of the camp pad with the burn pit and sedimentation pond in the background. Note: the old drill site is damaged and covered in the foreground.

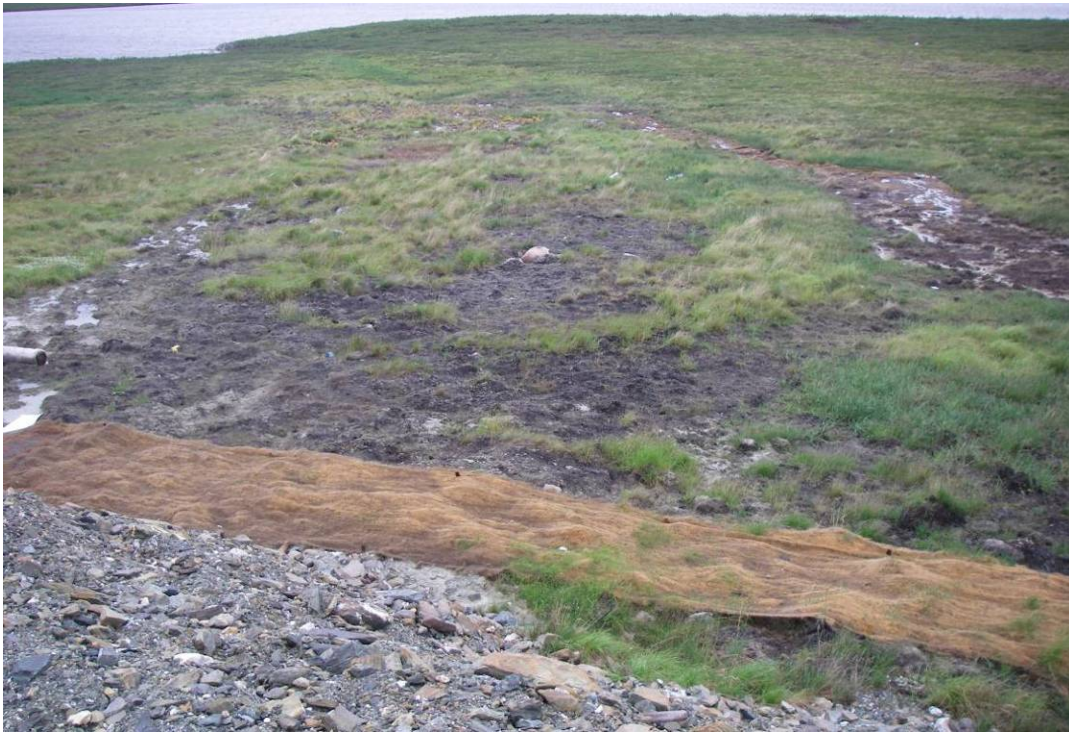
Photo 31: Cocoa matting placed on vegetation dieback areas to control erosion and promote revegetation. Note: damage from the drainage in the background.

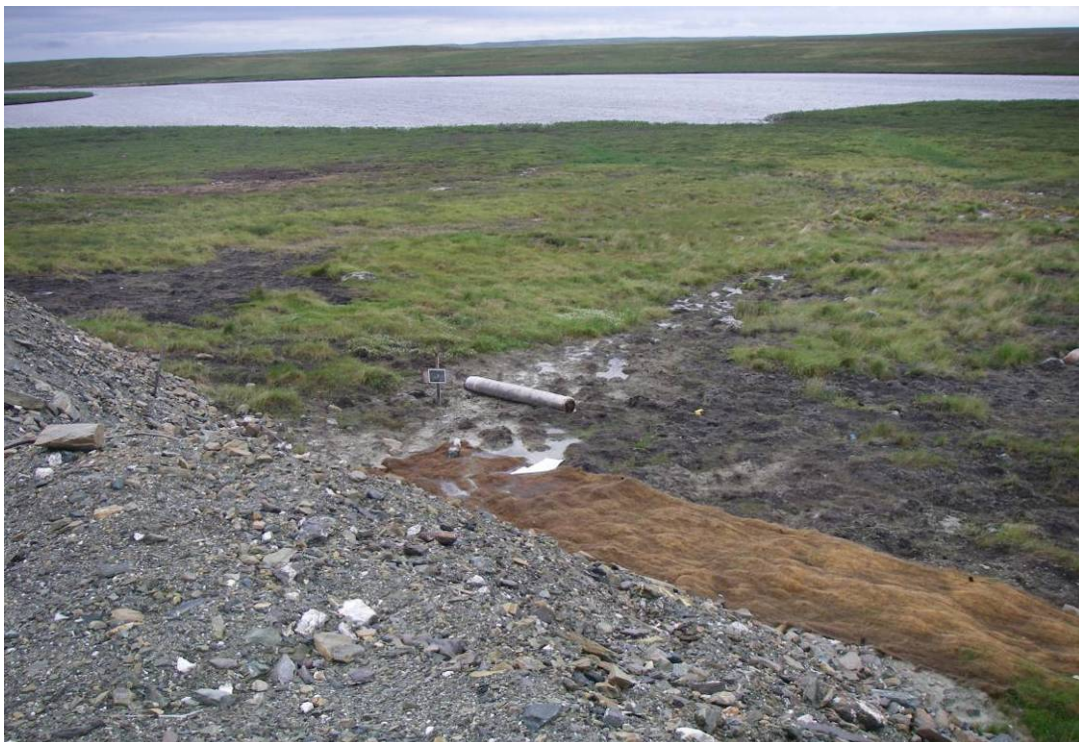
Photo 32: Vegetation dieback and erosion damage immediately downstream of the camp pod.

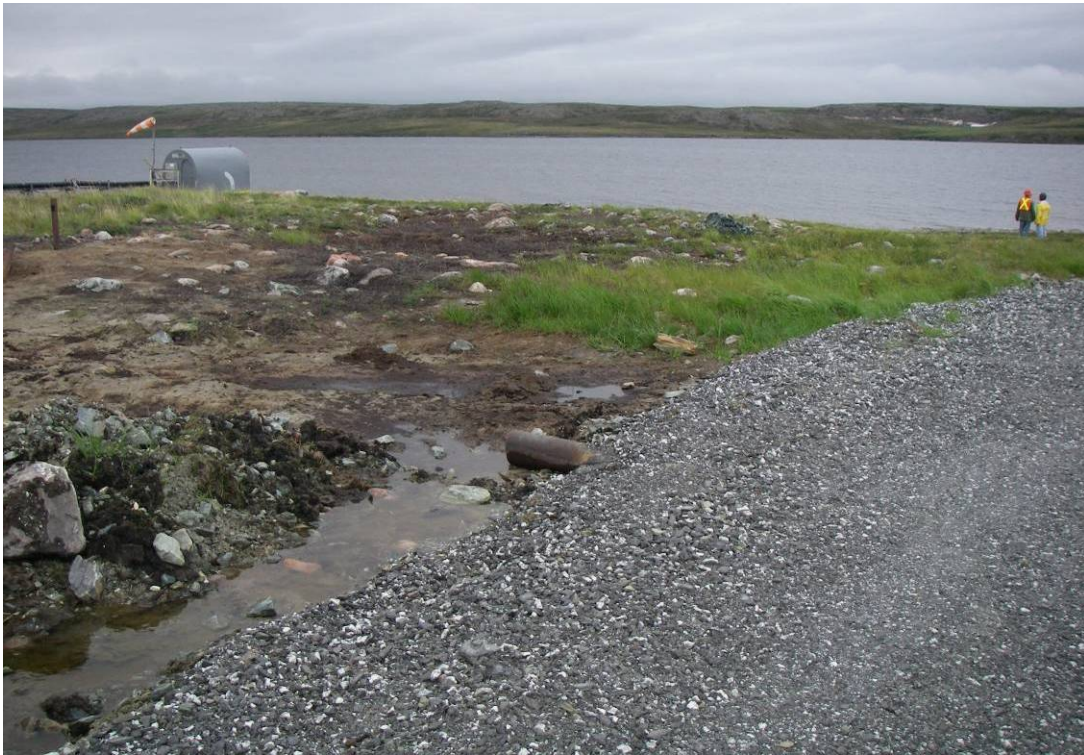
Photo 33: Vegetation dieback zone north of the camp pod. Spyder Lake shown in the background.

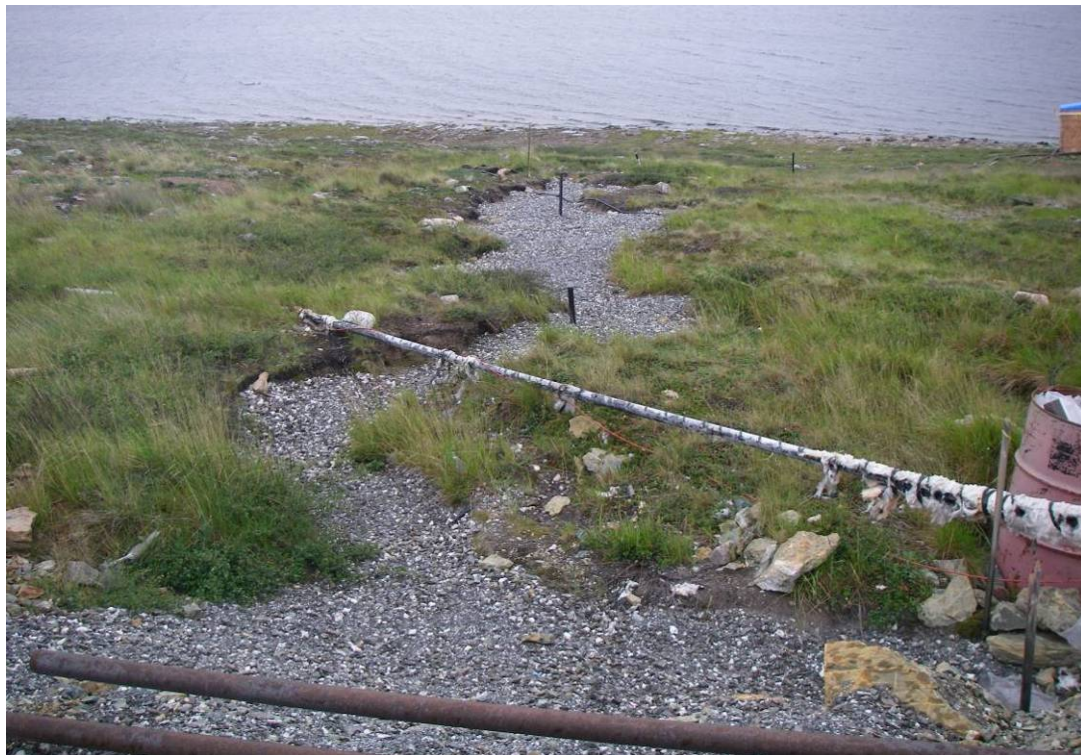
Photo 34: Repaired erosion gulley southwest of camp pad. Crushed ore material used for repair.

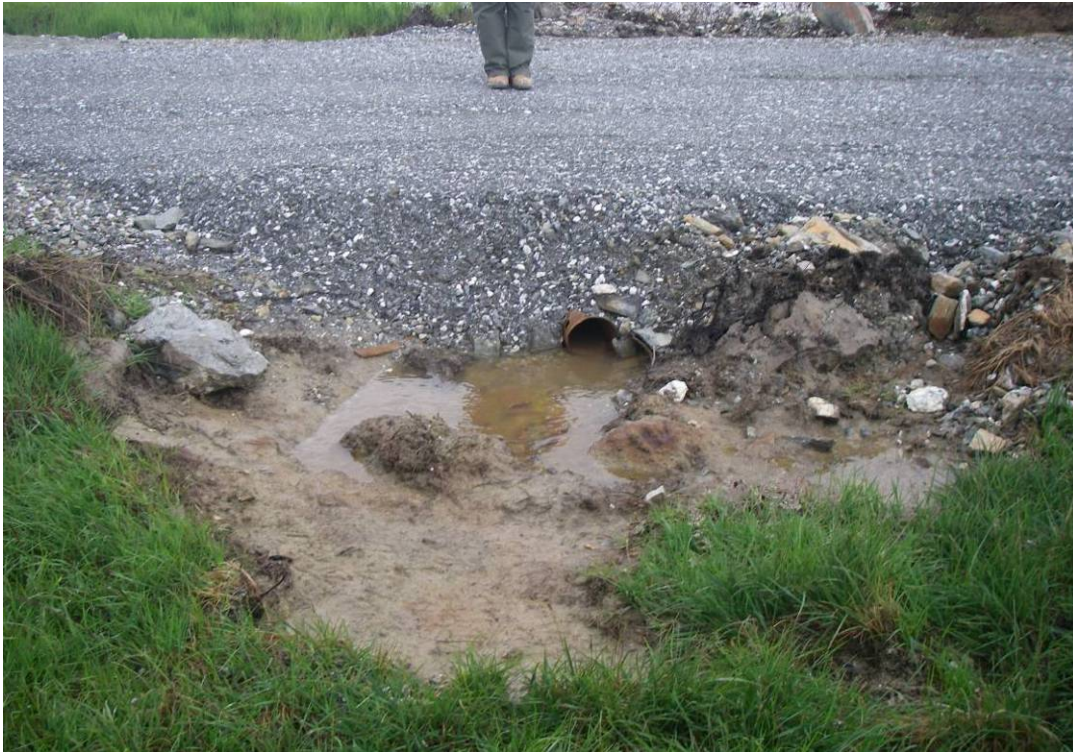
Photo 35: Pipe culvert outlet with no apparent drainage. This culvert is under the core storage area road.

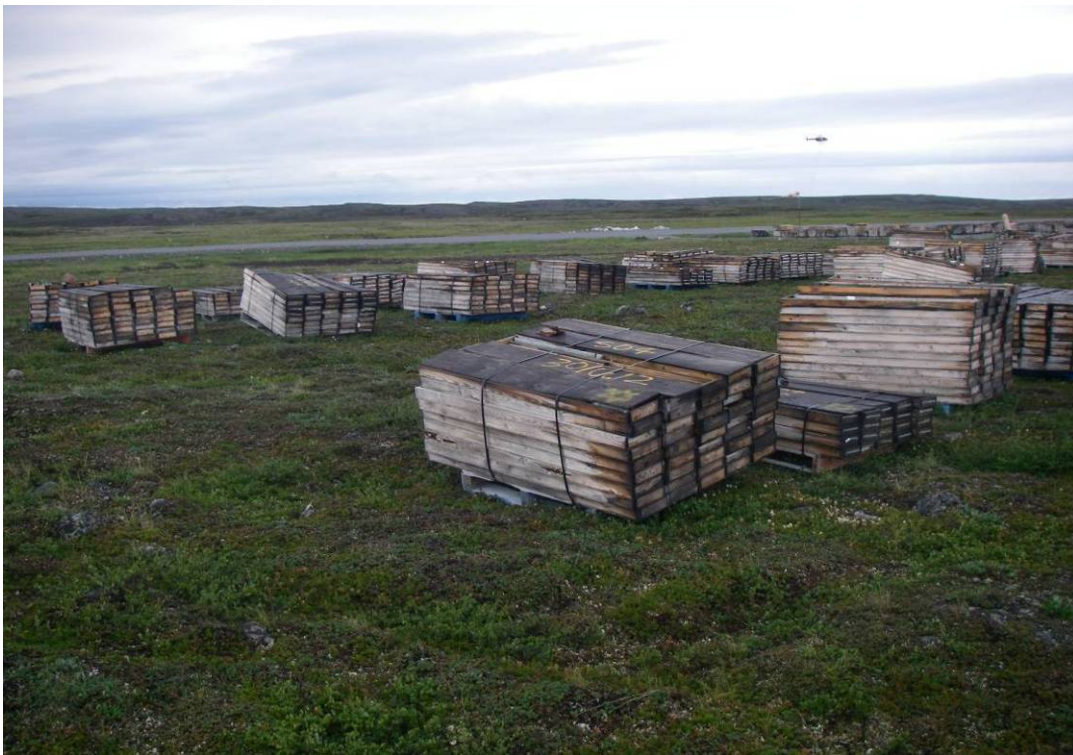
Photo 38: Core storage area. Many of the pallets are stored directly on the tundra.
