HOPE BAY MINING LIMITED

2008 Annual Geotechnical Inspection, Boston Advanced Exploration Project, Hope Bay, Nunavut

Project No. 1CM008.006

March 2009

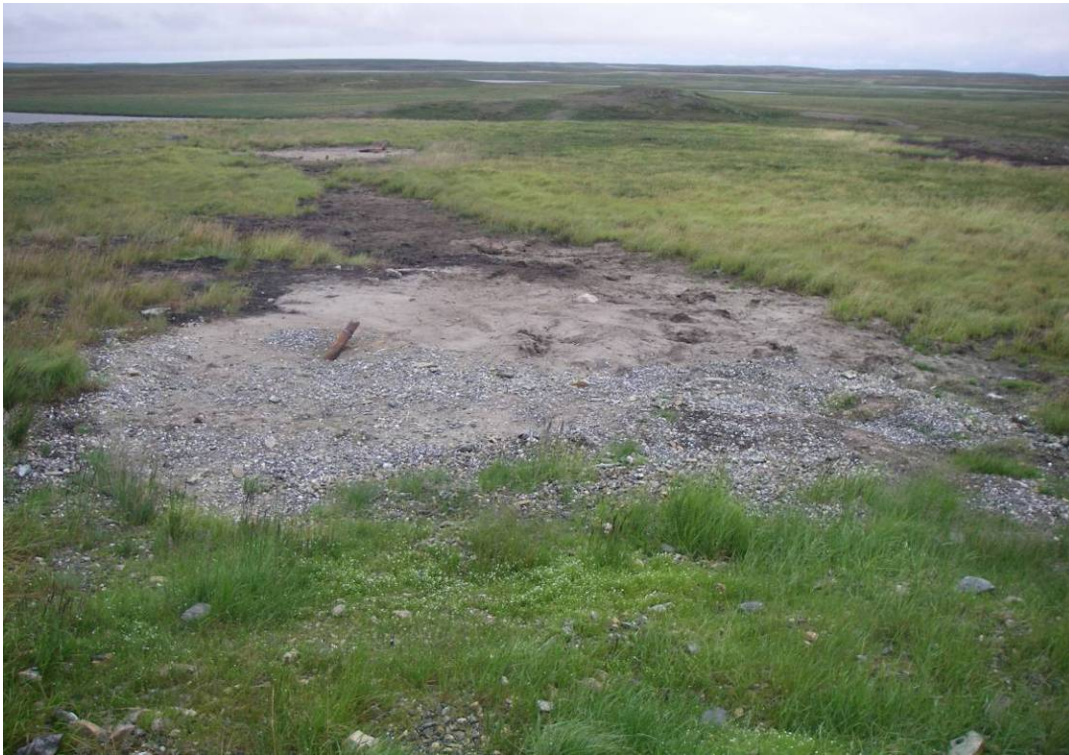
Photo 41: Example of permafrost degradation at the historic drill site. Note: same gravel (crushed ore) has been placed at one time in an attempt to mitigate the damage.

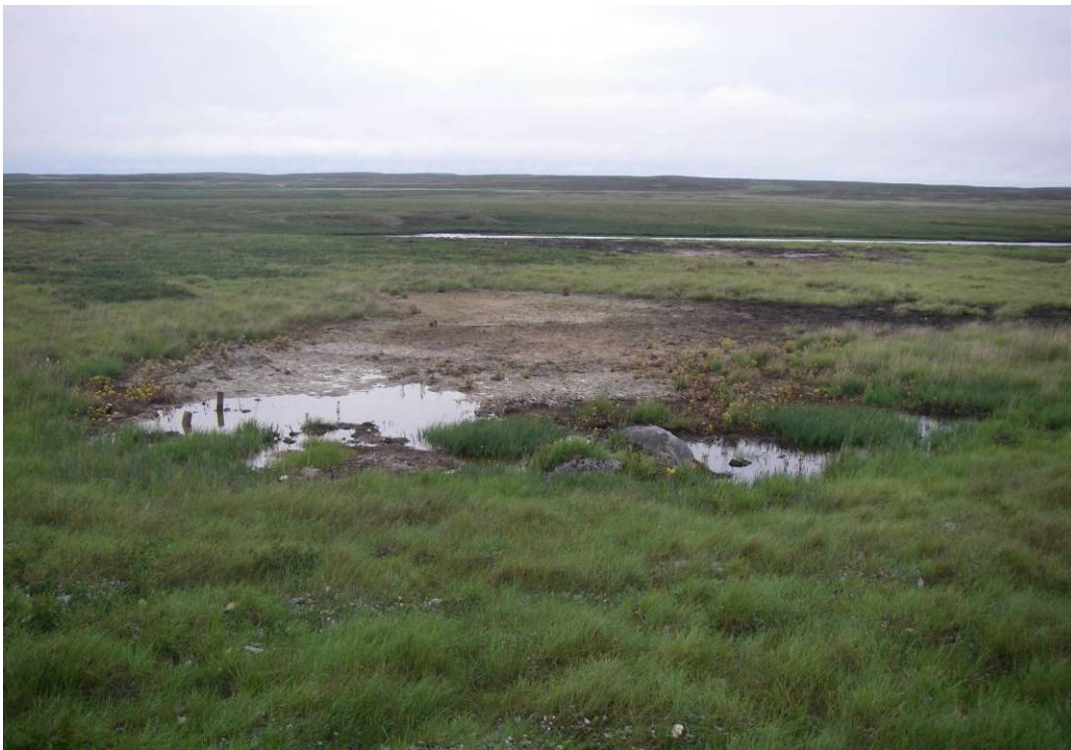
Photo 42: Another drill hole with standing water, extensive permafrost damage and vegetation dieback.

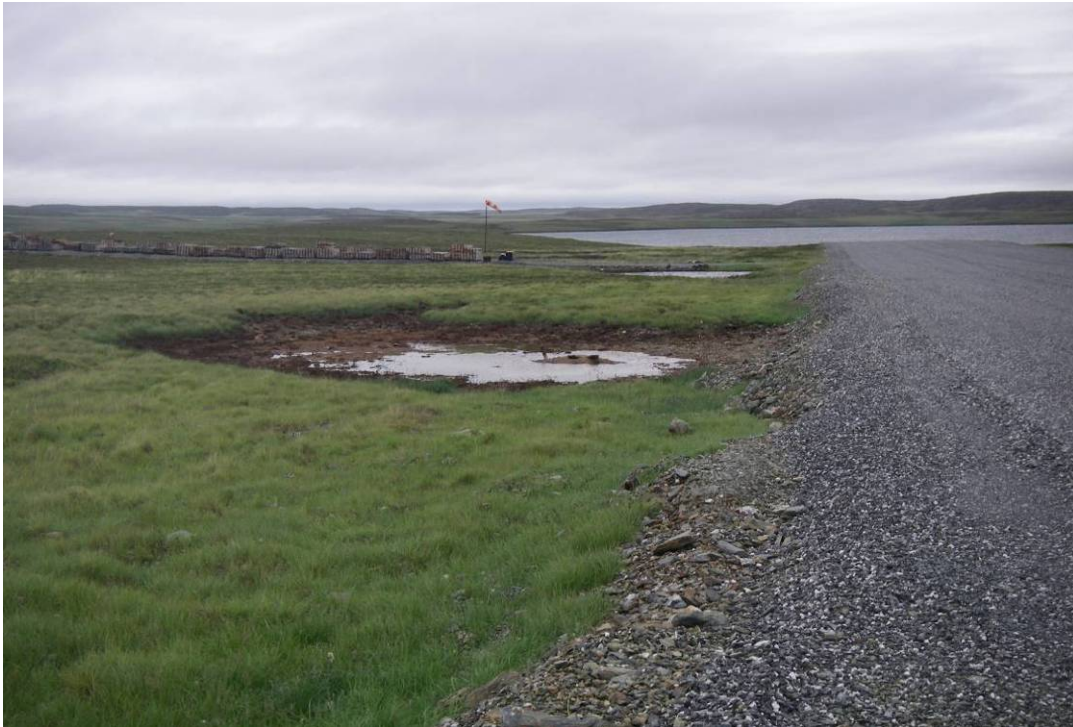
Photo 43: Permafrost damage and vegetation dieback at the historic drill hole location immediately adjacent to the airstrip.

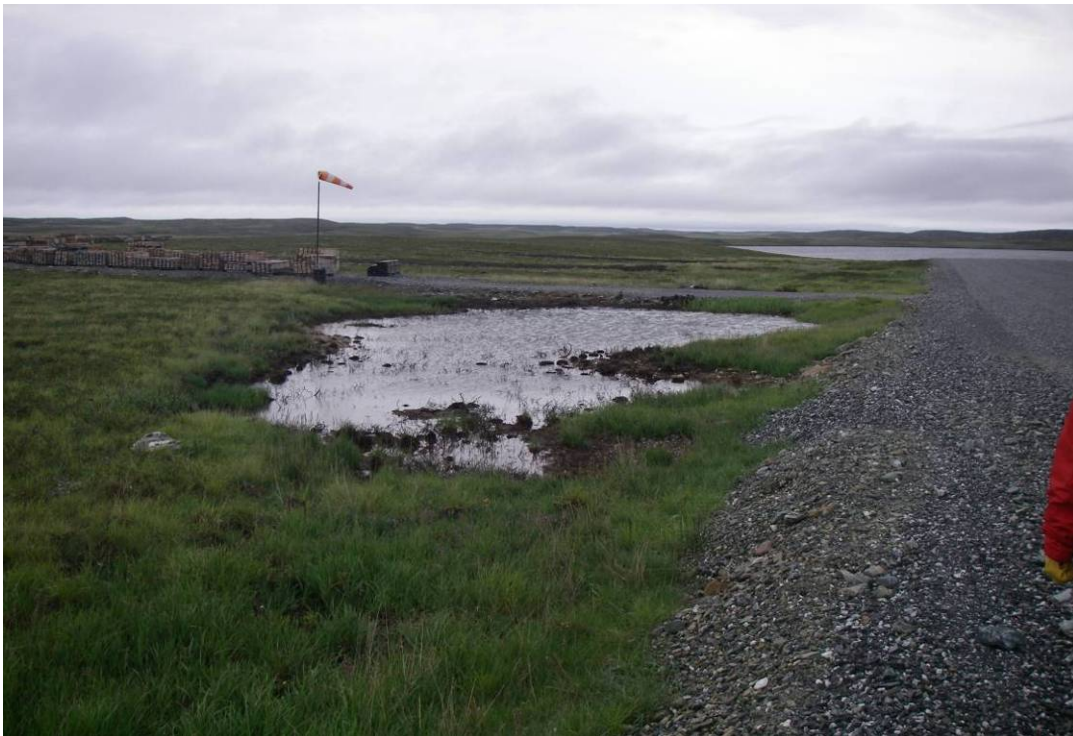
Photo 44: Large pool of standing water immediately adjacent to the airstrip. Ponding due to permafrost degradation at the old drillhole location.

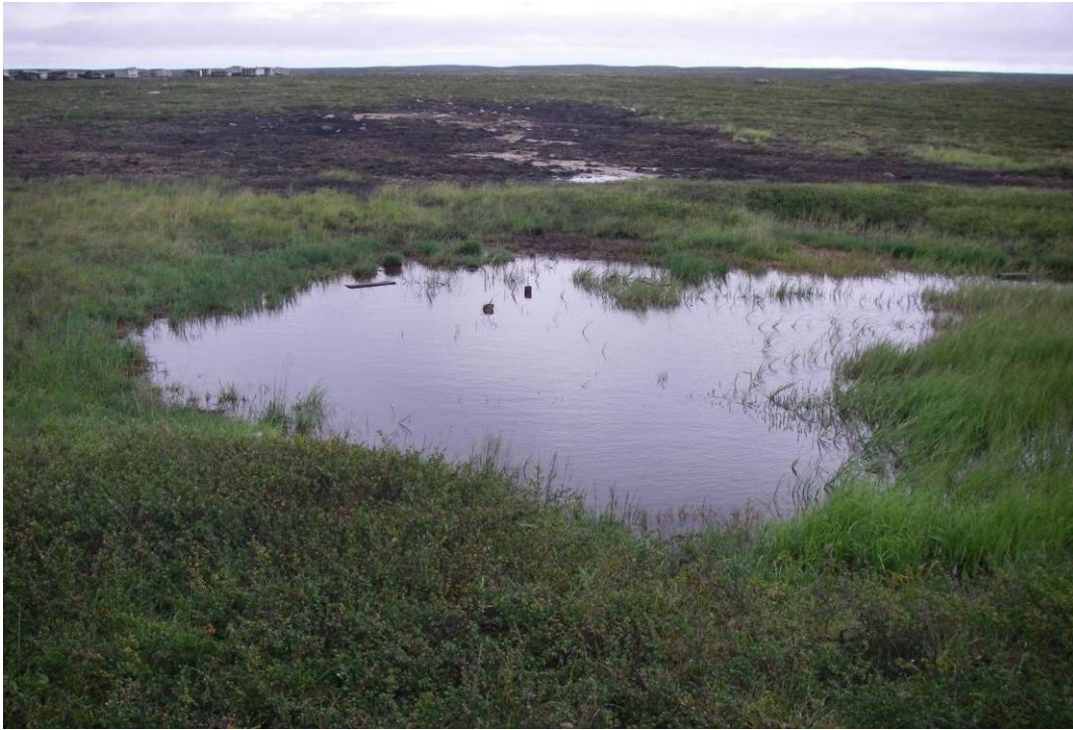
Photo 45: Another example of ponded water in a historic drill site leading to a progressive permafrost degradation.

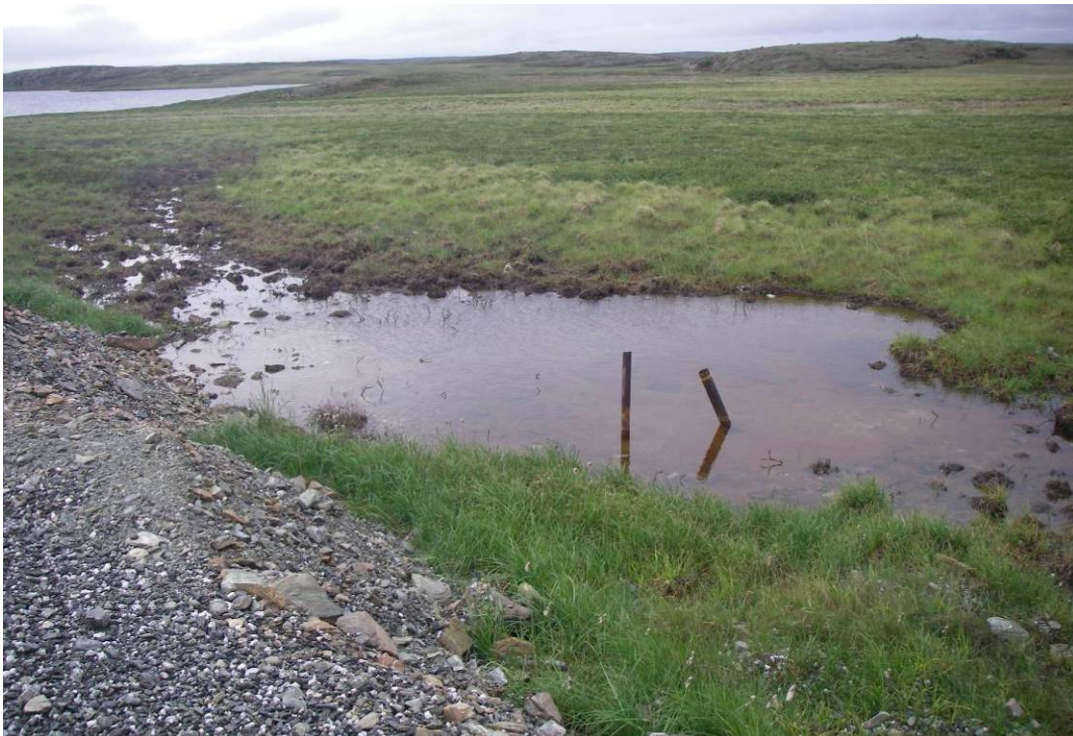
Photo 46: Another example of standing water at an old drillhole location. Note: the vegetation dieback occurring at the pond outlet.

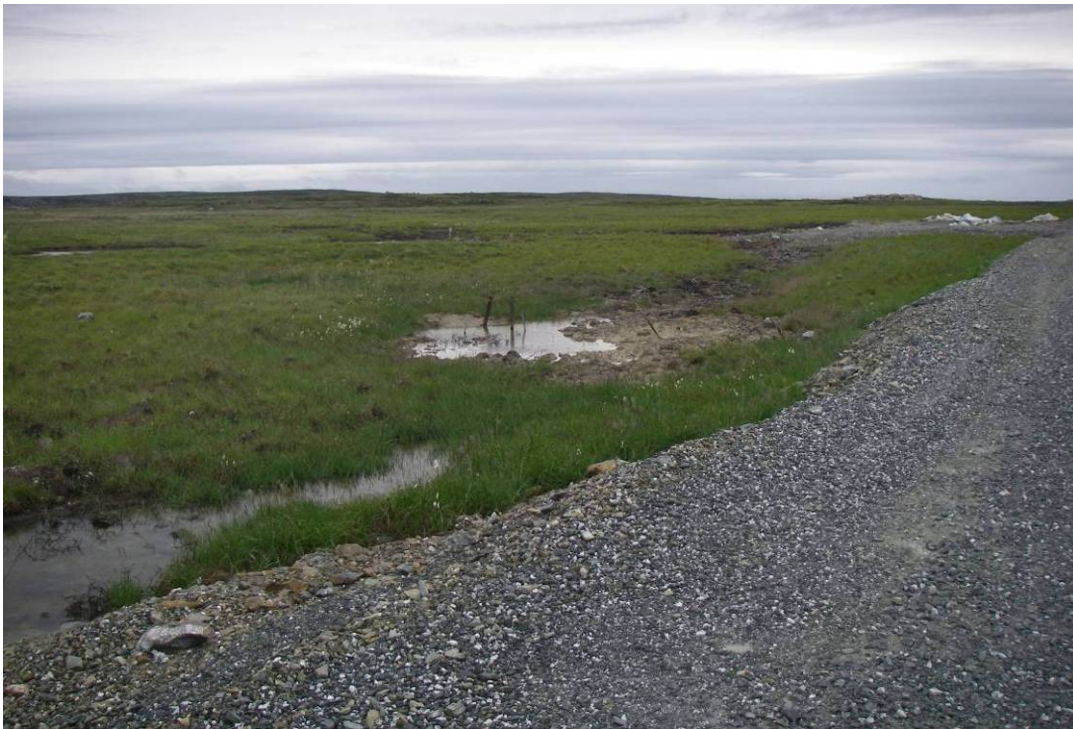
Photo 47: Extensive vegetation dieback along flowpaths created due to drillhole ponds overflowing and getting interconnected.

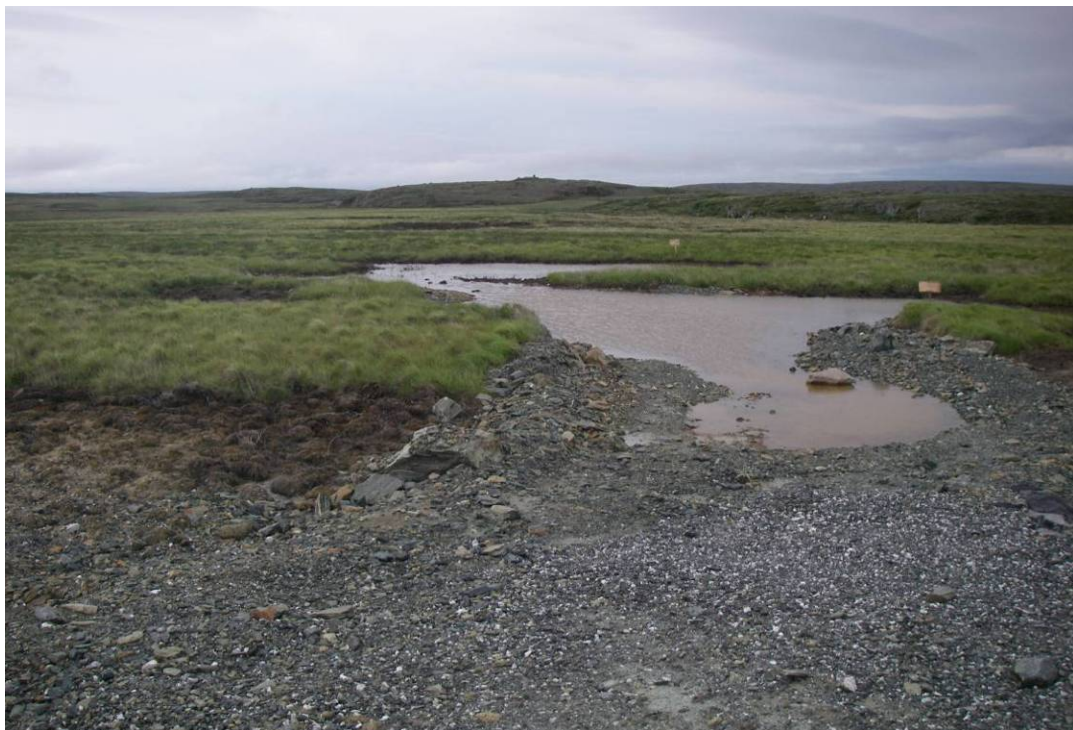
Photo 48: Large interconnected ponds from permafrost degradation at drillhole locations next to the airstrip. Note: the two signposts which SRK understands to be official sampling stations.

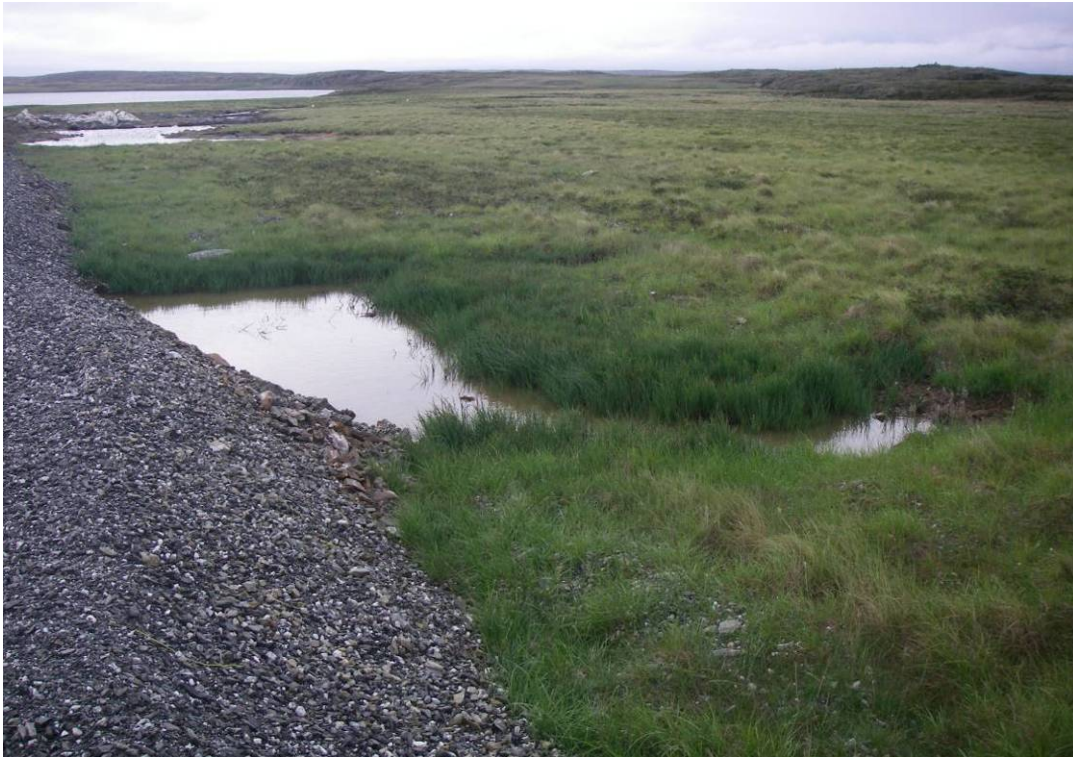
Photo 49: Another example of standing water adjacent to airstrip.

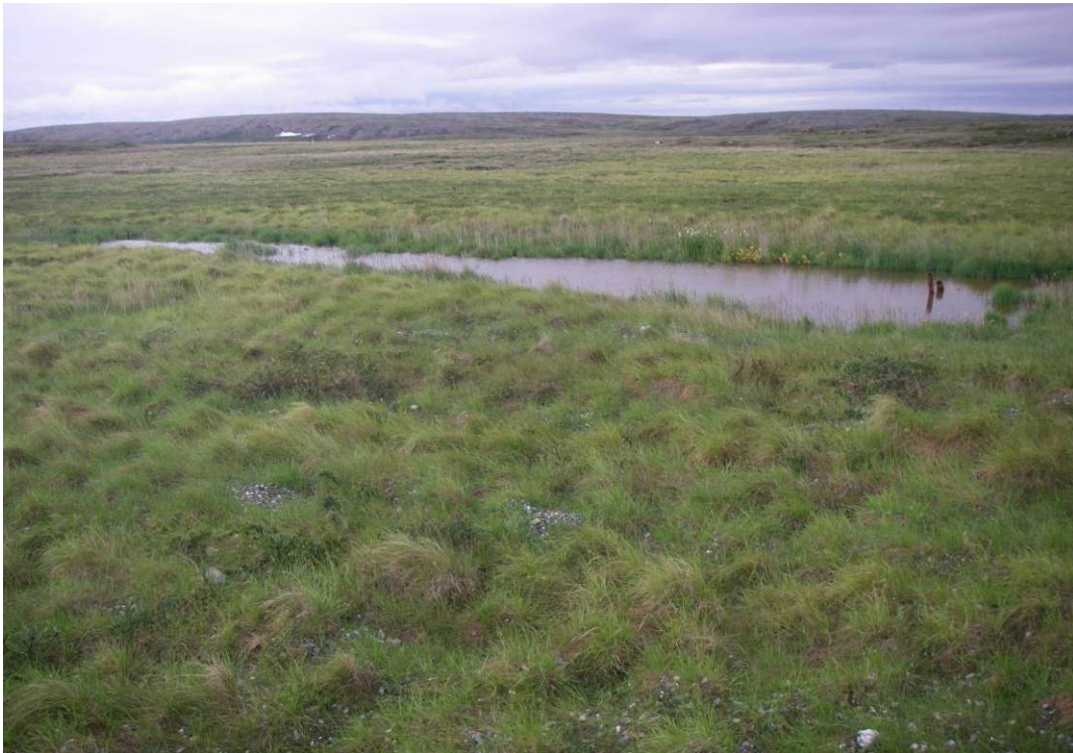
Photo 50: More standing ponds at old drill hole sites.

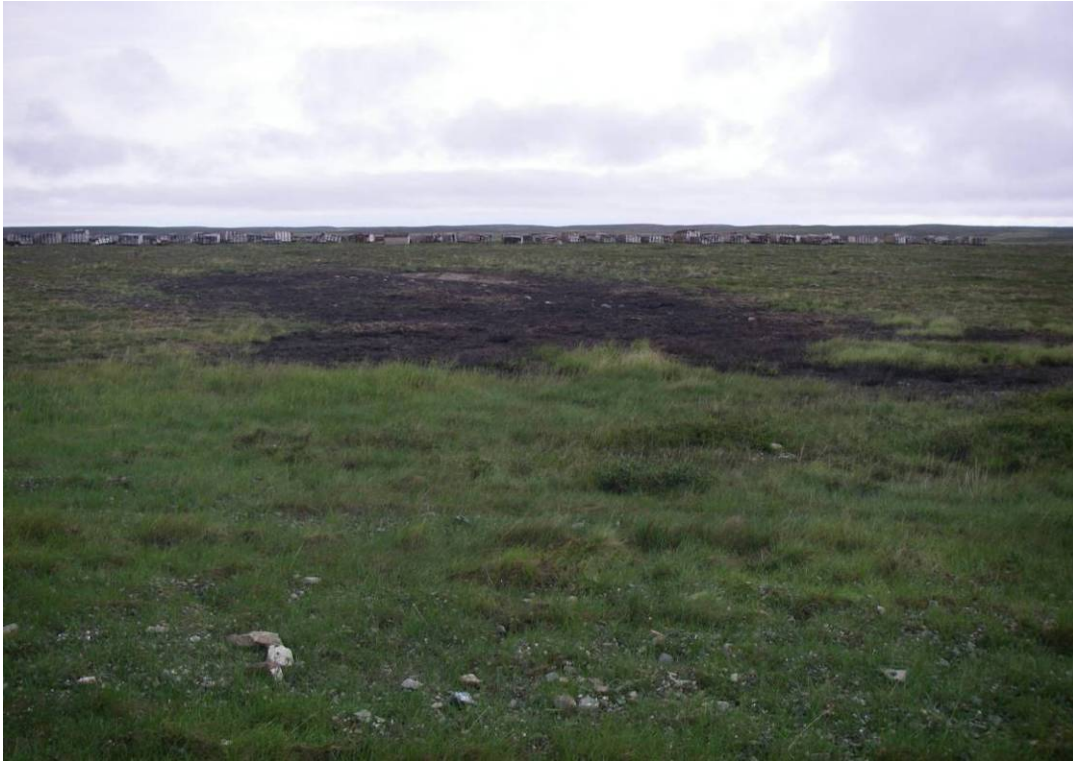
Photo 51: Vegetation dieback area between the core storage area and the airstrip. No apparent reason for this.

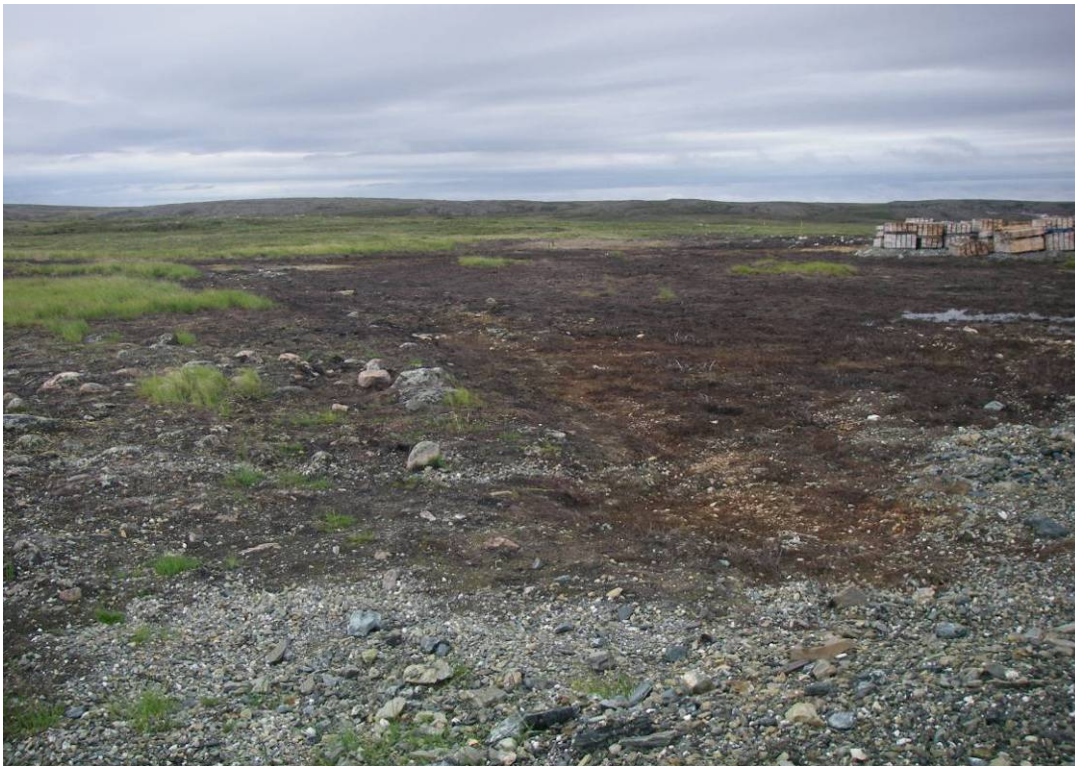
Photo 52: Vegetation dieback area immediately south of old drill access road.

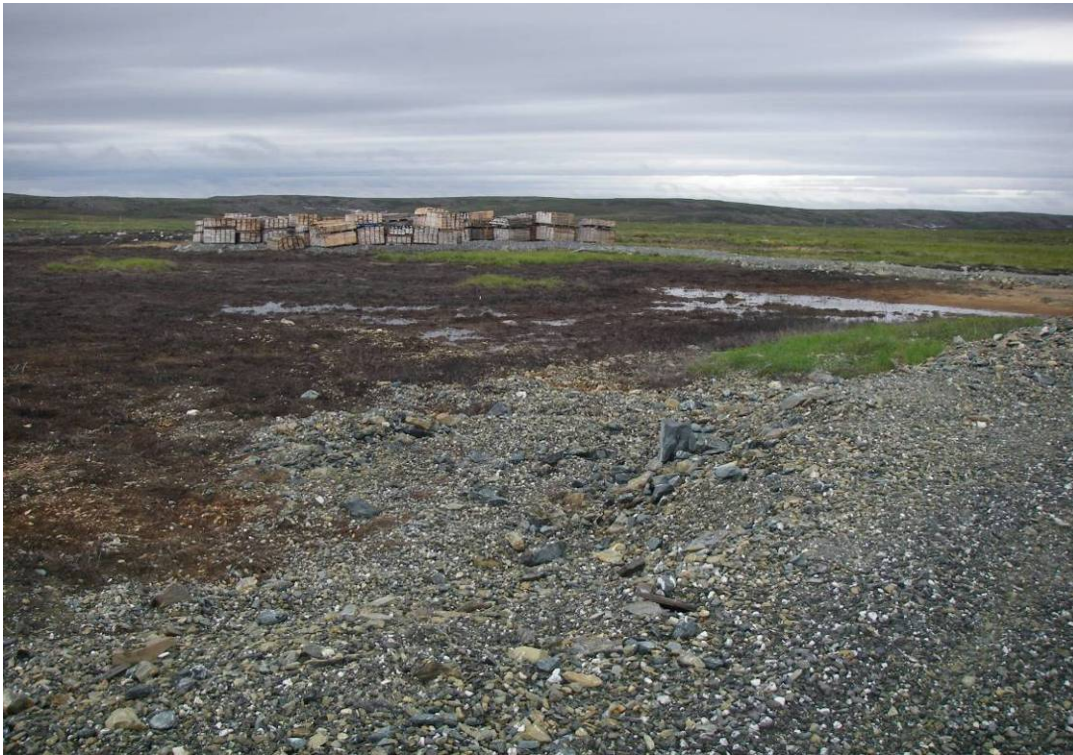
Photo 53: Another view of vegetation dieback area immediately south of old drill access road.

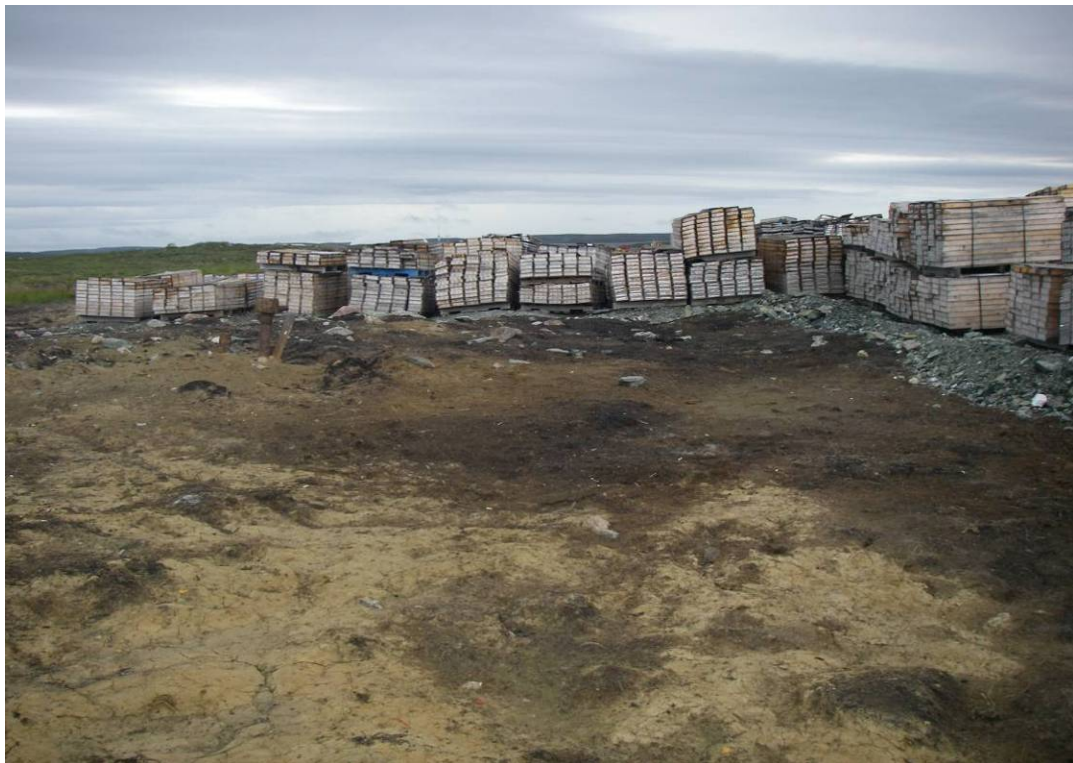
Photo 54: Close-up of vegetation dieback at end of old drill access road.
