# HOPE BAY MINING LIMITED

## 2009 Annual Geotechnical Inspection, Boston Advanced Exploration Project, Hope Bay, Nunavut

Project No. 1CH008.021

**November 2009**

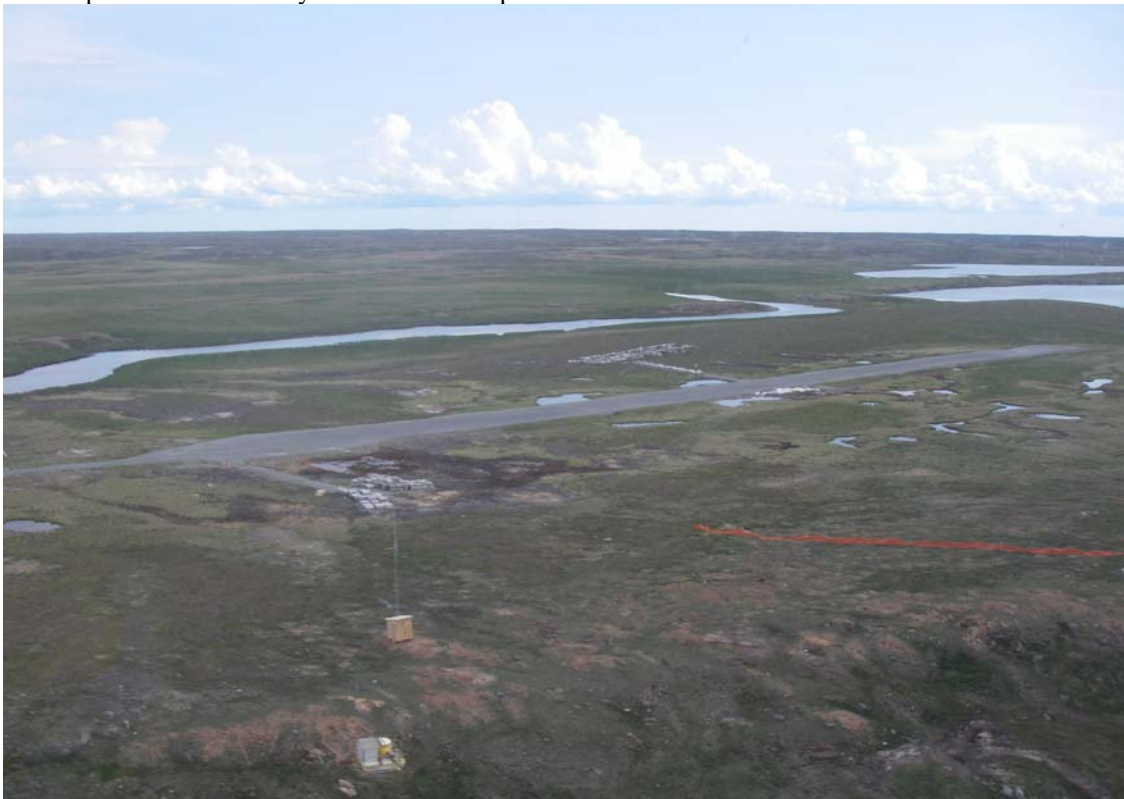
**Photo 4:** Oblique aerial view of the Boston airstrip looking south-east. Note the permafrost degradation damage visible at the north-west end of the airstrip.

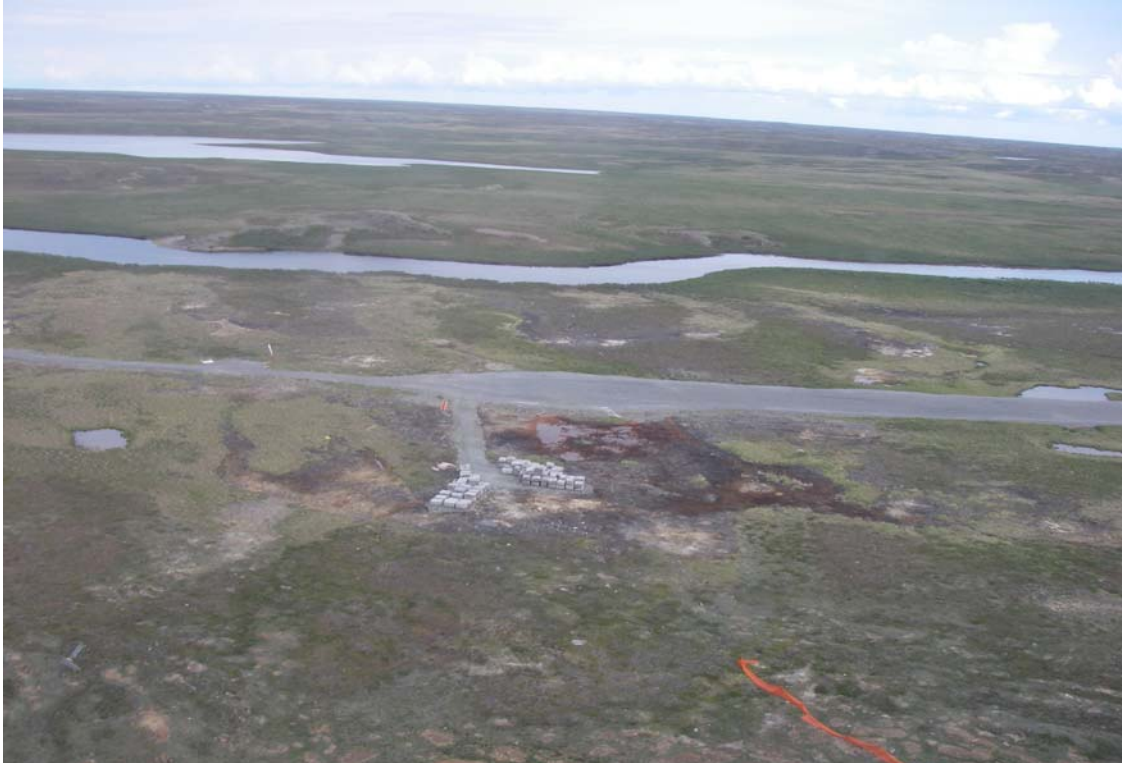
**Photo 5:** Oblique aerial view of the northern end of the Boston airstrip looking east. The brown patch between the airstrip and the core storage road (north airstrip core storage area) is an area of vegetation dieback and permafrost damage.

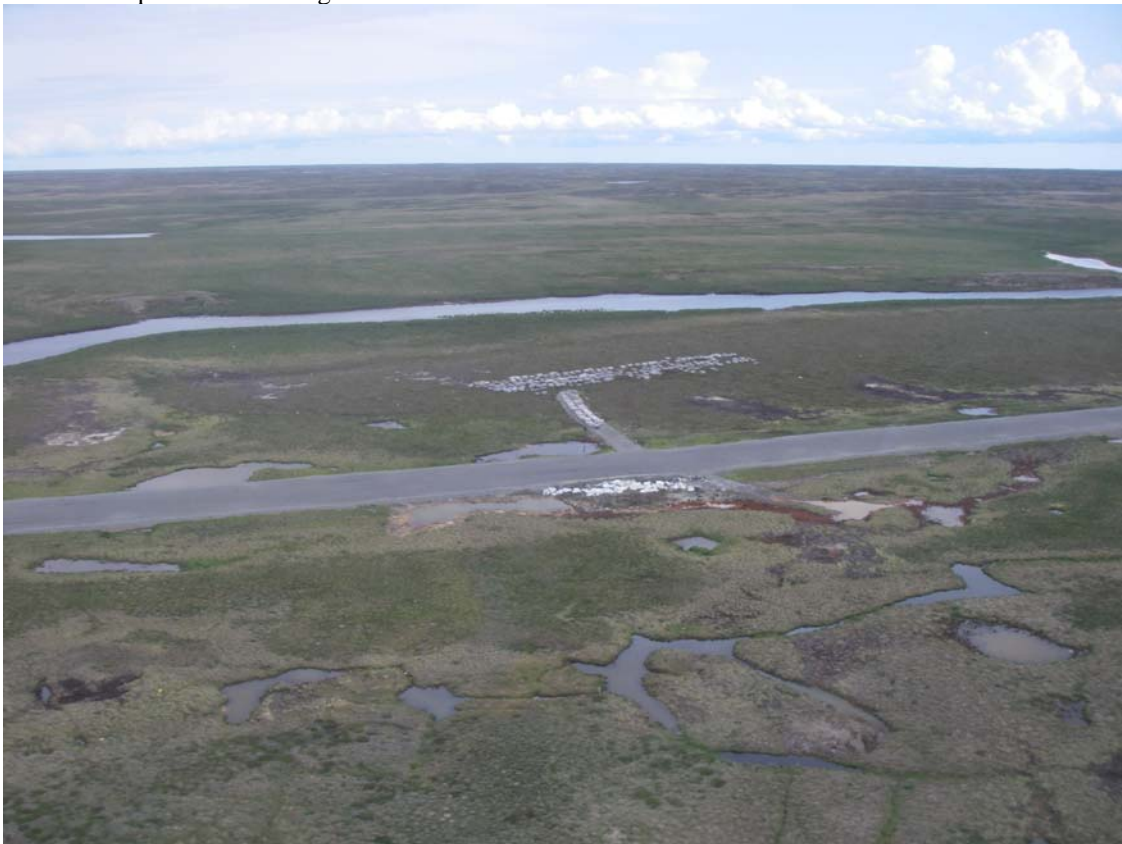
**Photo 6:** Oblique aerial view of the central section of the Boston airstrip looking east. The east airstrip core storage area is shown in the background. Permafrost damage is shown immediately west of the airstrip in the center of the photo.

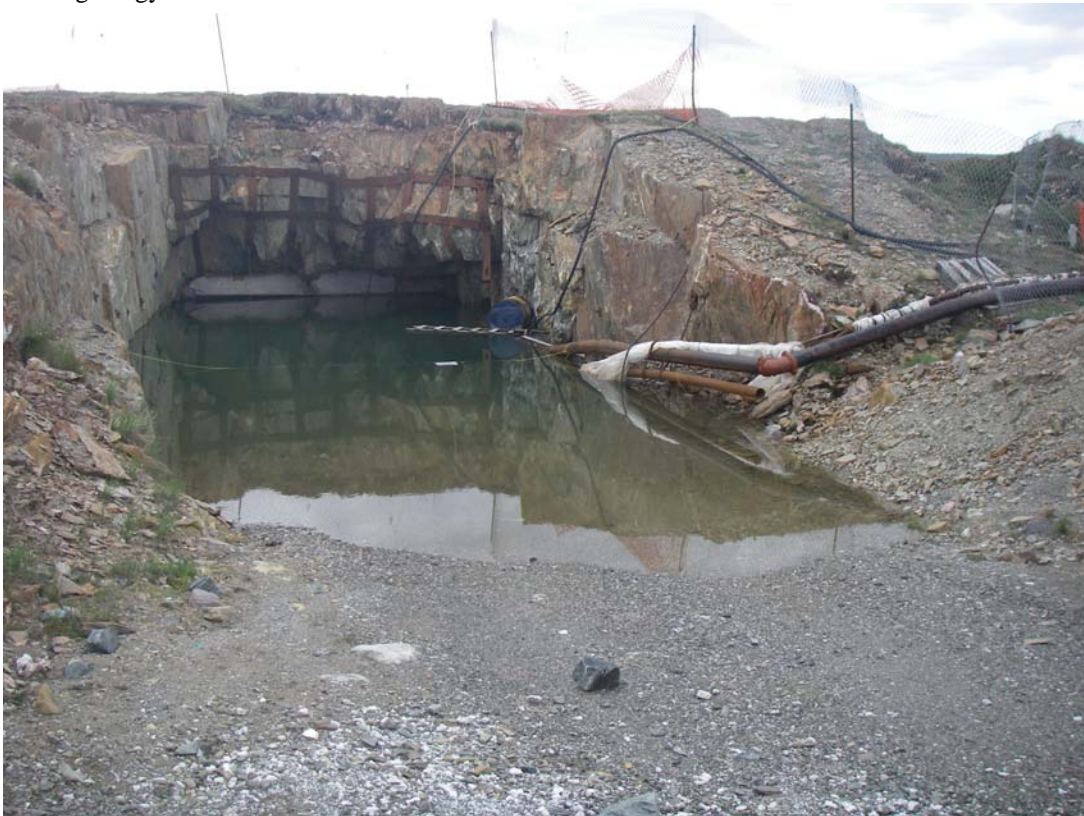
**Photo 18:** Looking north across the portal, which as can be seen from the photo was flooded at the time of the inspection.

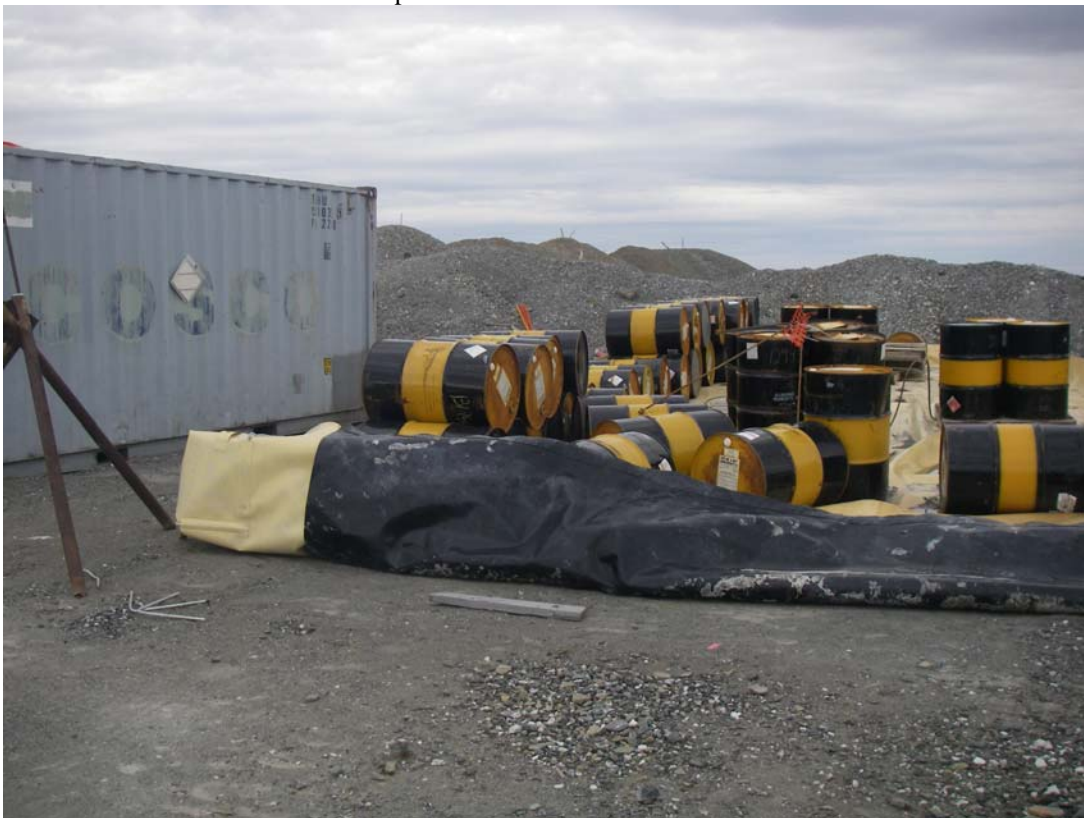
**Photo 20:** Jet fuel stored in secondary containment. Note one wall of the secondary containment has collapsed.

1. The secondary containment berms should be regularly inspected and repaired as needed.

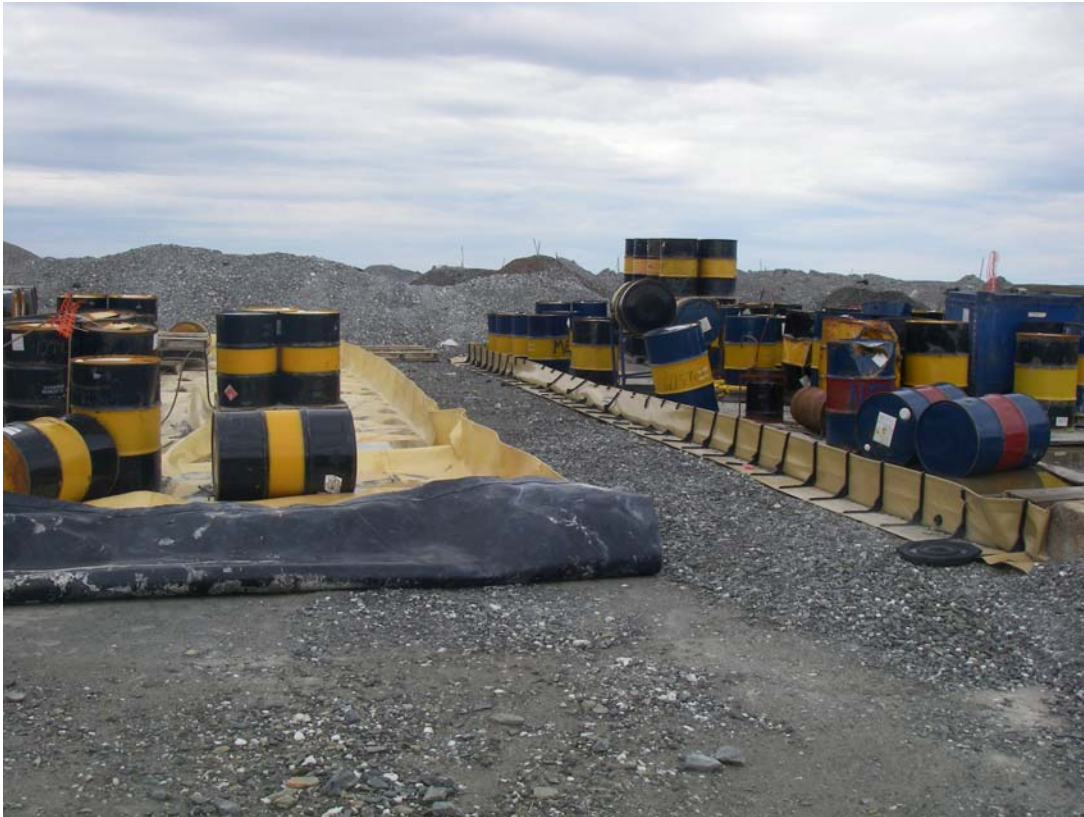
**Photo 21:** Another view of the collapsed secondary containment system wall, with another jet fuel stack and secondary containment system in the background.

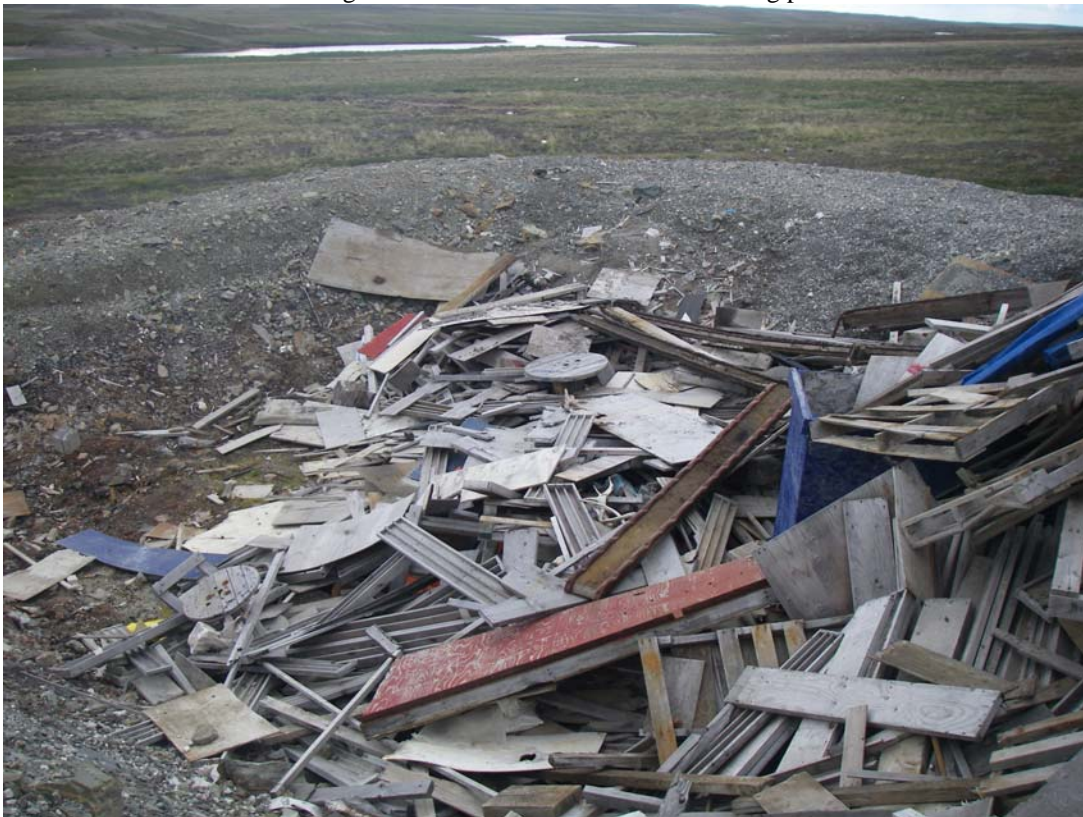
**Photo 28:** Wood debris stockpiled in the burn pit.

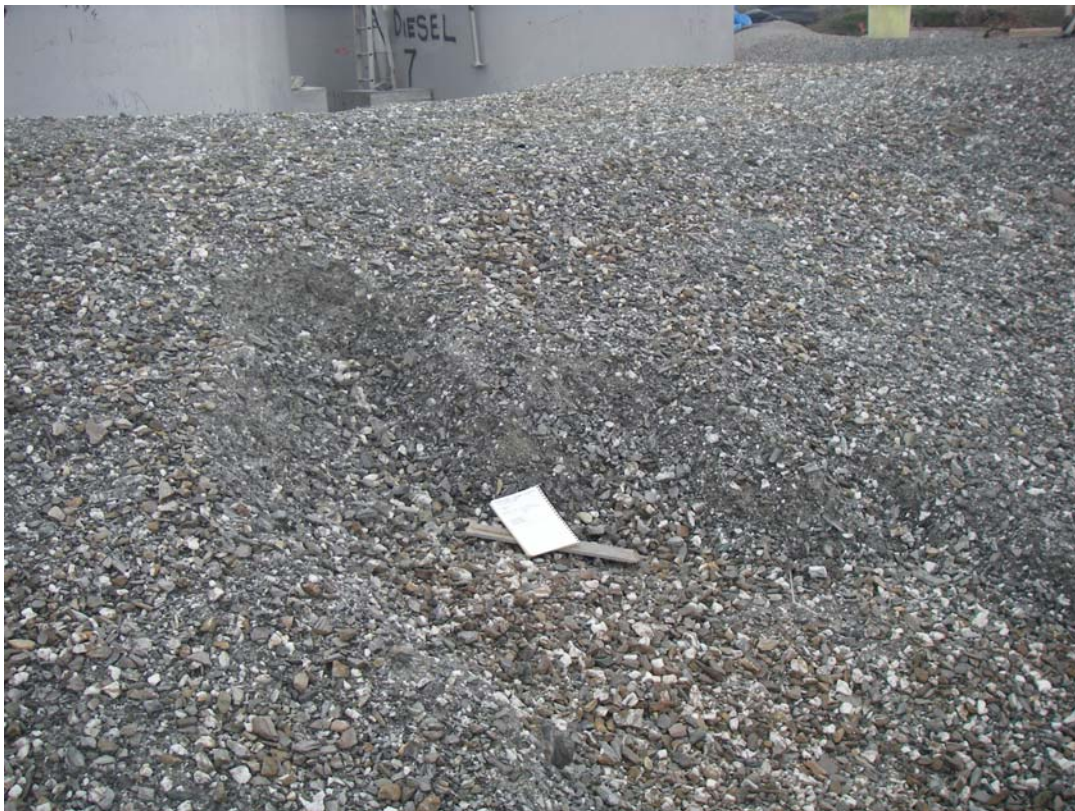
Visual inspection of the secondary containment facility showed several signs of surficial slip surfaces on the containment side slopes. In 2008 a few small tension cracks was observed along the berm crest; however, during the 2009 inspection there was no sign of these tension cracks. The slip surfaces could be an early indication of settlement, or may simply be relaxation due to the over steepened nature of the gravel berm. The liner is not exposed anywhere, and the containment berms for both the main containment facility and the fuel transfer areas are intact. There were no visible signs of fuel spills outside of the respective containment areas. HBML has rigorous protocols in place for fuel transfer, and provided those are followed, the facility design appears adequate to provide environmental protection.

**Photo 30:** Evidence of small sloughing failures on the northern outside berm of the fuel tank farm. These failures do not pose a risk to the containment design at this time.

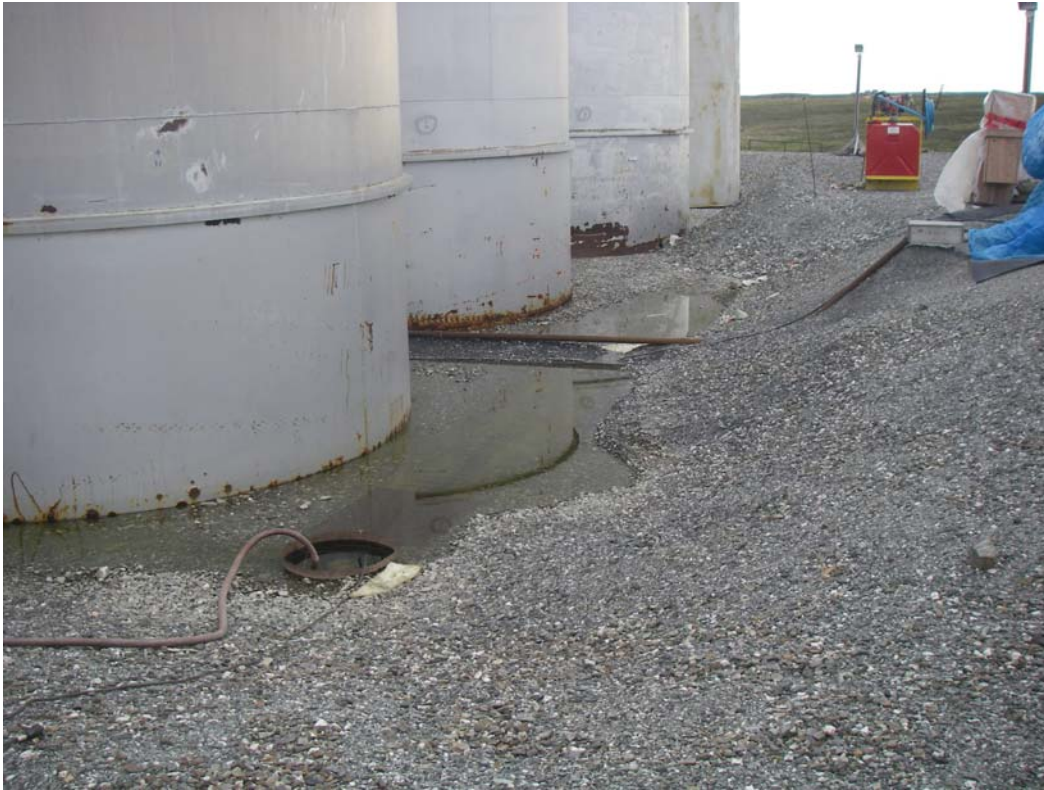
During the inspection it was noted that there was a small amount of ponded water in the containment area. The facility is equipped with a sump, and at the time of the inspection there was a trash pump installed in the sump, with a pipeline leading out from it. The practice of keeping the containment area free of ponded water is appropriate and should be maintained.

**Photo 31:** View of water ponded in the fuel tank farm. A trash pump is installed in the sump.

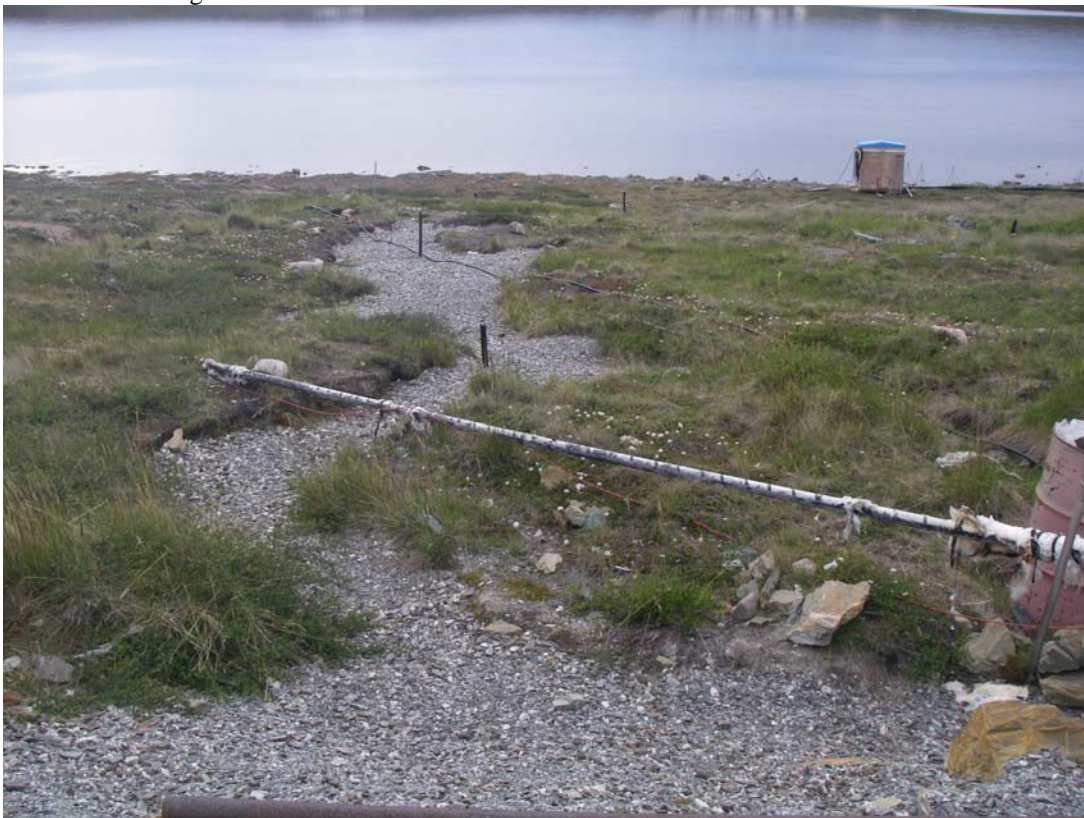
**Photo 38:** Looking west at an area of erosion and permafrost damage repaired by infilling with gravel.

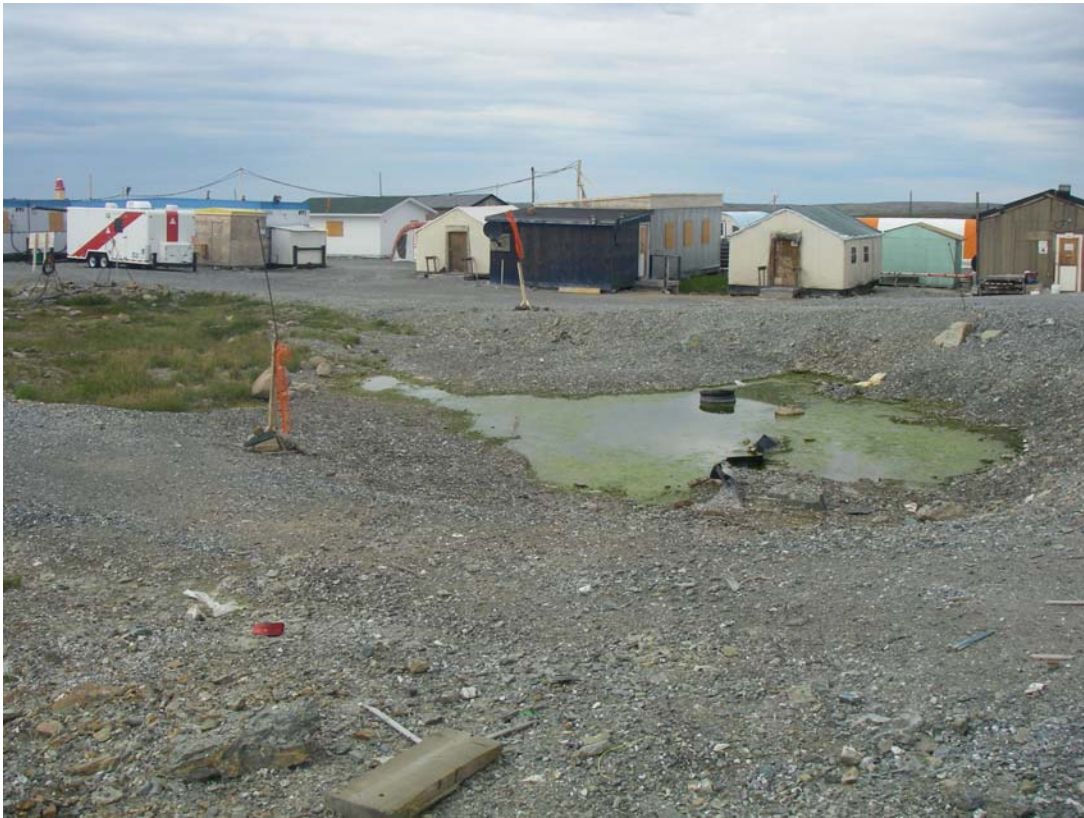
**Photo 41:** Ponded water in a depression on the pad where the historic fuel spill occurred.

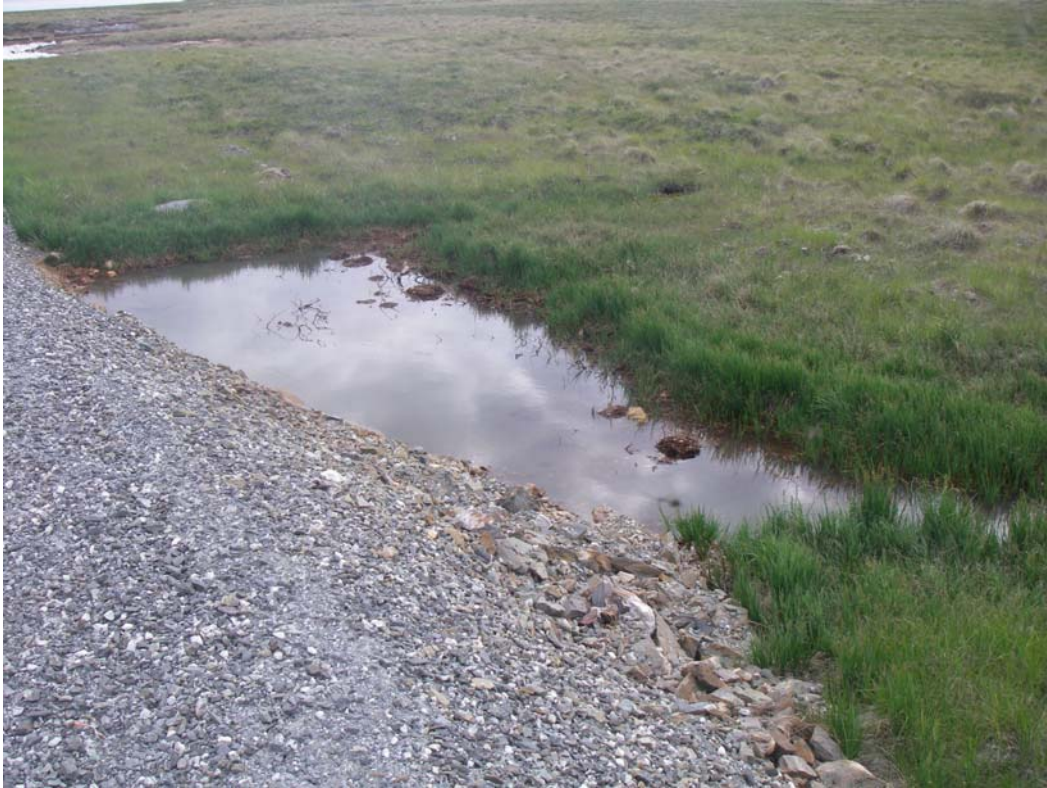
**Photo 43:** View of water ponded next to airstrip leading to permafrost degradation. The pond was created by drilling.

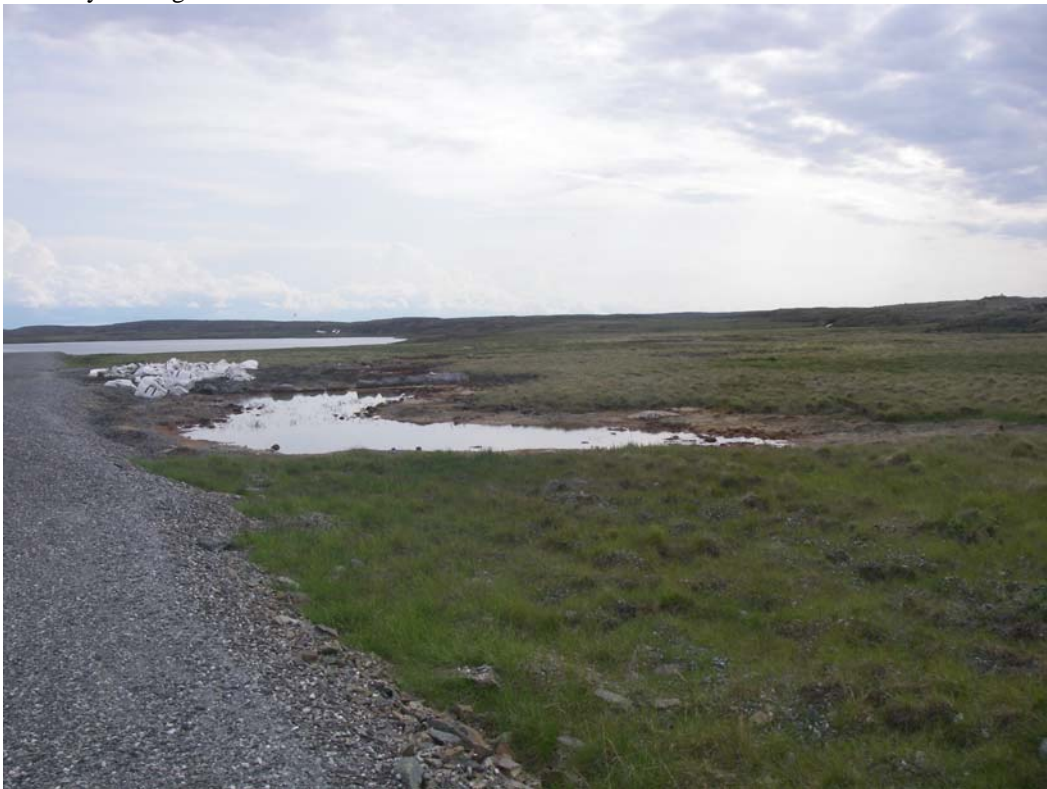
**Photo 44:** More examples of water ponded next to the airstrip as a result of historic drilling activities.

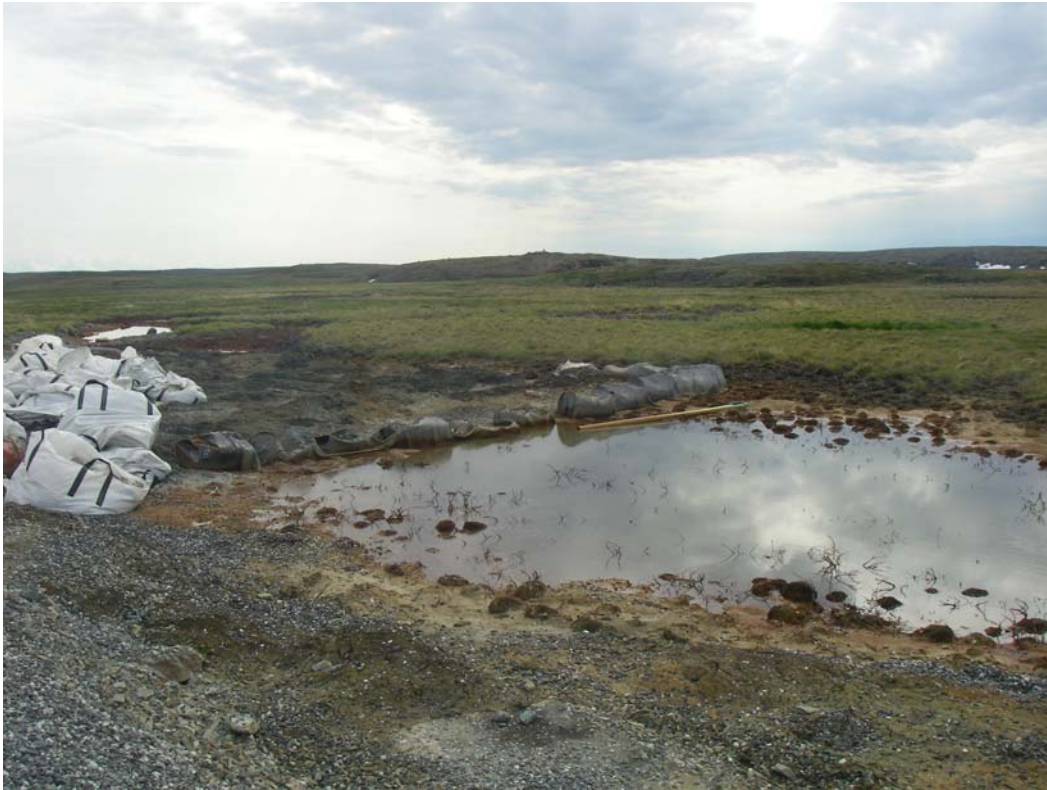
**Photo 45:** Close-up of extensive permafrost damage immediately adjacent to the airstrip. This area has been used as a sediment pond in the past.

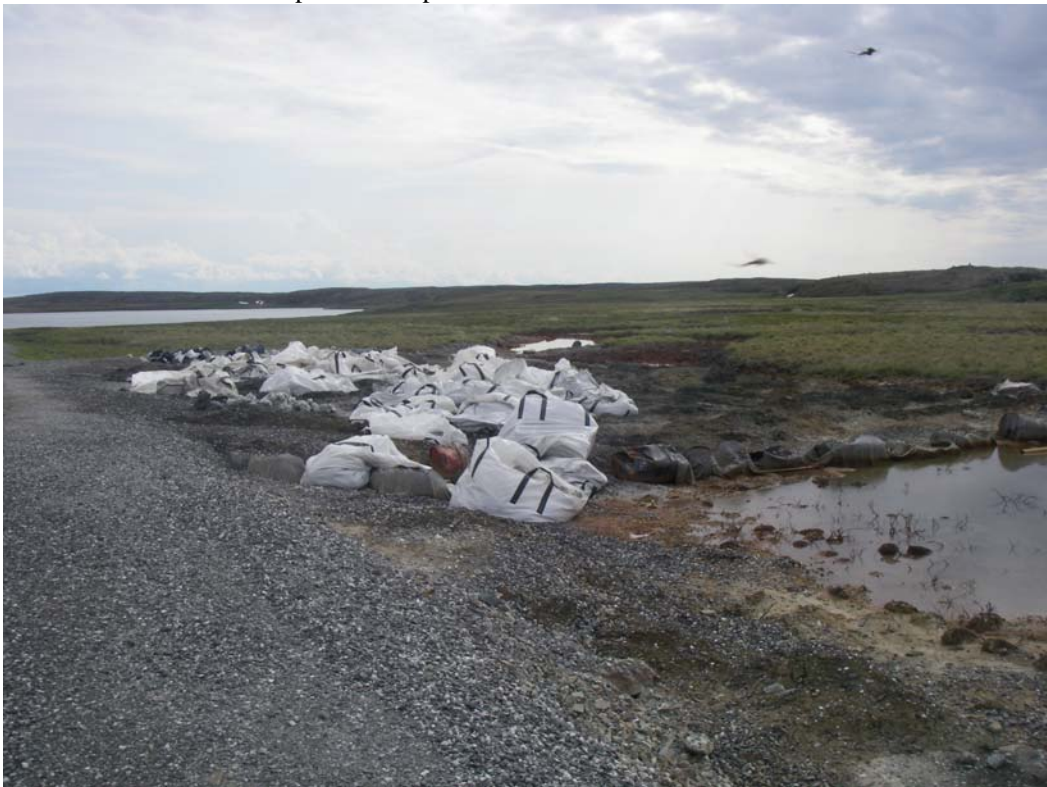
**Photo 46:** Close-up of permafrost damage immediately adjacent to the airstrip. The bags in the picture are filled with drill cuttings.

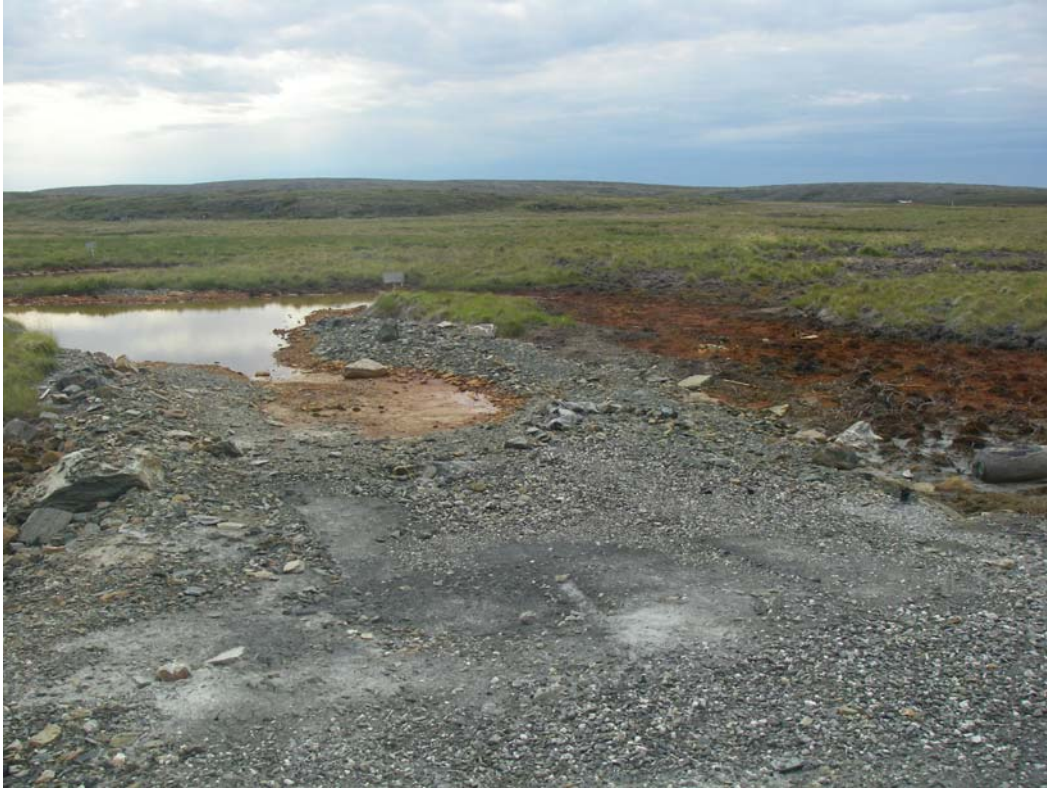
**Photo 47:** Another example of permafrost damage and vegetation dieback next to the airstrip as a result of historic drilling activities.

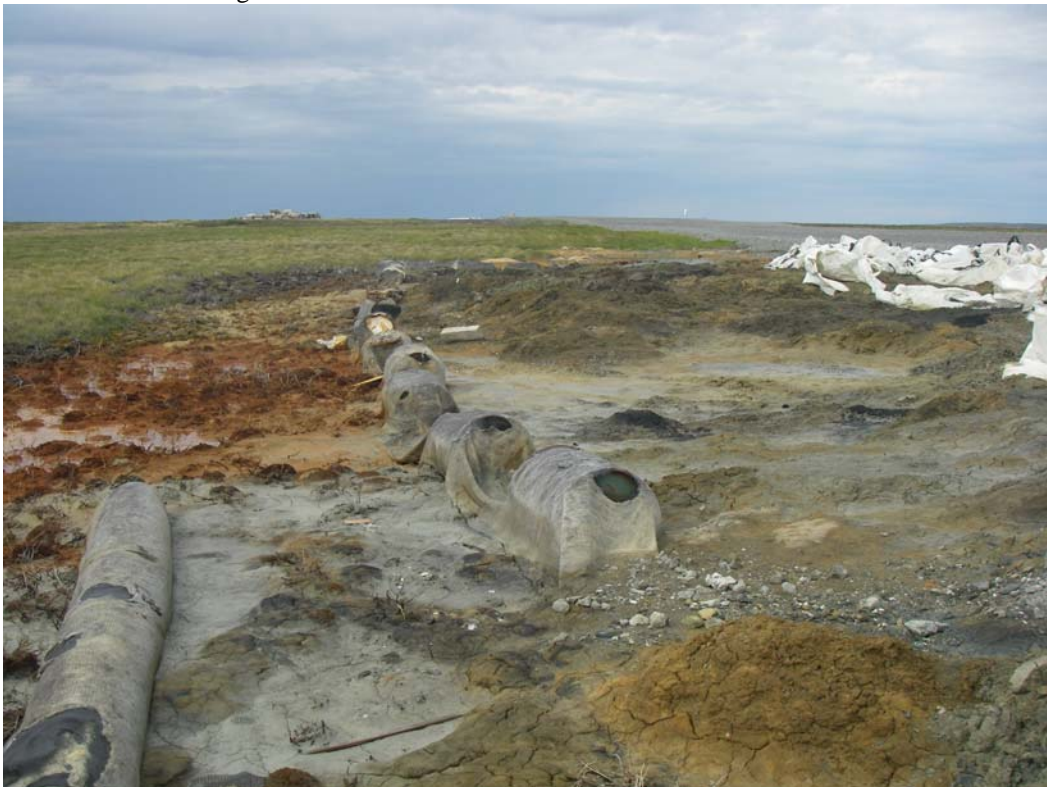
**Photo 48:** Looking north across the permafrost degradation area that has historically been used as a sediment pond. Note the use of geotextile.

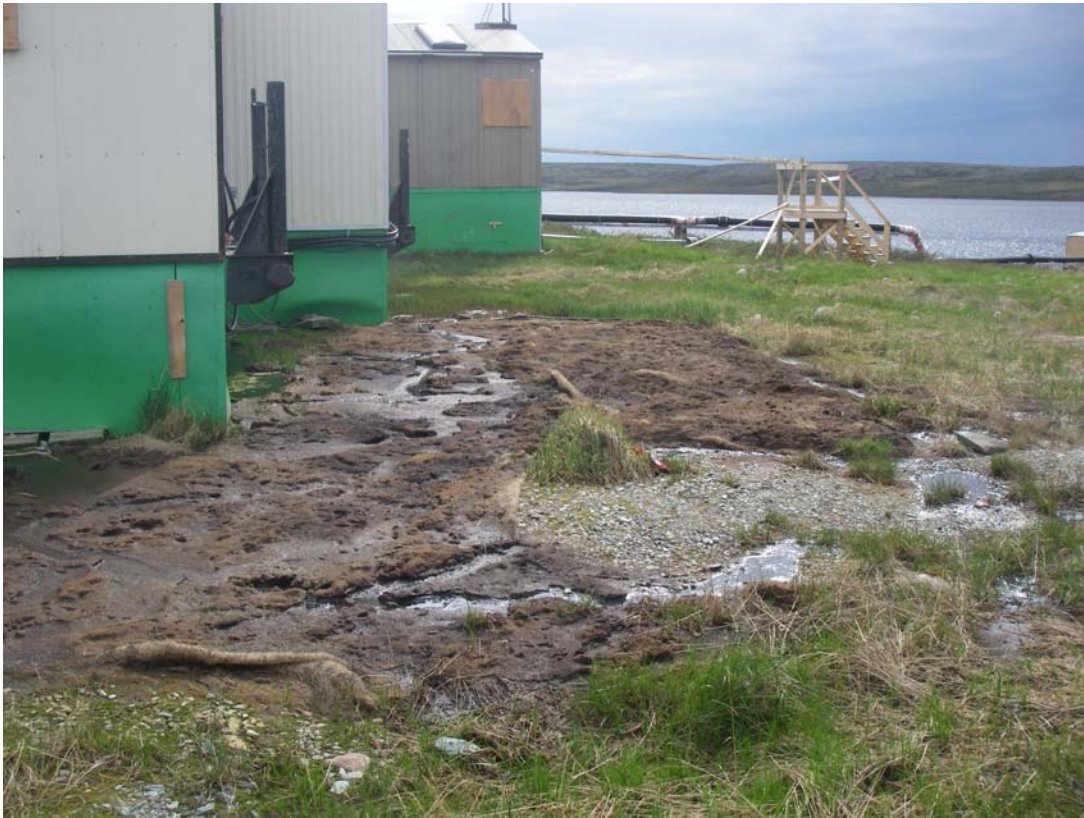
**Photo 55:** Area of permafrost degradation behind the administration office buildings.

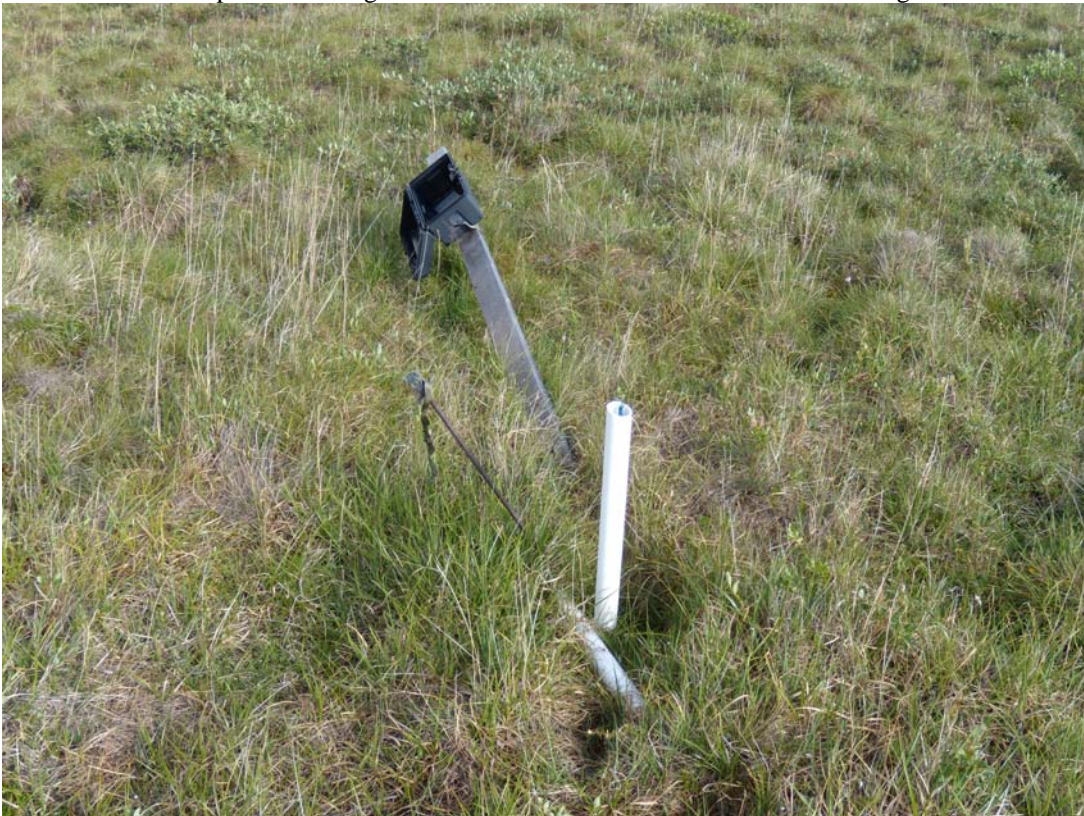
A summary of the available site thermistors are discussed in Section 2.5 and all available data are presented graphically in Figures 5 through 11. With the help of MHLB surveyors, the 1996 and 1997 thermistor strings were located as part of the geotechnical inspection. Three of the four strings were still in tact, although they are generally in poor condition, having fallen over from their support struts. Photos 58 through 61 in Appendix A, illustrate their state. The fourth cable has been completely severed, most likely by an animal (see Photos 56 and 57). The section of cable to which the readout connector is attached, is still at the site, and it should be possible to re-attach the cable through splicing.

**Photo 56:** Drill hole 12259-03 (BH3) with thermistor string #1049. The cable has been severed.

spliced and tested as well. Any strings that are found to be functional should be included in the formal thermistor monitoring program for the site.

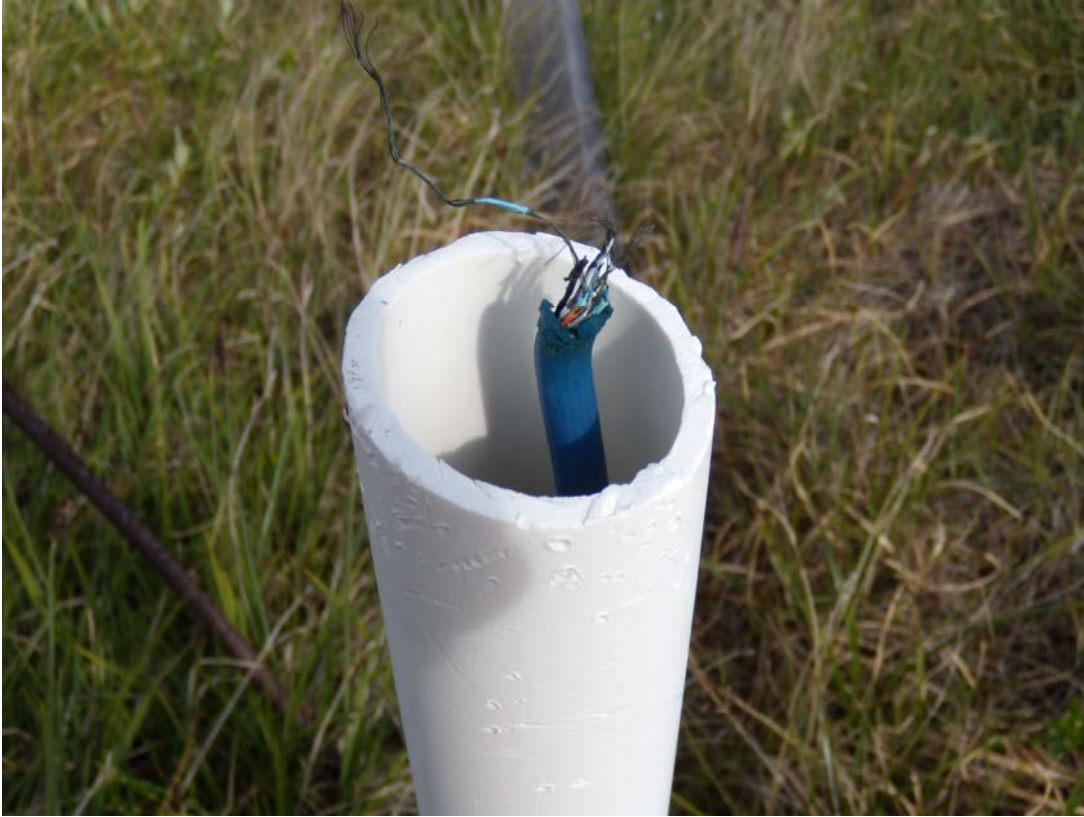
**Photo 57:** Close-up of the severed cable on drill hole 12259-03 (BH3) with thermistor string #1049.
