2010 Annual Geotechnical Inspection, Boston Advanced Exploration Project

Hope Bay, Nunavut

Project Reference Number
SRK 1CH008.032

February 2011

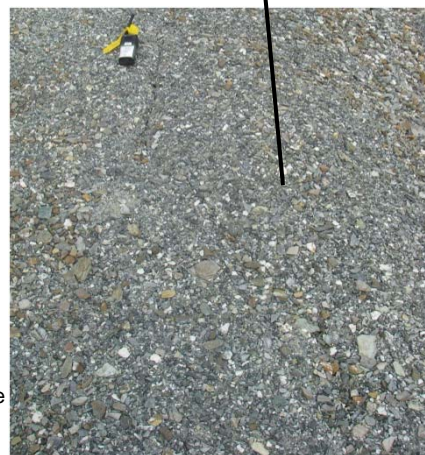
Tension cracks along the crest of the containment berm.

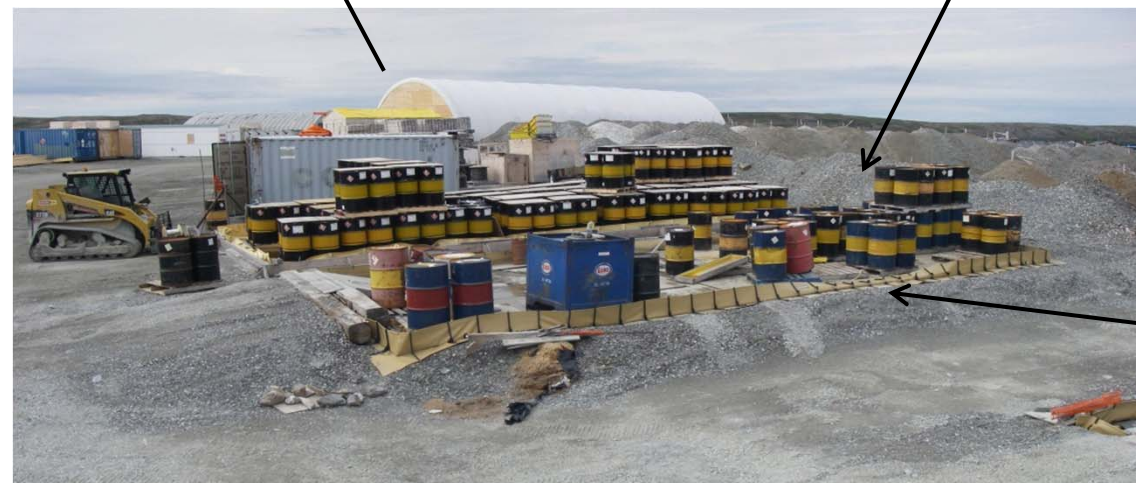
Containment berm collapsed and in need of repair.

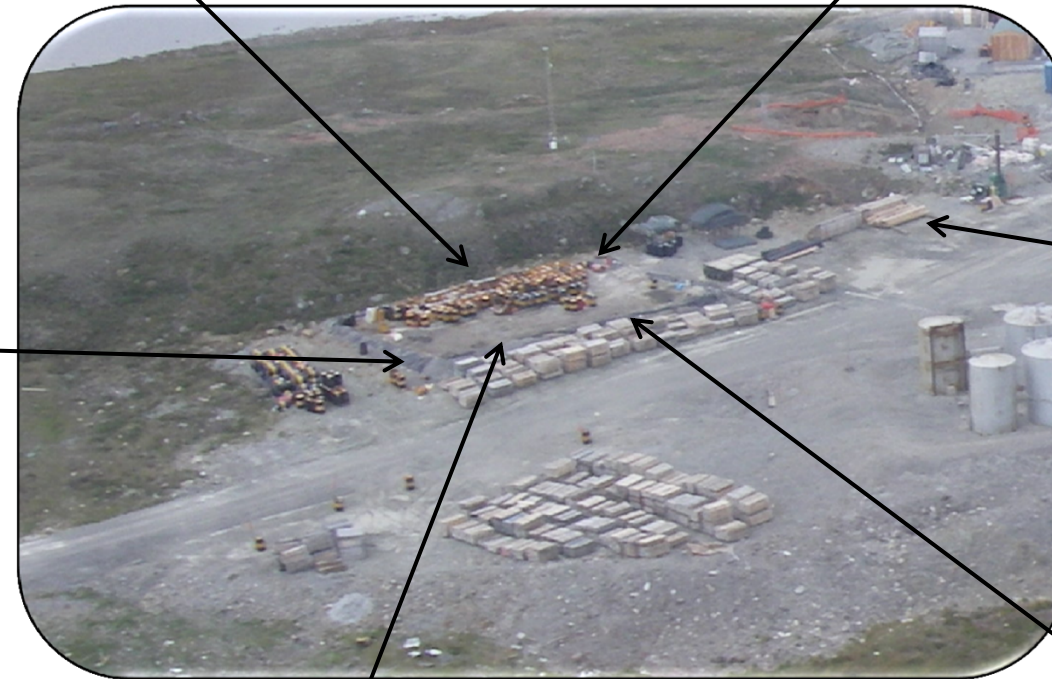
Wood, liner and other material scarps stored in the bone yard.

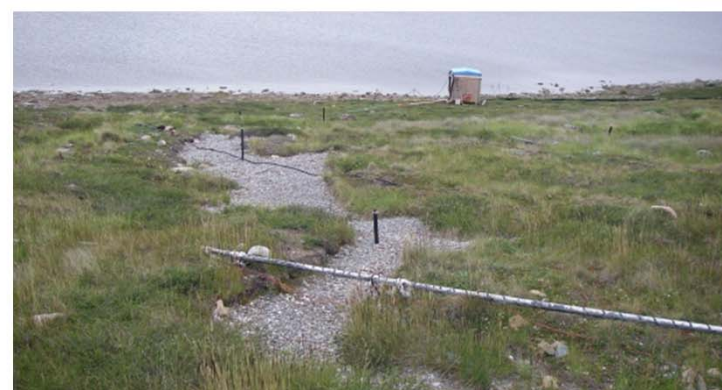
Looking west at an area of erosion and permafrost damage repaired by infilling with gravel

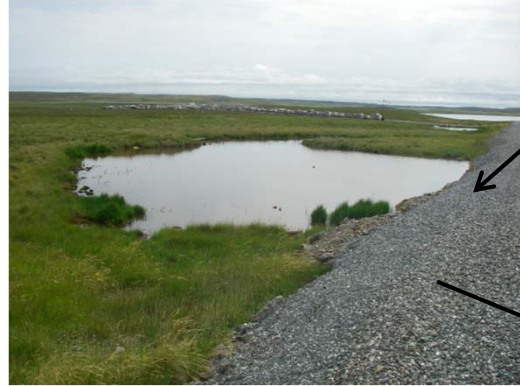
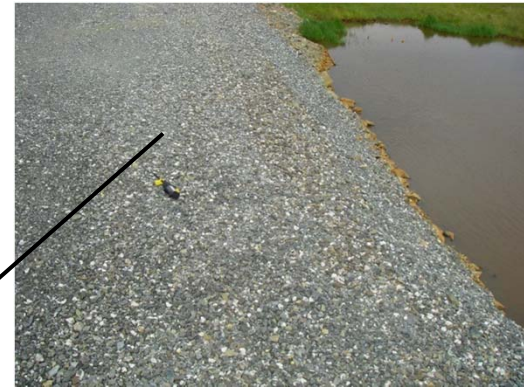
Permafrost degradation pond along east shoulder of airstrip

Tension cracks along crest of airstrip in areas where ponding exist,

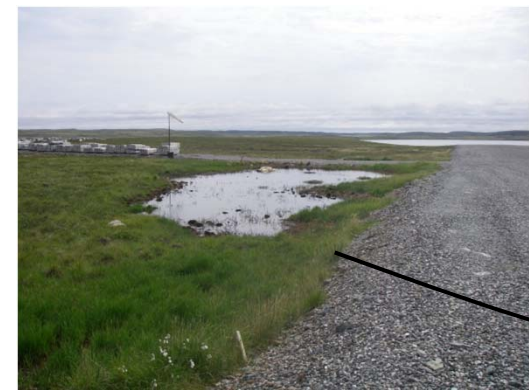
Permafrost degradation pond along east shoulder of airstrip.

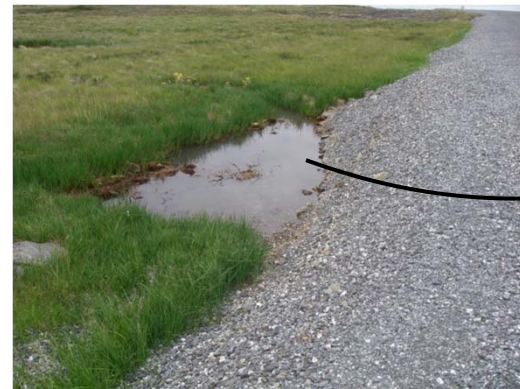
Permafrost degradation pond along west shoulder of airstrip.

Large permafrost degradation and vegetation dieback area along west shoulder of airstrip.

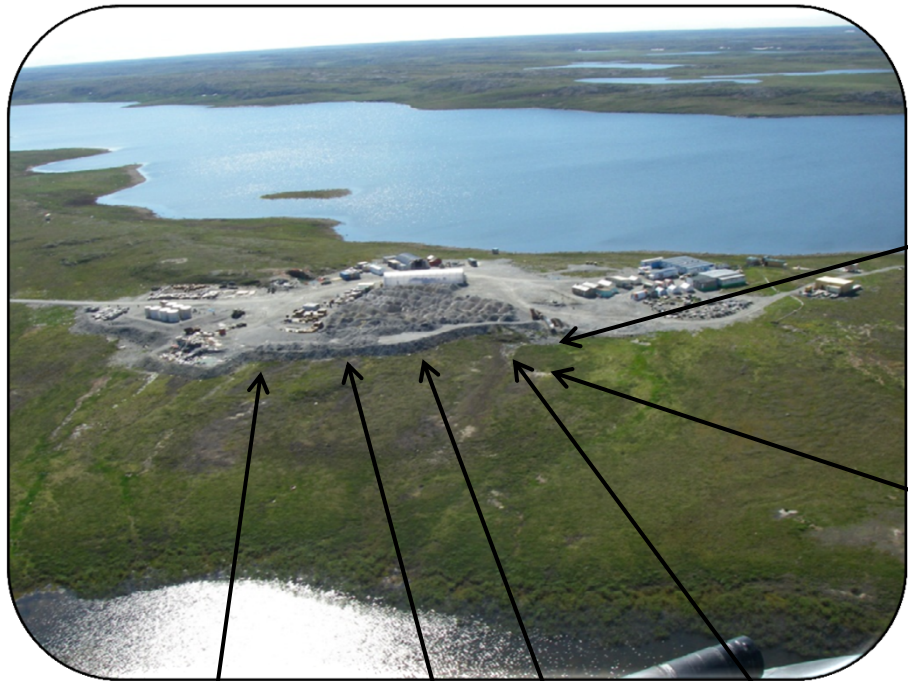
Gravel cover over an area of historic vegetation dieback.

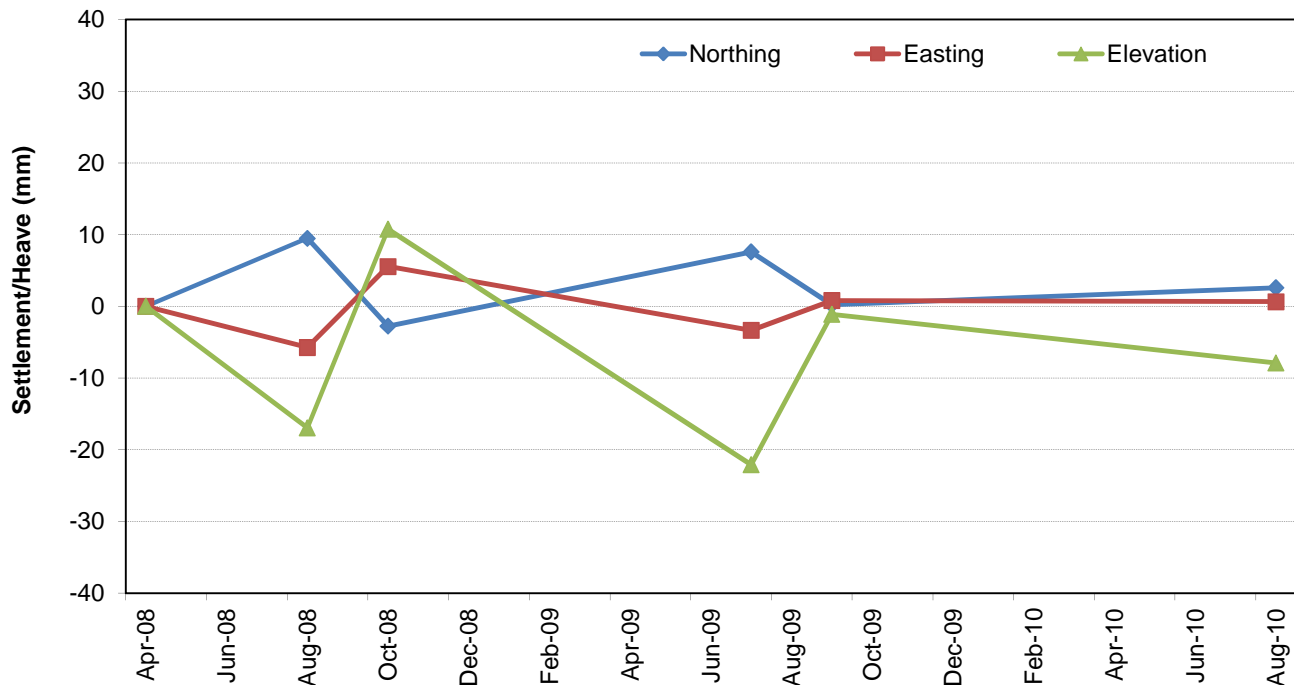
Boston Primary Fuel Tank Farm Settlement Monitoring

A review of the data suggest a slow but consistent trend of the tanks settling; however, this settlement is very small and since there is no trend of movement in the horizontal plane there is no indication that differential settlement is taking place which may cause the tanks to topple.

TANK AVERAGES BY DATE (mm)	22-Apr-08	0.0	0.0	0.0
	8-Aug-08	9.5	-5.7	-17.0
	18-Oct-08	-2.8	5.6	10.7
	25-Jul-09	7.6	-3.3	-22.1
	19-Sep-09	0.2	0.8	-1.1
	2-Aug-10	2.6	0.7	-7.9
OVERALL PERIOD AVERAGE (mm)		3.4	-0.4	-7.5

- Quarterly monitoring (or as close to this schedule as the camp operating window allows) of tank settlement should continue. This data should be reviewed and reported on as part of the annual geotechnical inspection, and should there be any signs of undue movement, appropriate mitigation plans can be put in motion.
- The foundation settlement risk should be recognized in the spill response plan for the tank farm.
