2011 Annual Geotechnical Inspection, Boston Advanced Exploration Project, Hope Bay, Nunavut

Hope Bay Mining Ltd

SRK Consulting (Canada) Inc.
1CH008.046
March 2012

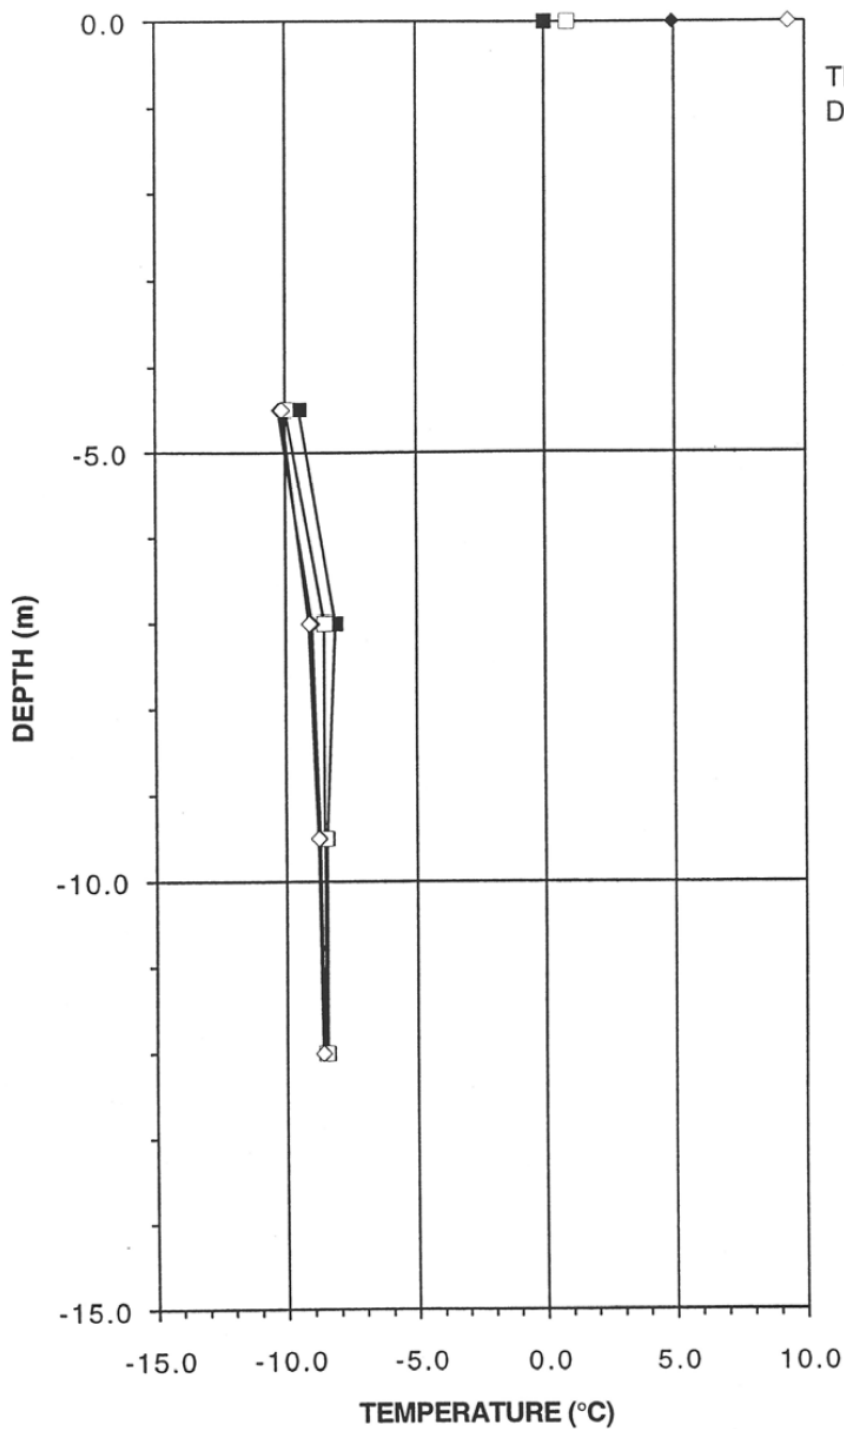
Thermistor No.: 1049
Date Installed: 96-05-17

Drill hole 12259-03 (BH3) with thermistor string #1049. The cable has been severed.

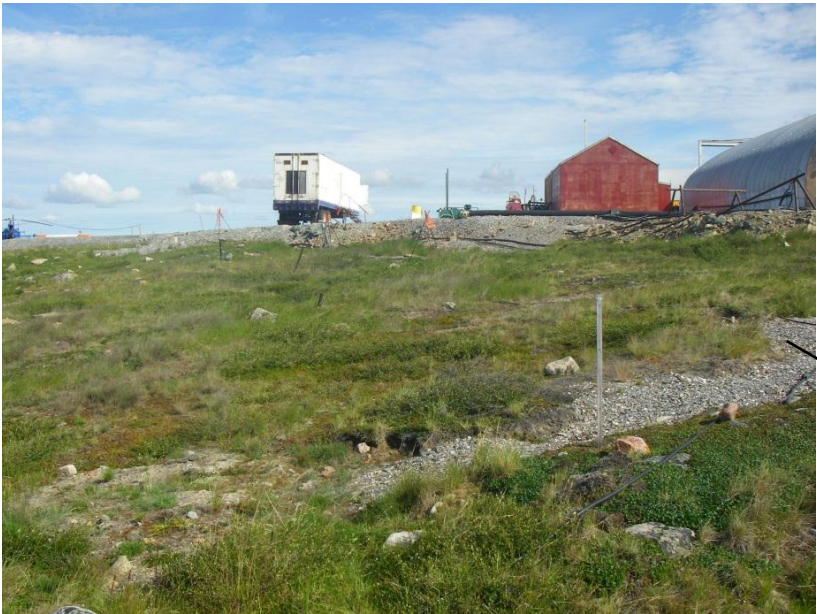
Looking east behind the powerhouse (red building). Note backfill of erosion piles in the foreground.

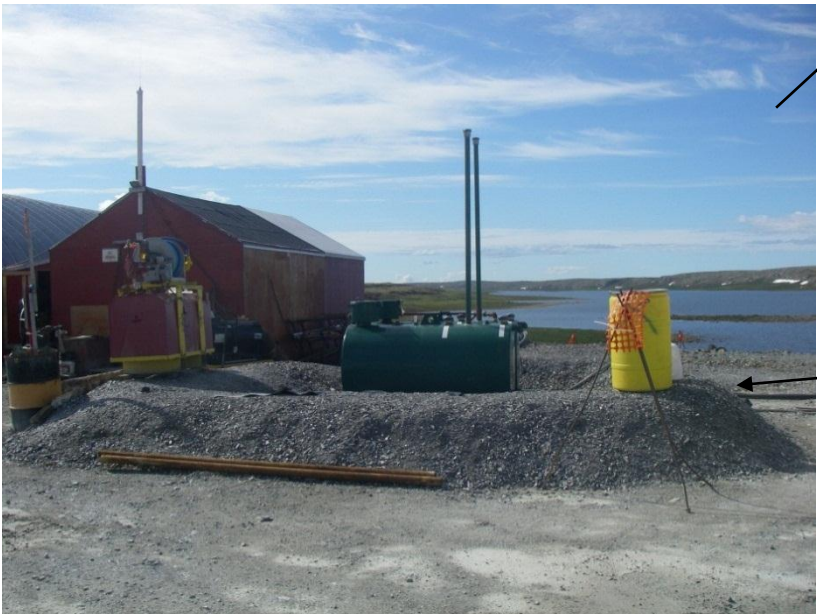
Looking west toward the secondary containment of power plant/shop fuel supply.

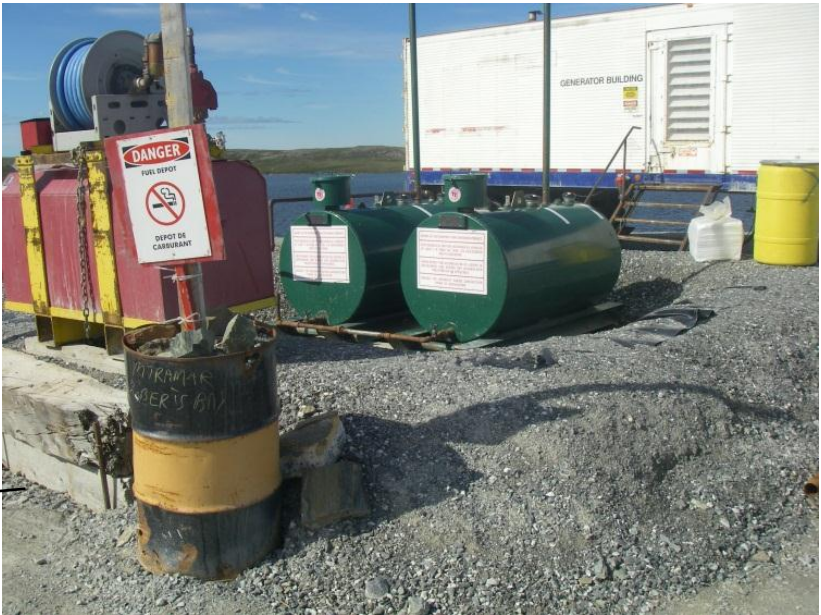
Secondary containment of powerhouse and shops fuel supply. Photo looking northwest

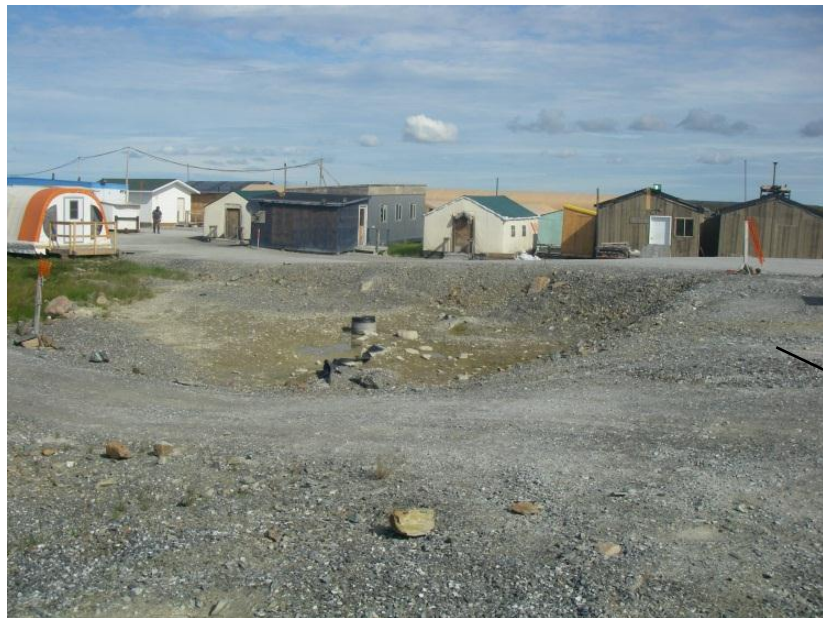
Looking north at core logging shed and offices. The depression in the foreground is the historic hydrocarbon spill

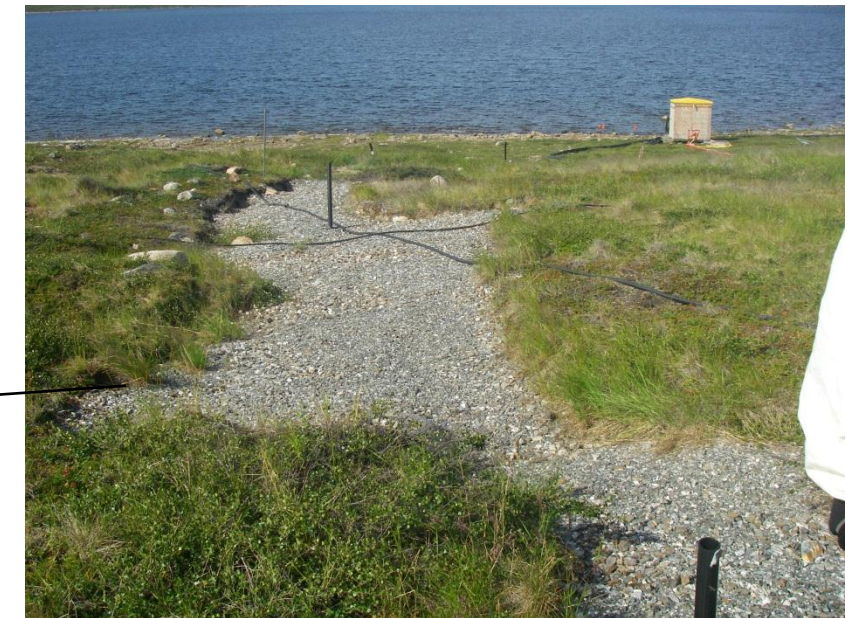
Trench on tundra filled with gravel

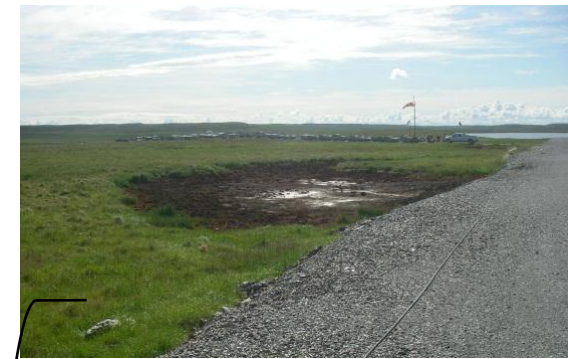
Permafrost degradation along east side of Airstrip

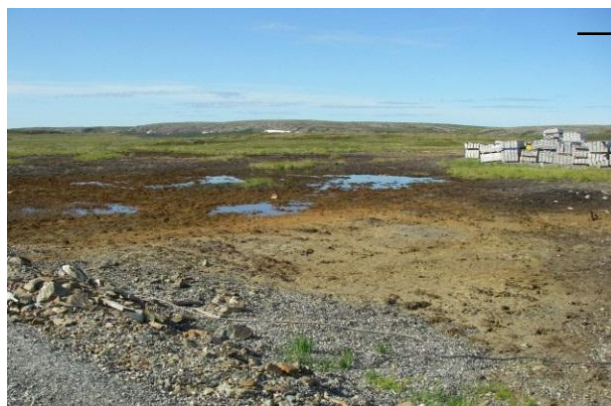
Permafrost degradation and vegetation die-back

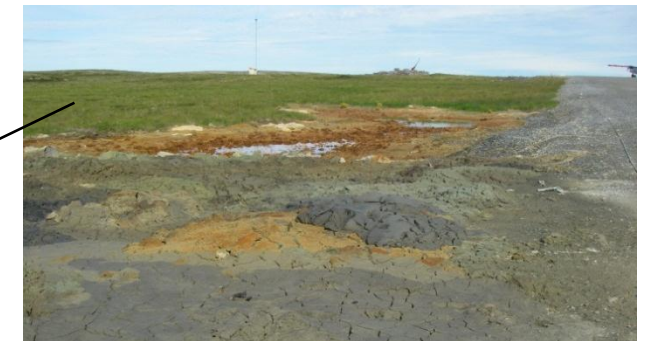
Vegetation die-back and permafrost degradation (background). Drill cuttings (foreground)

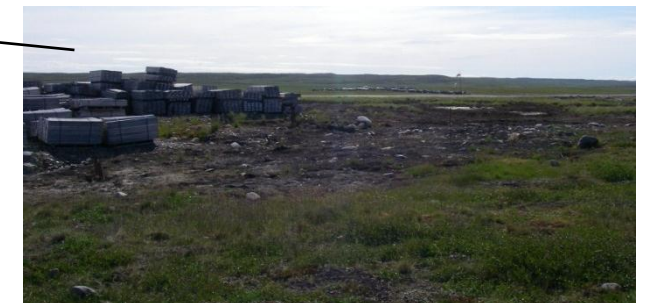
Core storage area on west side of Airstrip. Vegetation die-back and permafrost degradation visible.

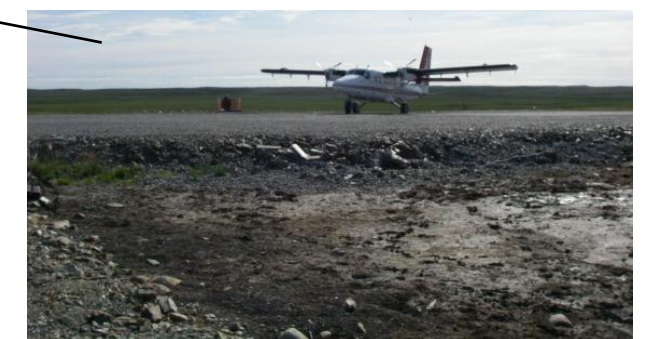
Permafrost degradation and vegetation die-back

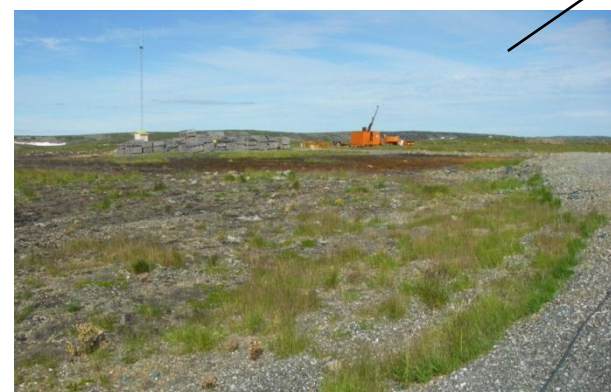
Drill located on northwest end of Airstrip, permafrost degradation and vegetation die-back
