# 2012 Annual Geotechnical Inspection Boston Advanced Exploration Project Hope Bay, Nunavut

SRK Consulting (Canada) Inc.  
1CH008.066  
January 2013

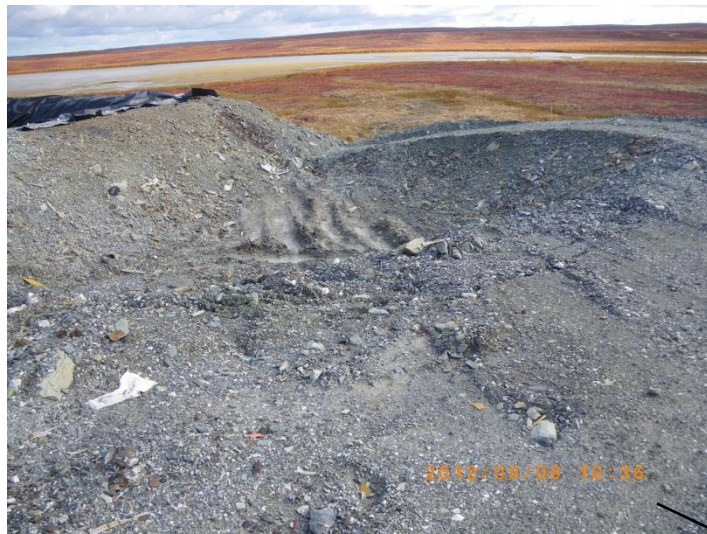
Burn pit – looking northeast

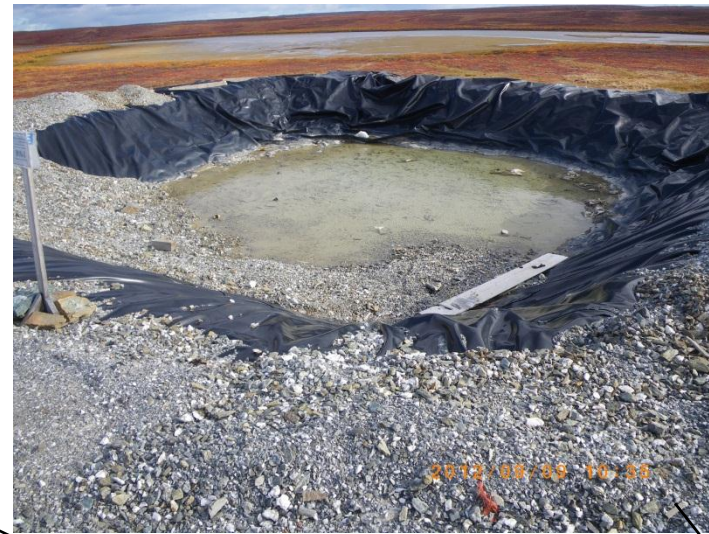
Settling Pond – looking north east

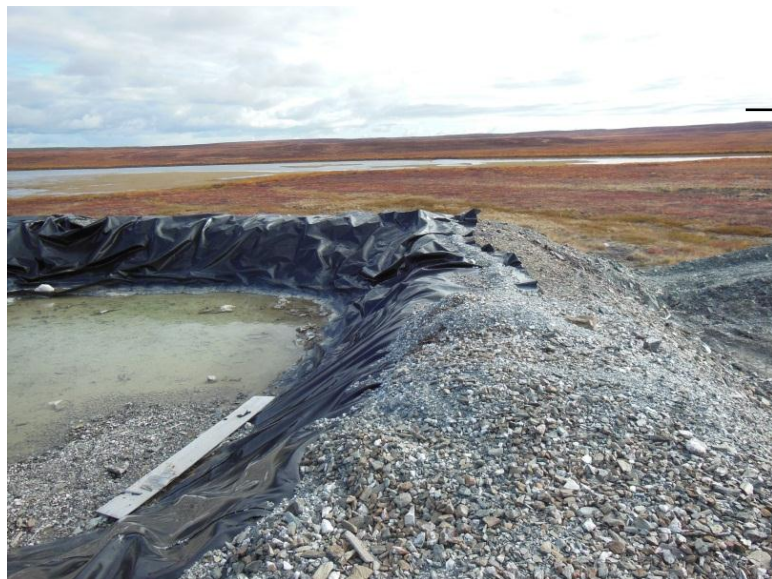
Settling Pond – looking east across top of berm

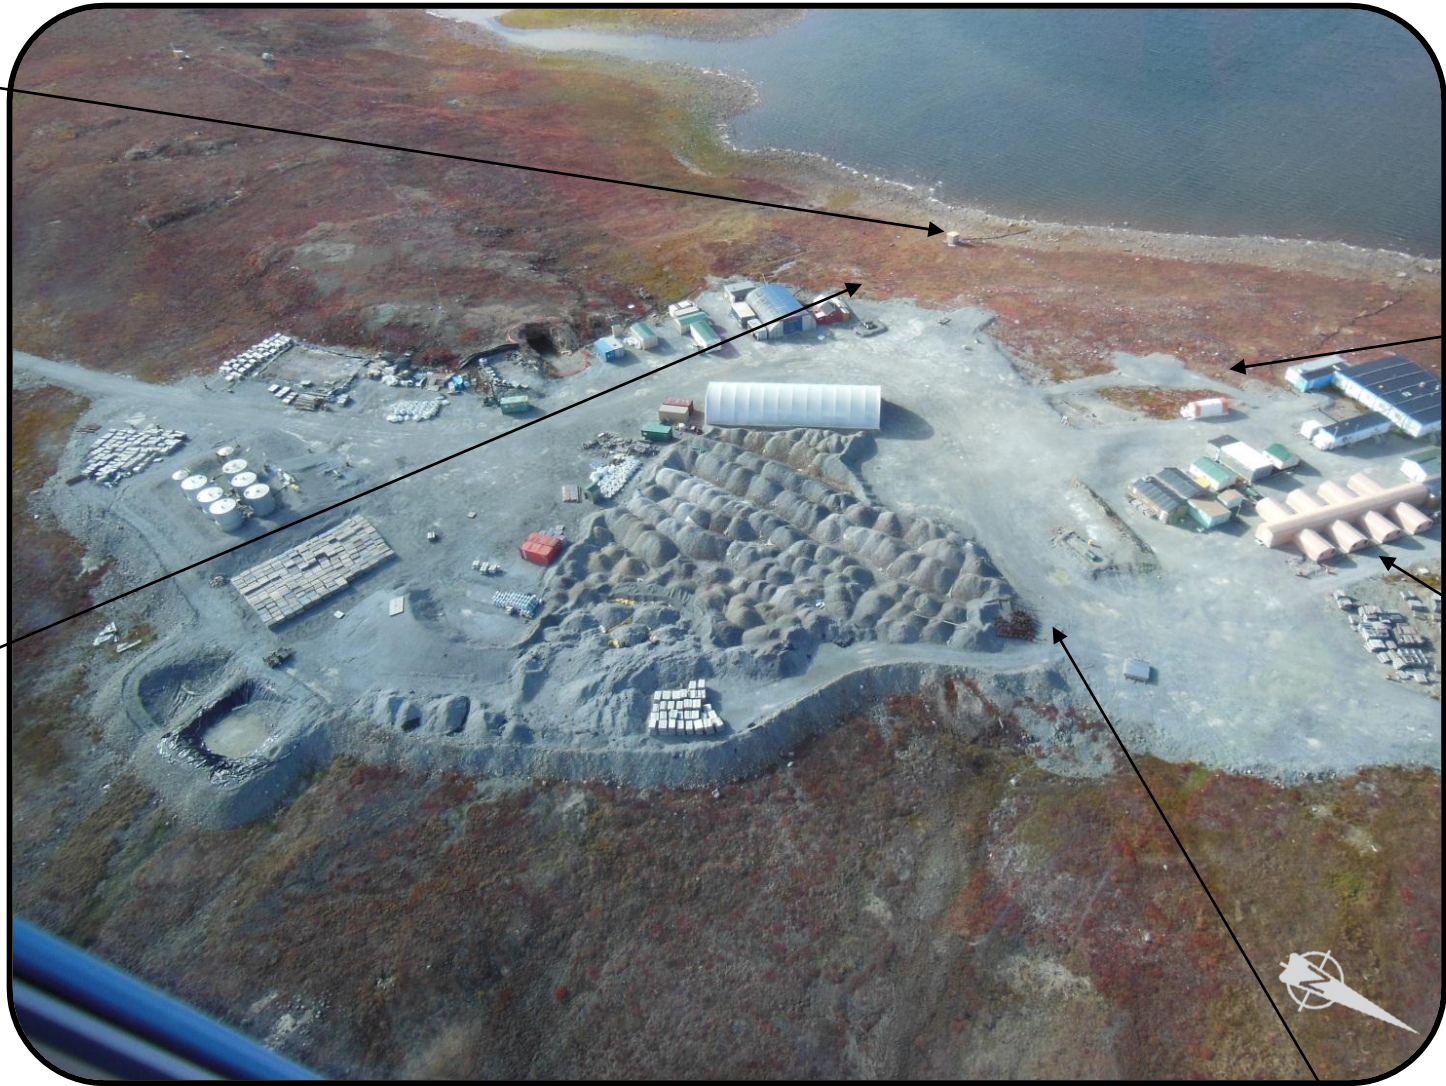
Old hydrocarbon spill area with geology offices and camp buildings in the background

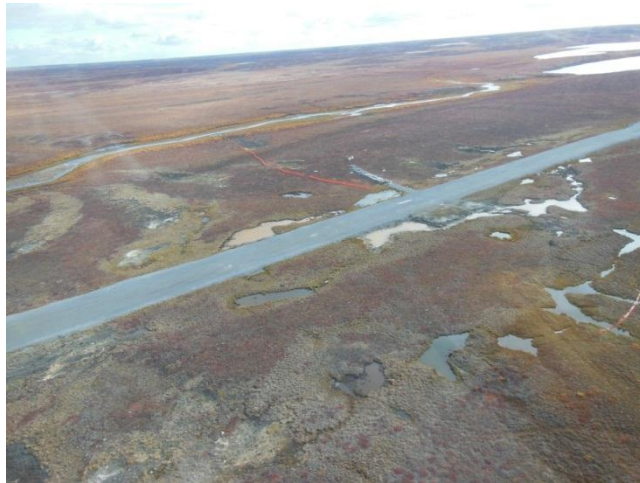
Aerial view of core box clean-up around core storage road/ drill cutting disposal and permafrost degradation along the airstrip perimeter – looking southeast

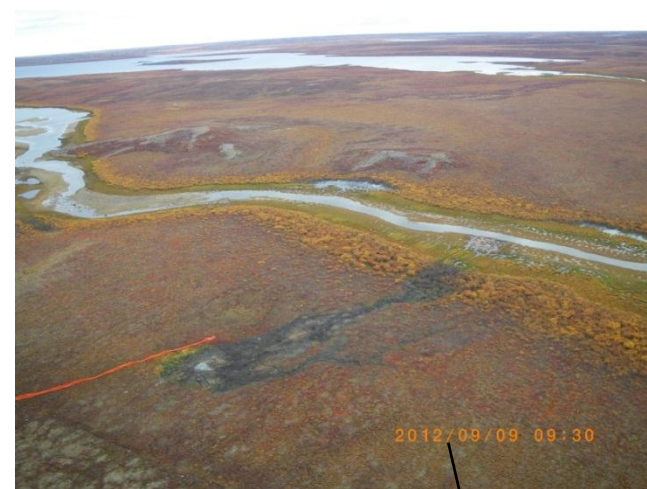
Orbit 25 Salt Spill

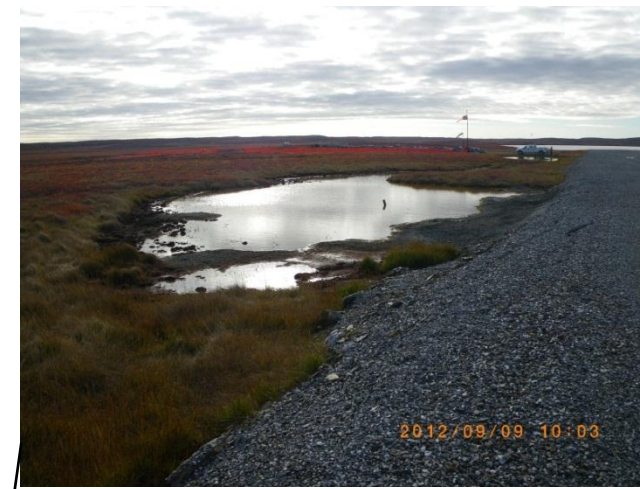
Permafrost degradation and ponded water

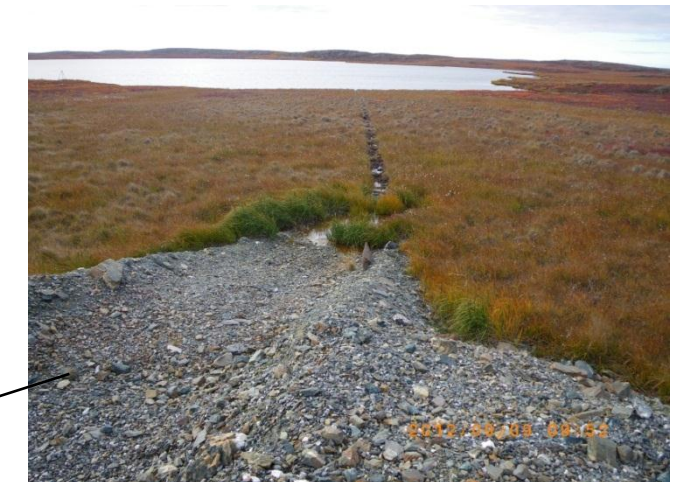
Removed boardwalk at south end of airstrip

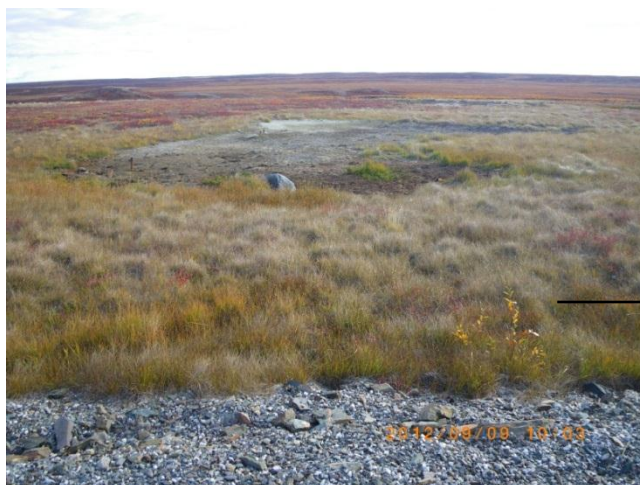
Tundra damage along east side of airstrip

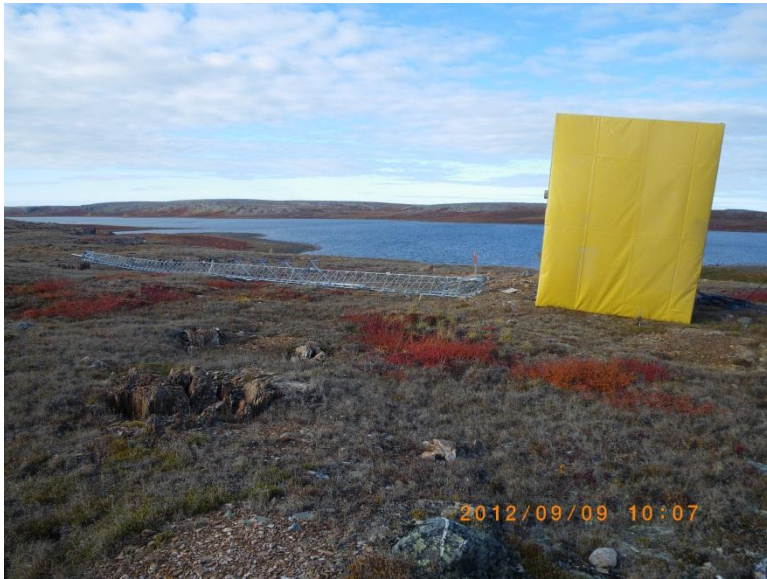
Dismantled radio tower – looking southwest

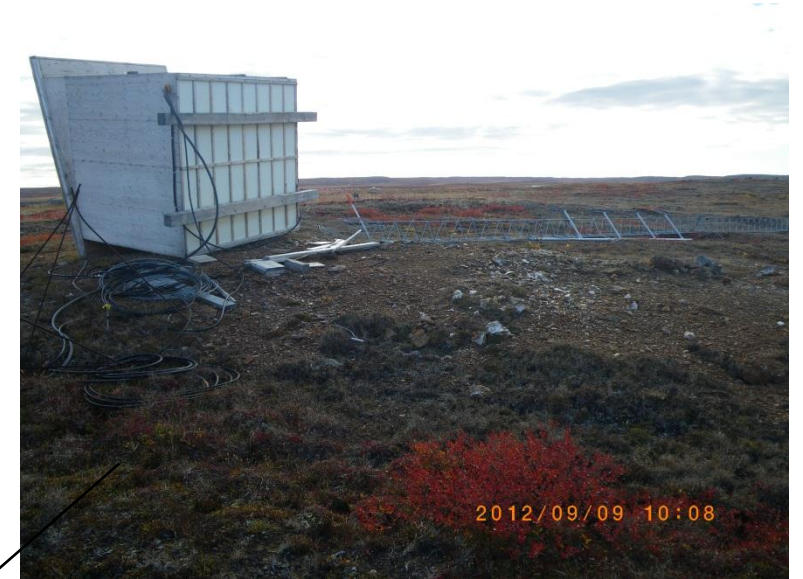
Dismantled radio tower – looking southeast

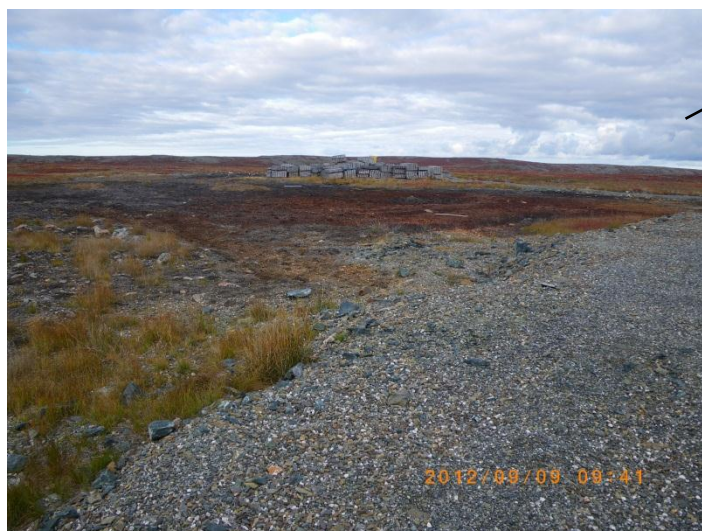
Core storage boxes relocated onto drill road and tundra damage in the foreground. Looking northwest from the airstrip

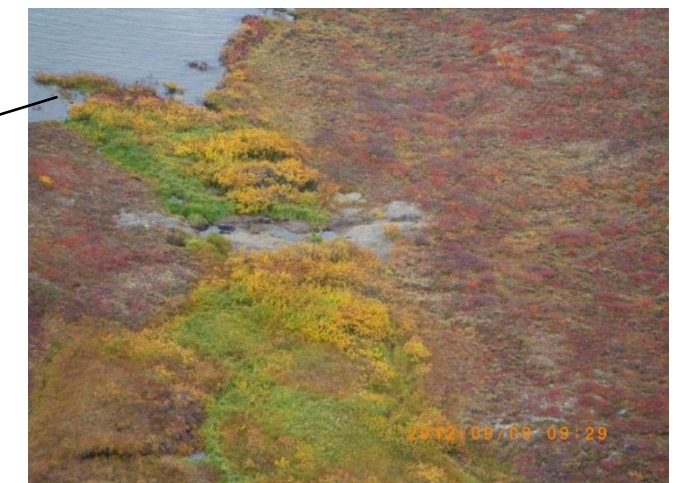
Removed weir at south end of airstrip

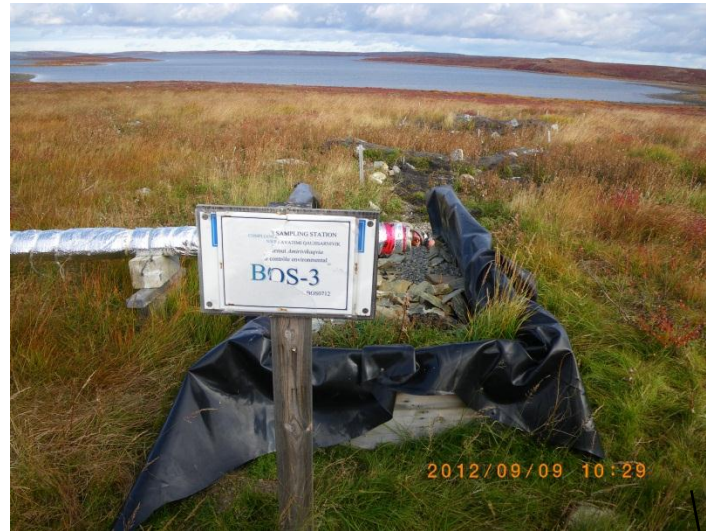
STP Discharge location with vegetation damage shown in the background
