Re: 2BB-BOS1217 – 2013 Annual Geotechnical Inspection Report

TMAC Resources Inc.

2013 Geotechnical Inspection	
		Containment Pond and Burn Pit	
Job No: 1CT022.000	HOPE BAY PROJECT	Date: March 2014	Approved: LW
Filename: Boston Geotech_Figures_1CT022.000_Rev04.pptx		Figure: 17

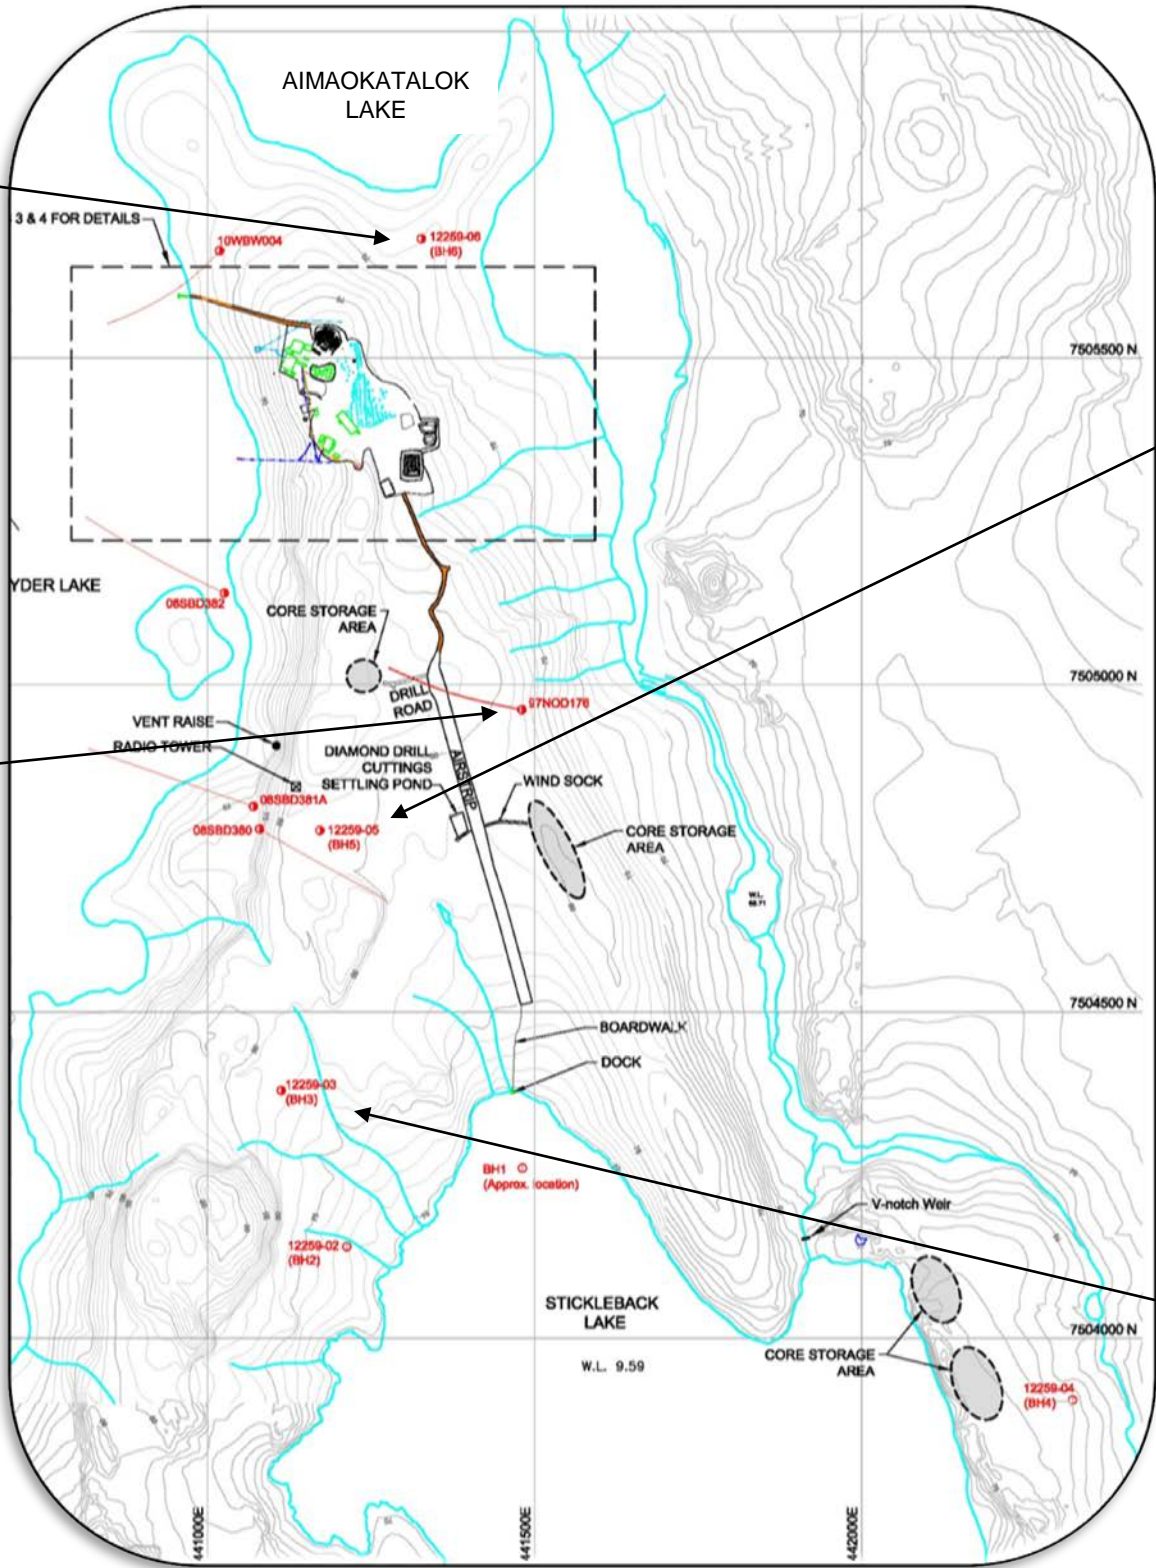
Drill hole 12259-05 (BH5) with thermistor string #1050.

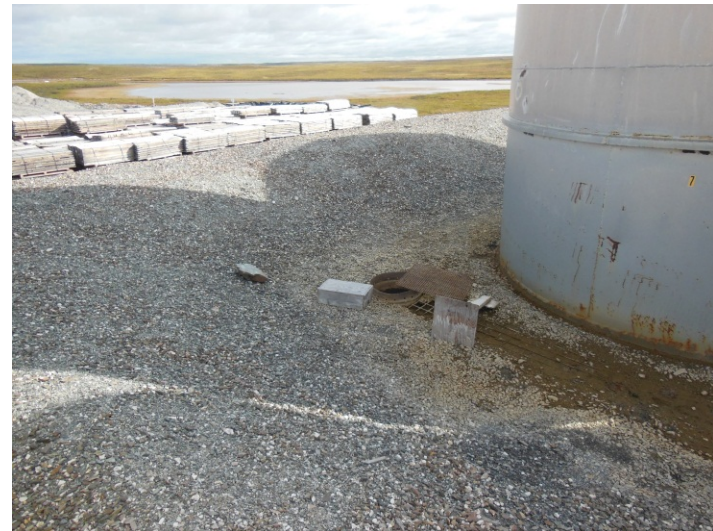
Condition of sump in north west corner of the Primary Tank Farm

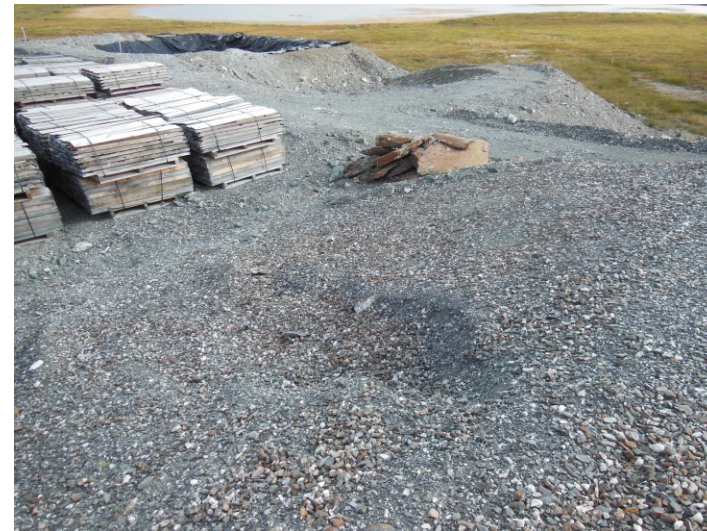
A depression at the north end of the Primary Tank Farm

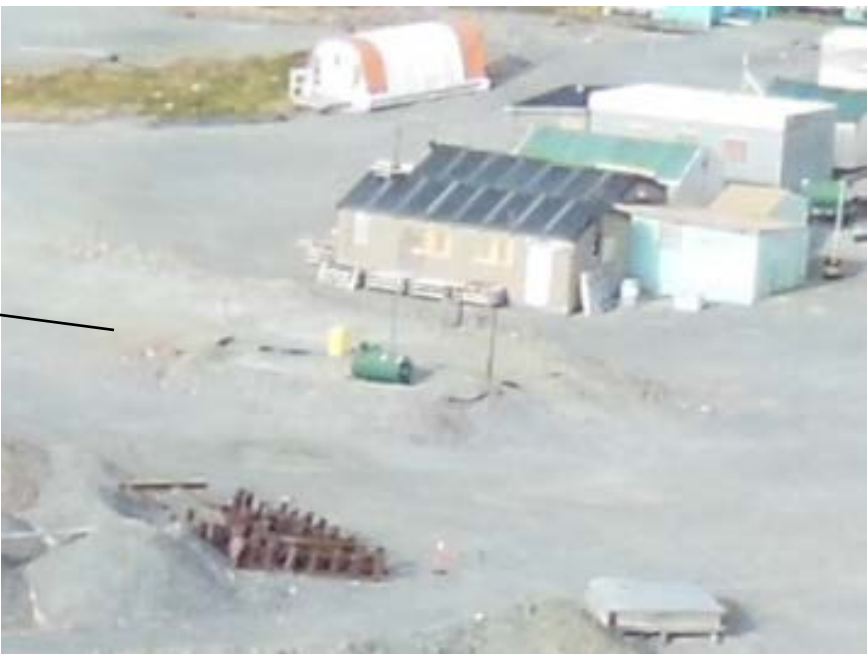
Mid pad fuel transfer station

- No action required. Should this fuel transfer station be used, the exposed liner should be covered to prevent exposure and/or operational damage.

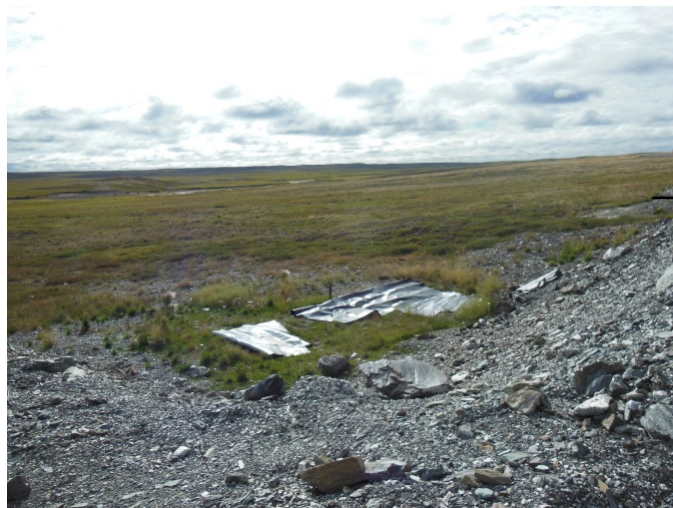
Pieces of liner laying on the tundra to the south of the Burn Pit

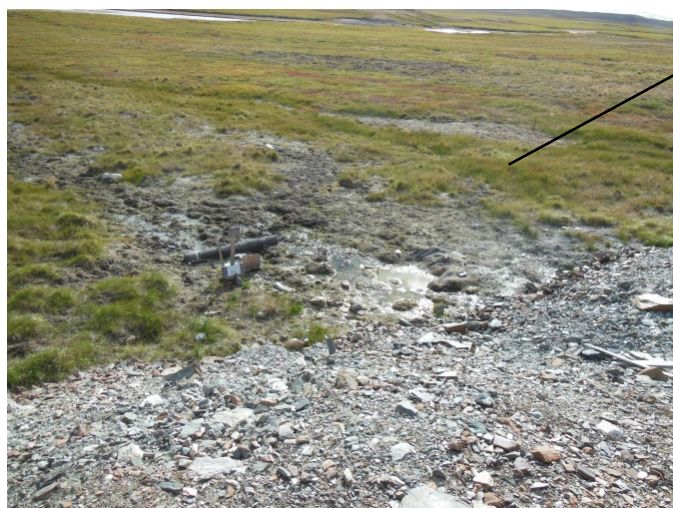
Seepage and vegetation die back along the toe of the Burn Pit

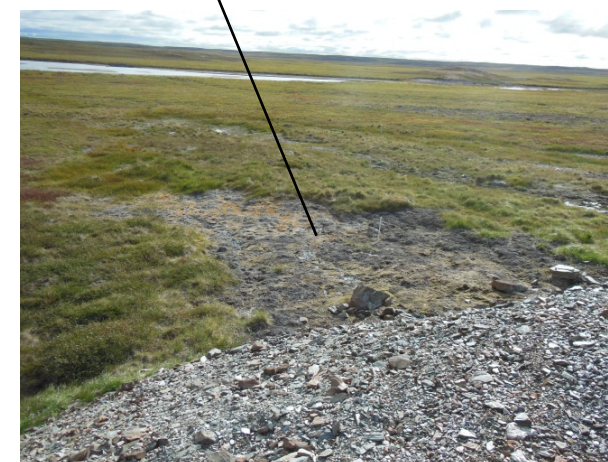
Seepage and vegetation die back along the toe of the Containment Pond

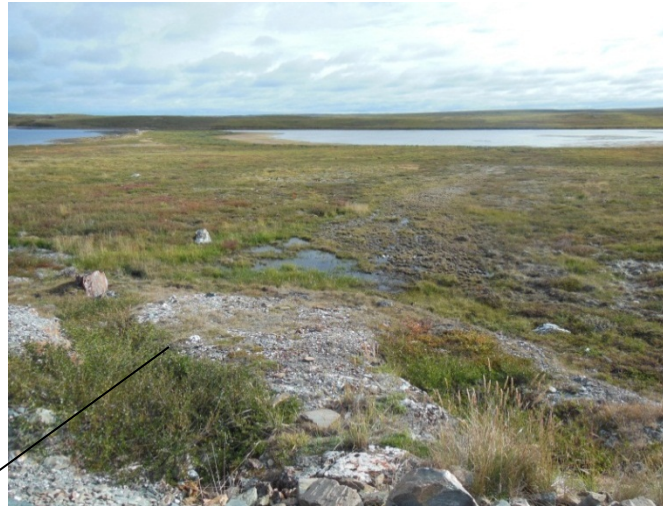
Seepage and vegetation die back at the toe of the rock fill pad at north end of the Ore Stockpiles

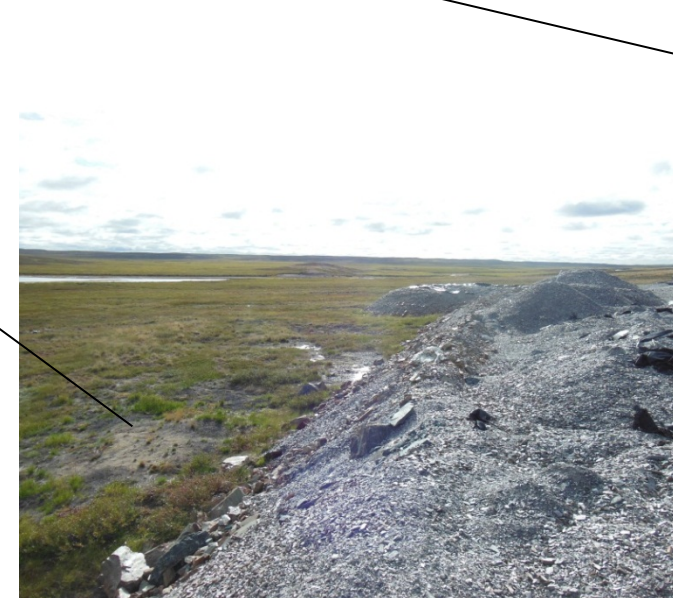
Seepage and vegetation die back at the toe of the rock fill pad by the Ore Stockpiles

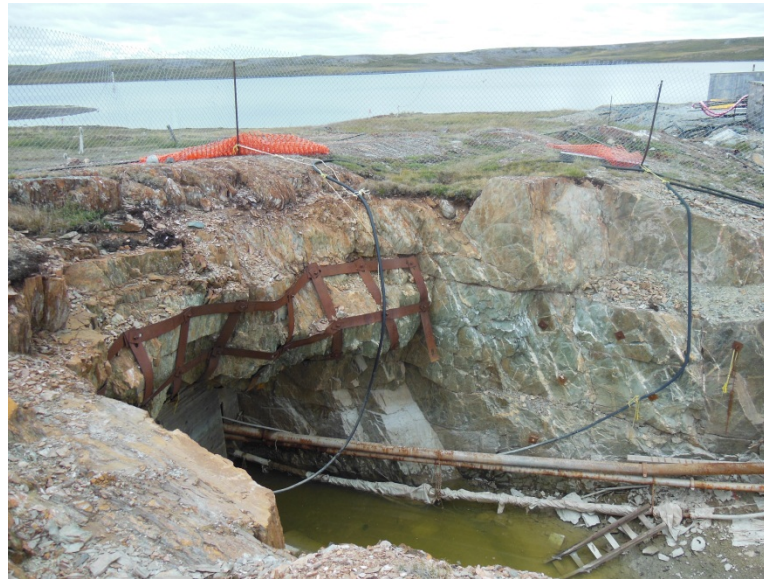
Condition of the reinforcement over the Portal entrance

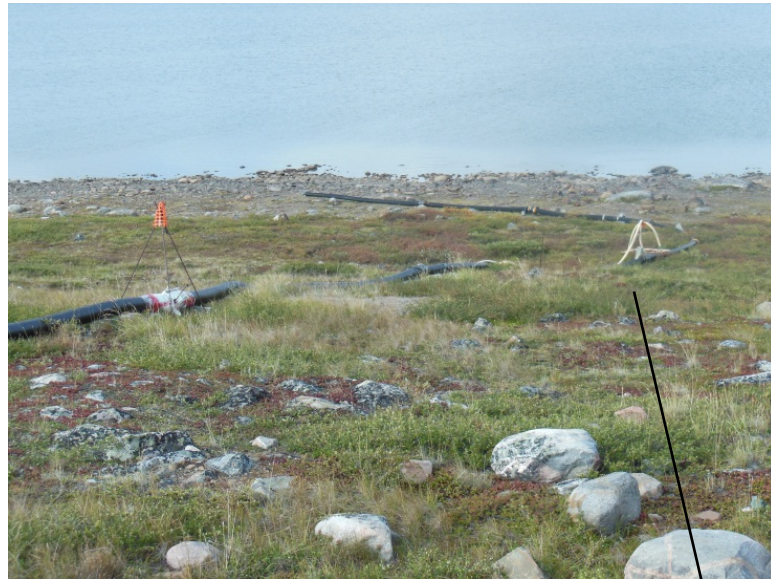
Abandoned fresh water intake pipe line and backfilled erosion gully

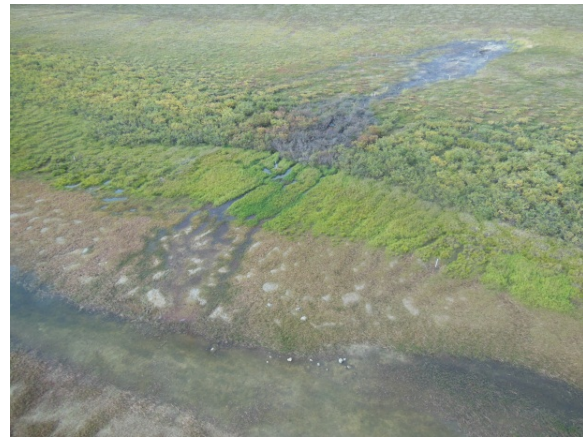
Orbit 25 Drill Site salt-burn

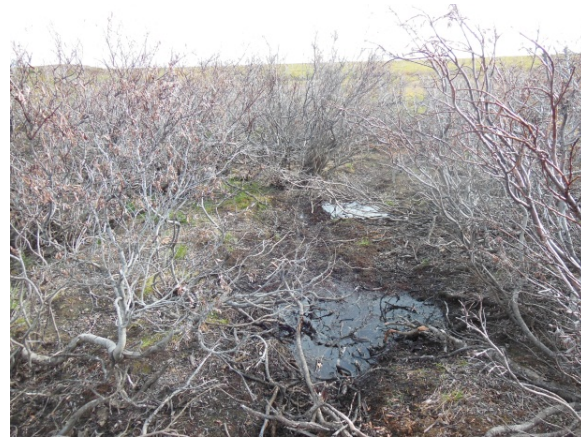
Vegetation die back within the Orbit 25 Drill Site salt-burn

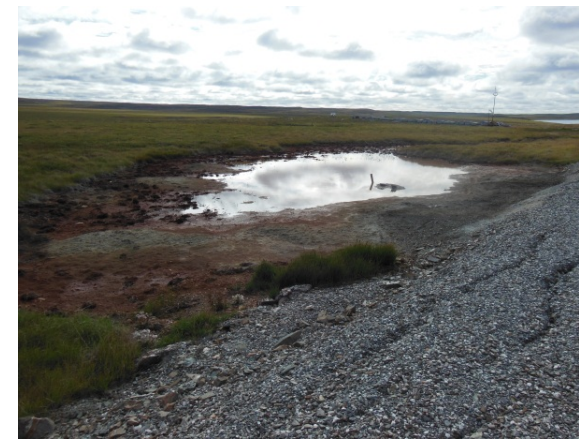
Permafrost degradation and ponded water along edge of the Airstrip

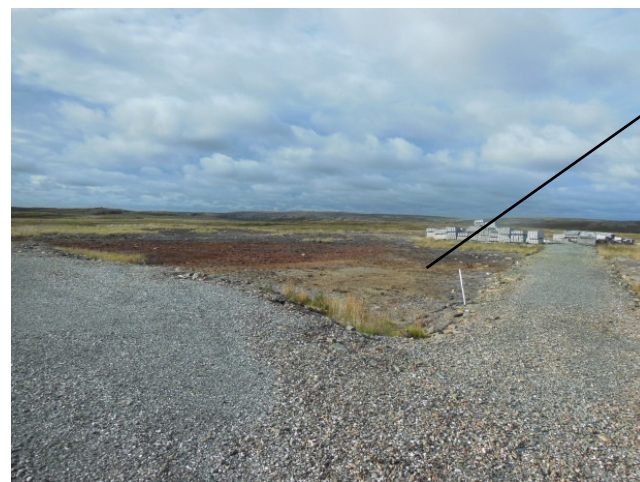
Tundra damage along east side of airstrip – looking northwest towards core boxes stored along Drill Road
