2014 Geotechnical Inspection

HOPE BAY MINING LTD.

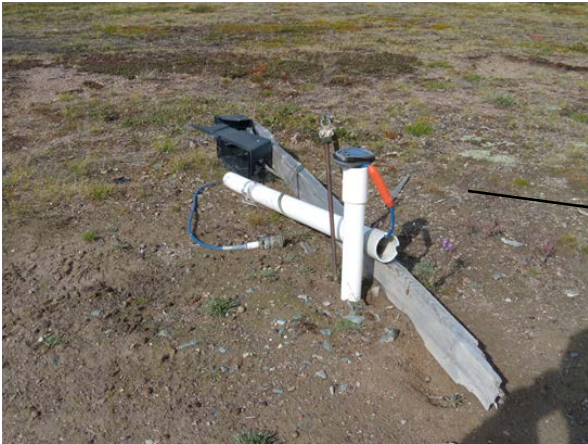
Drill hole 12259-06 (BH6) with thermistor string #1051.

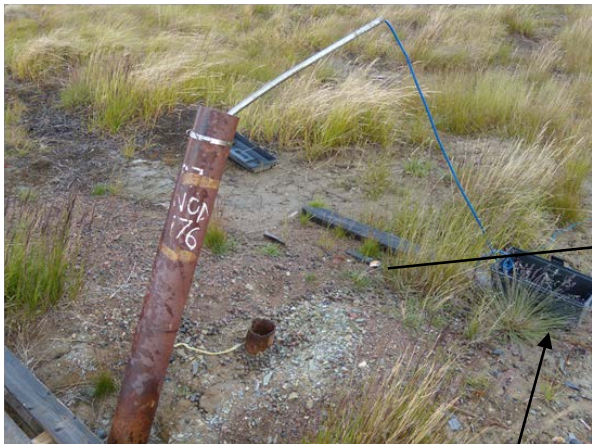
Drill hole 97NOD176 with thermistor string.

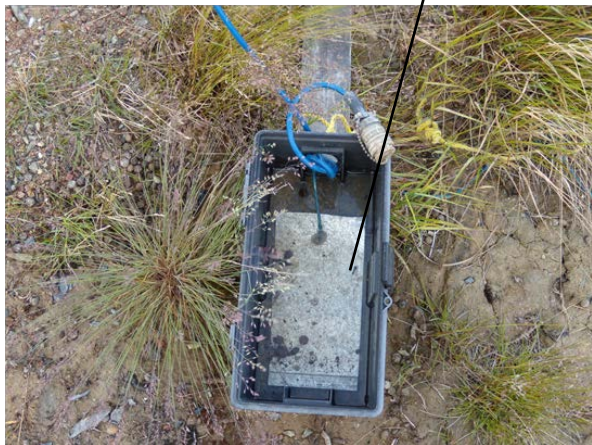
Close-up of the readout box and terminal connector for the thermistor string on drill hole 97NOD176.

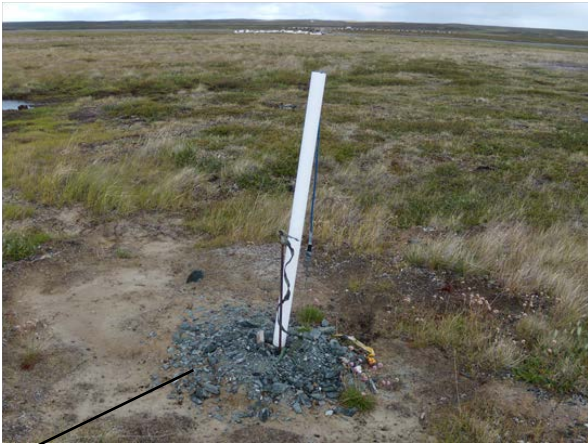
Drill hole 12259-05 (BH5) with thermistor string #1050.

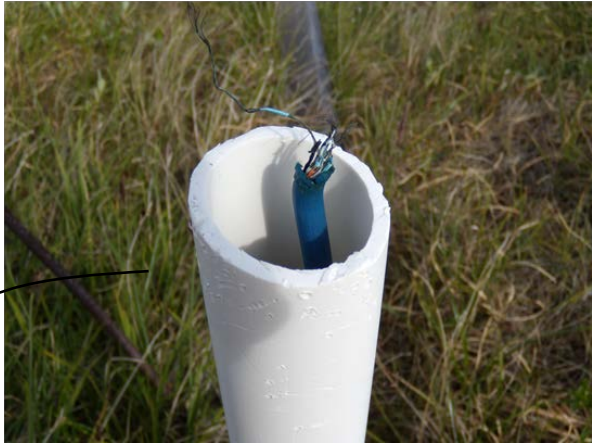
Close-up of the severed cable on drill hole 12259-03 (BH3) with thermistor string #1049.

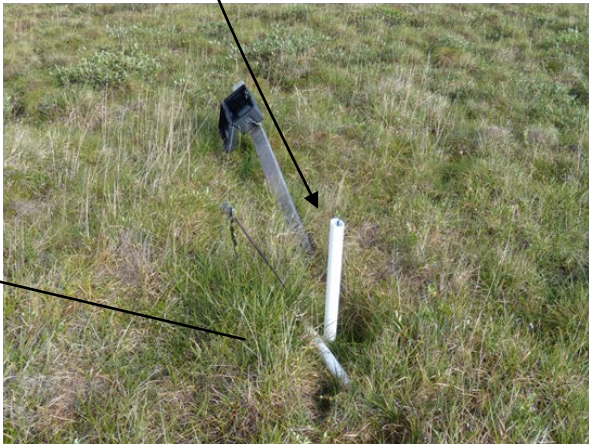
Drill hole 12259-03 (BH3) with thermistor string #1049. The cable has been severed.
