2014 Geotechnical Inspection

HOPE BAY MINING LTD.

HOPE BAY PROJECT

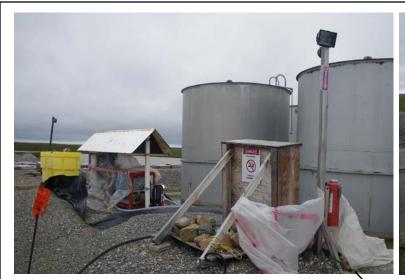
Vehicle fueling station — looking north from the

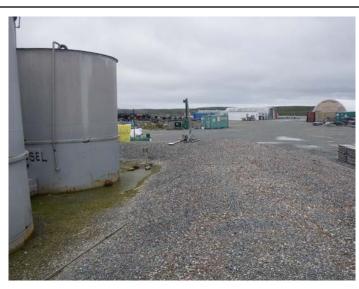
North side of Primary Tank Farm - looking west towards the incinerator

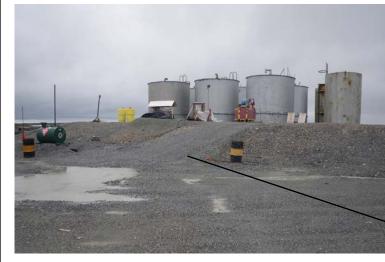
Entrance into the Primary Fuel Tank Farm –

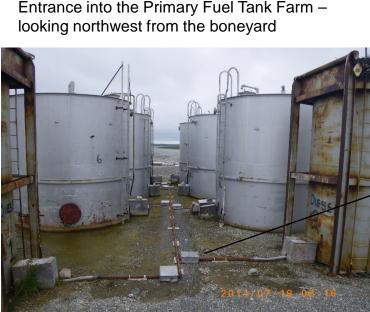
The interior of the Primary Tank Farm - looking north from the south end

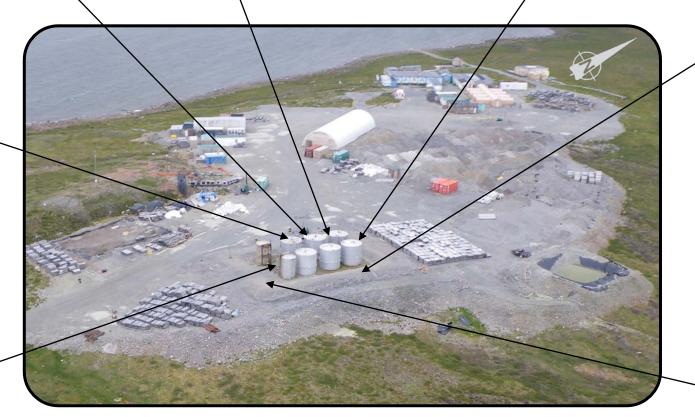
East side of Primary Tank Farm – looking north towards the Containment Pond

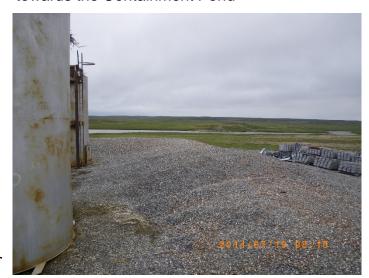
South side of Primary Tank Farm – looking east

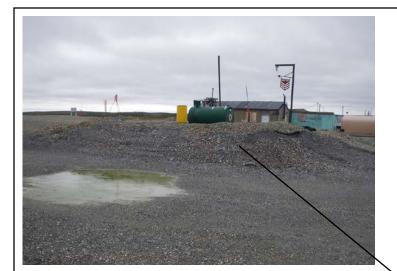
Mid pad fuel transfer station – looking north from the ore stockpiles

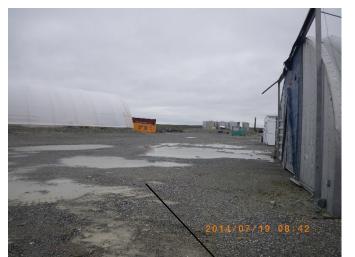
Camp pad between the Workshop and the Crusher Building – looking south

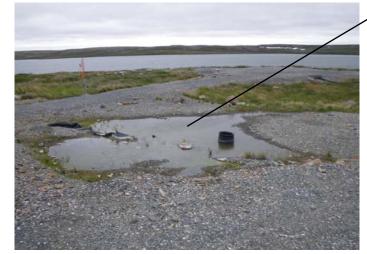
Old fuel spill area – looking west from the Geology Office

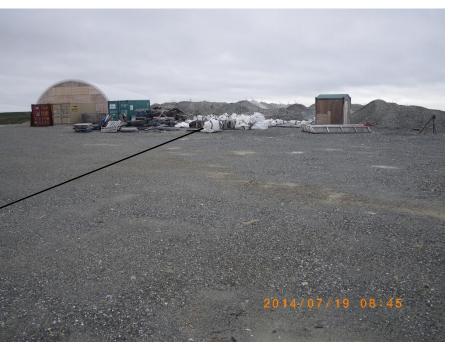
Remaining waste to be removed from site – looking north from the core storage area

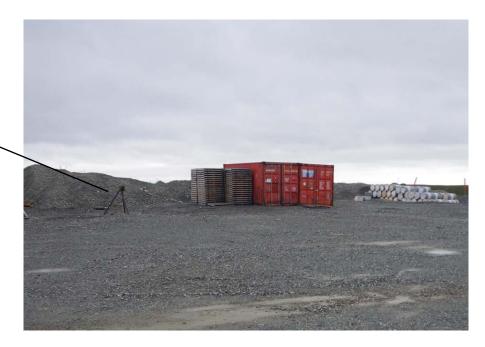
Jet fuel stored in the two sea cans with empty fuel drums stored in the Jet Fuel and Lubricant Storage Area – looking north from the core storage area

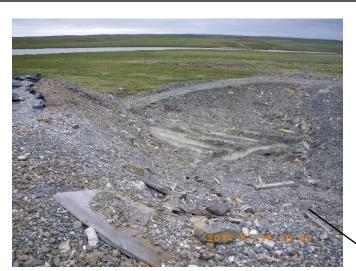
Burn Pit – Looking northwest

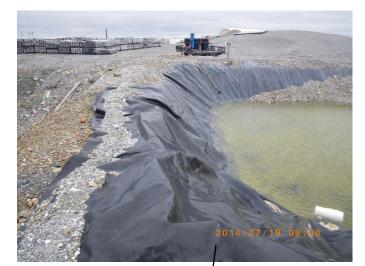
Containment Pond - looking northwest

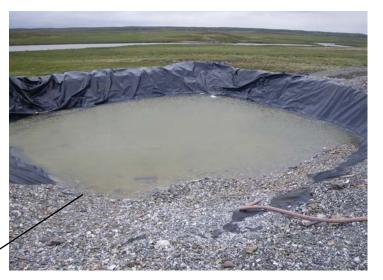
Containment pond– Looking southeast

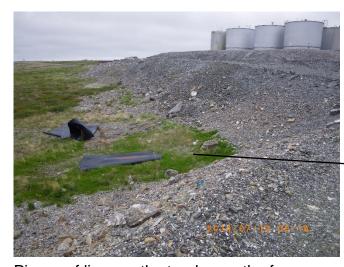
Pieces of liner on the tundra south of the Burn Pit – looking south

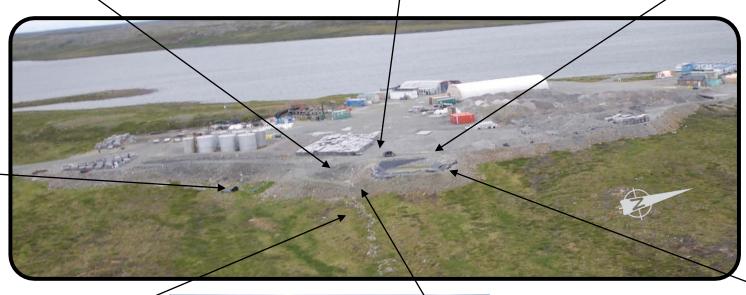
Looking southwest across the Burn Pit towards the Primary Tank Farm

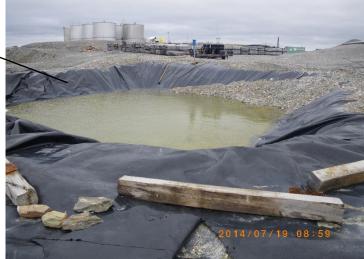
Containment Pond – looking south towards the Primary Tank Farm

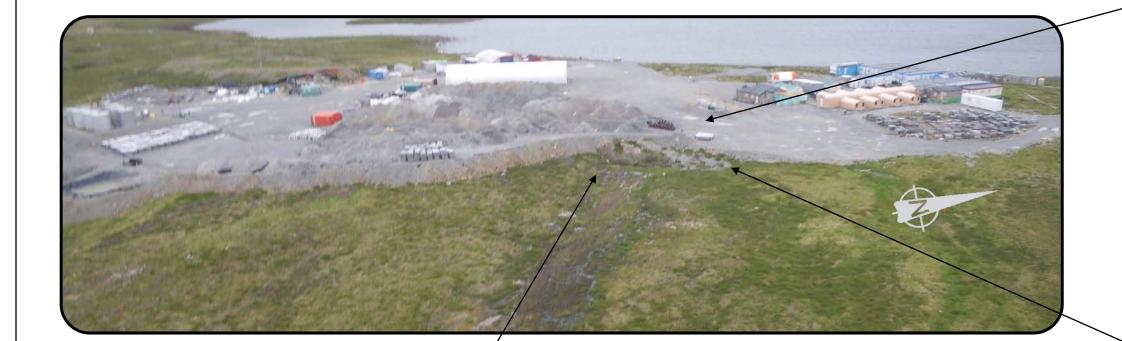
North end of the Ore Stockpiles with construction material for new STP

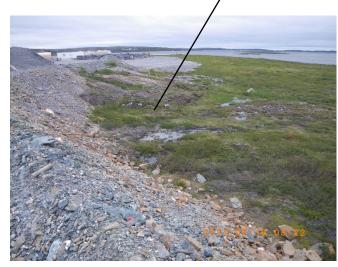
Seepage and vegetation die back at the toe of the rock fill pad by the Ore Stockpiles – looking north

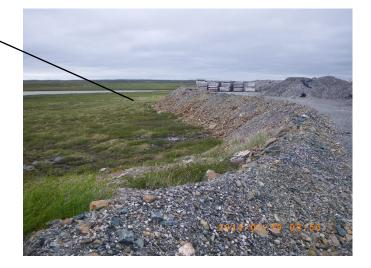
Seepage and vegetation die back at the toe of the rock fill pad at north end of the Ore Stockpiles – looking south
