| | | 2014 Geotechnical Inspection | | |
| | | Landfarm and Bone Yard | | |
| Job No: 1CT022.000 Filename: Boston Geotech_Figures2014.pptx | HOPE BAY PROJECT | Date: Dec 2014 | Approved: LW | Figure: 19 |

| | | Portal and Incinerator Area | | |

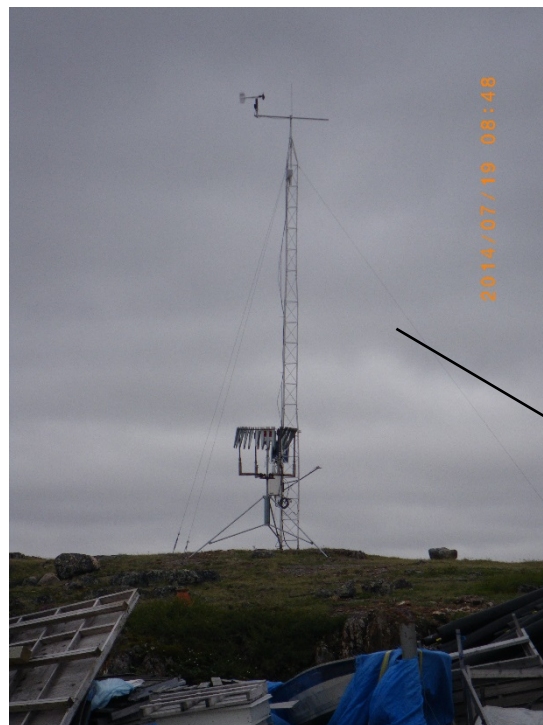
The meteorological station – looking west from the Boneyard

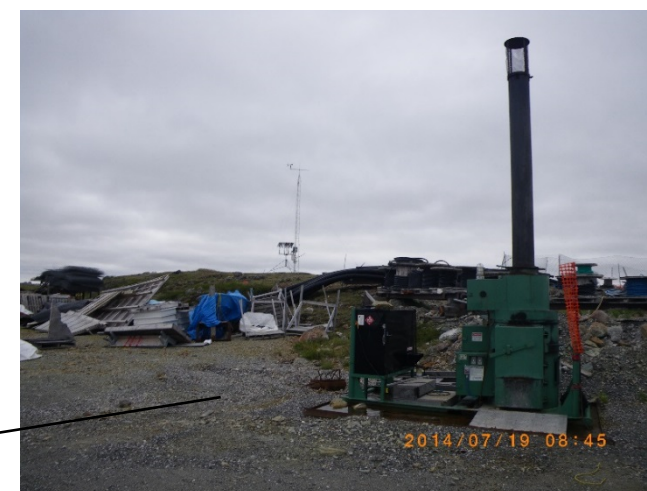
The north end of the Boneyard – looking west

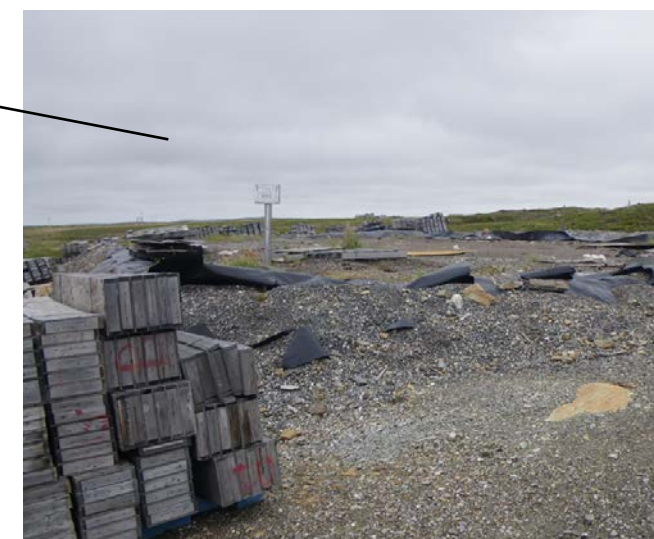
The north end of the Landfarm – looking south

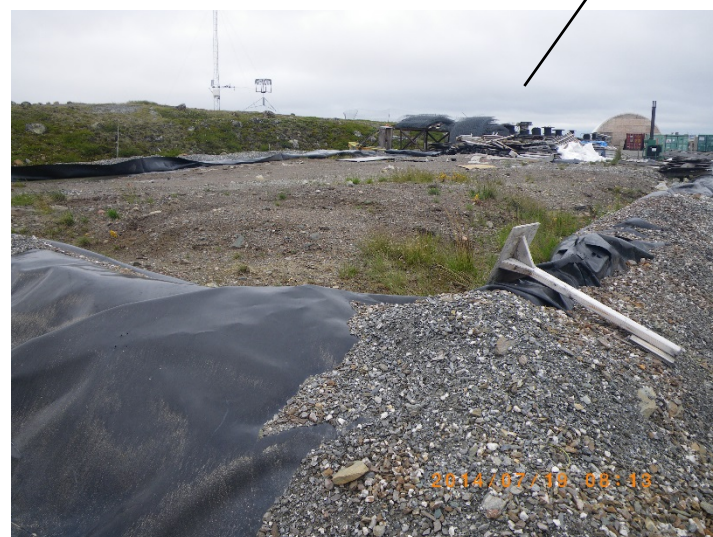
The southeast corner of the Landfarm – looking north

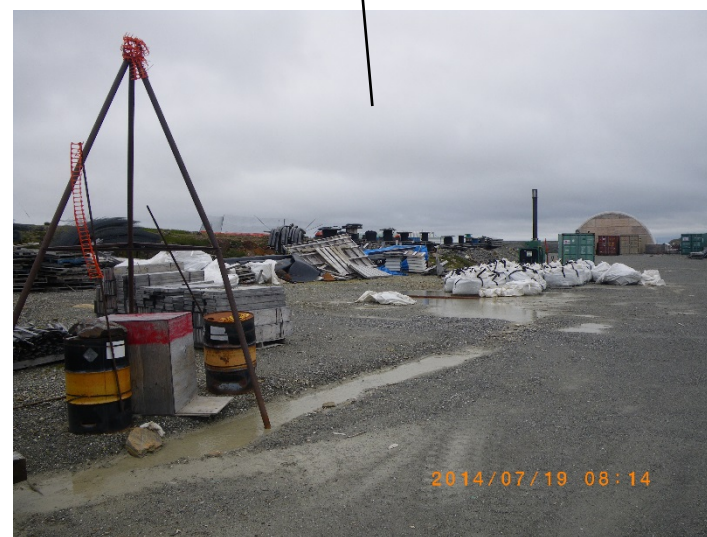
A general overview of the Boneyard – looking north

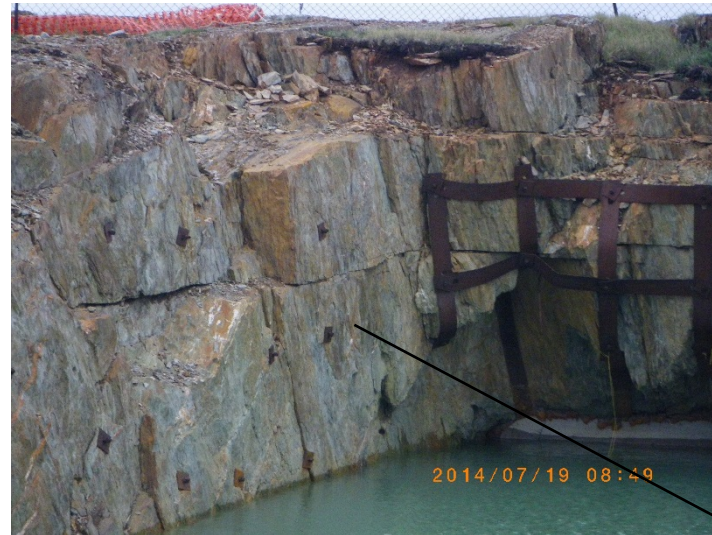
Condition of the rock face on the left side of the Portal entrance

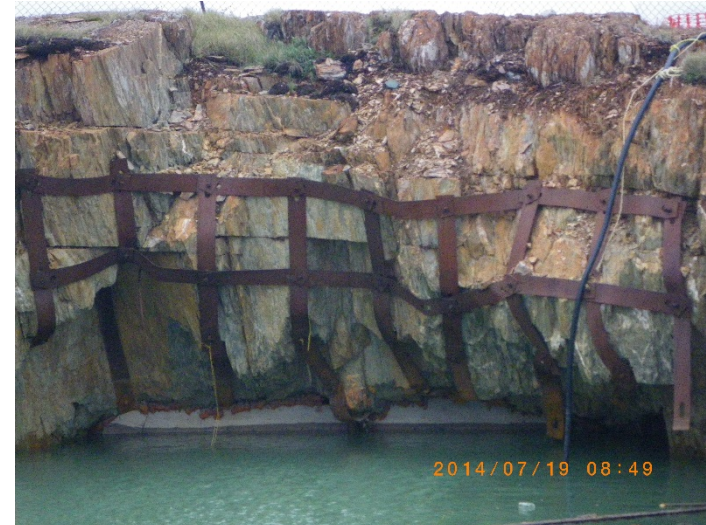
Condition of the reinforcement over the Portal entrance

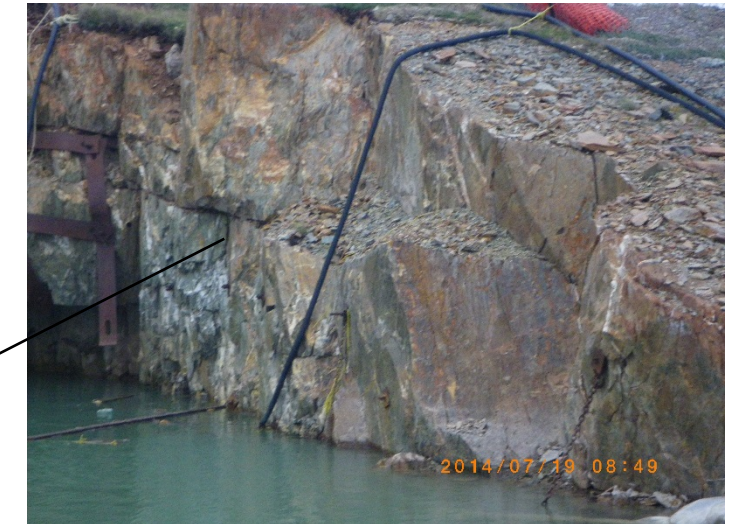
Condition of the rock face on the right side of the Portal entrance

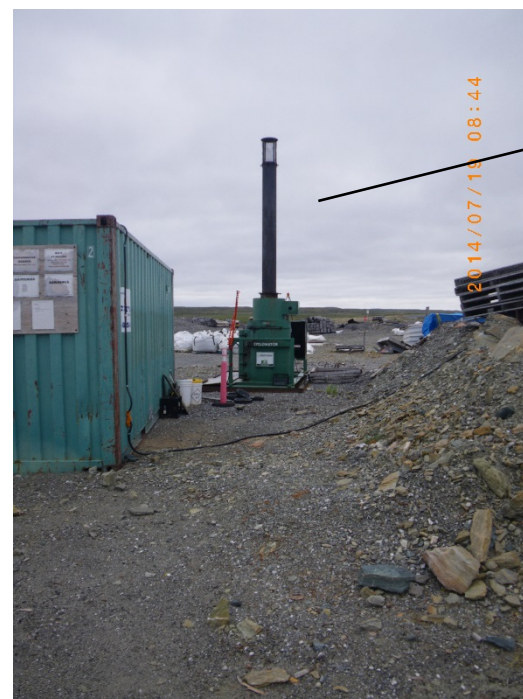
The Incinerator – looking south from the Portal Entrance

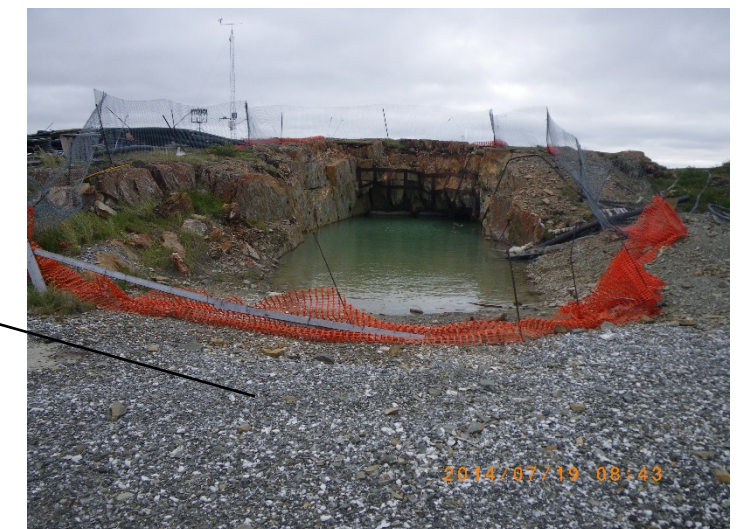
The Portal Entrance – looking southeast

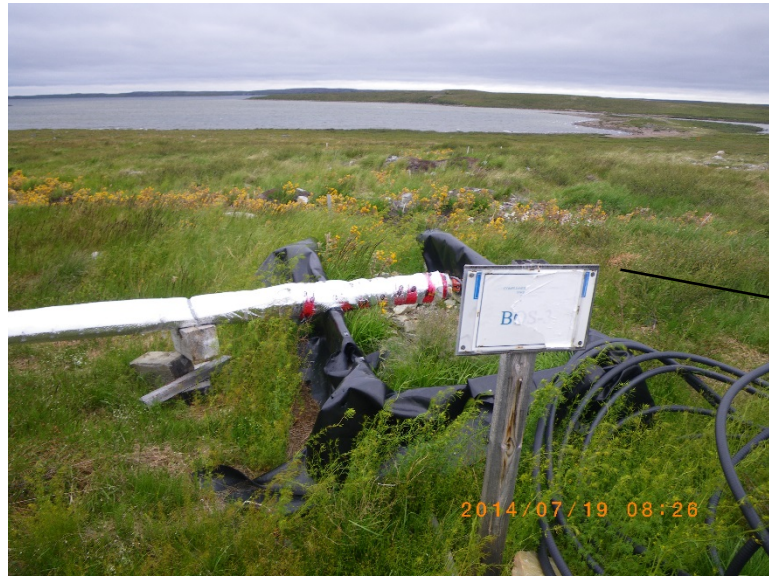
STP Discharge Location – looking north

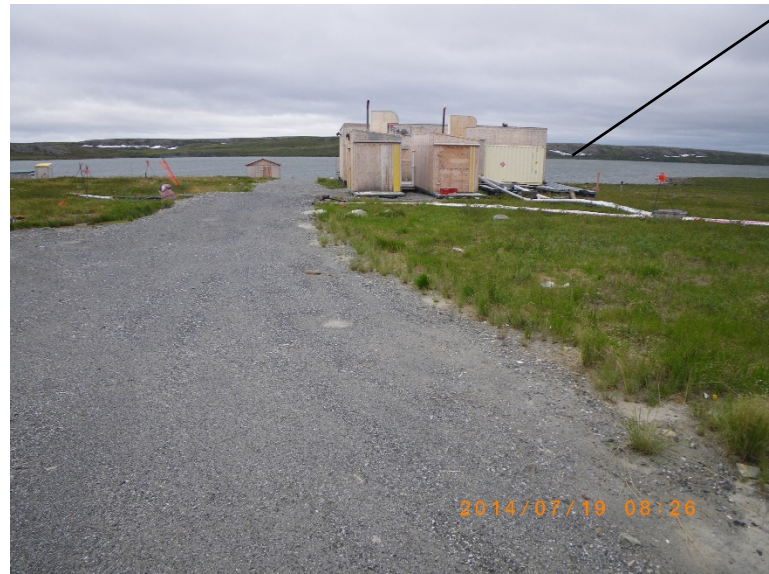
New STP – looking west along the Road to Dock

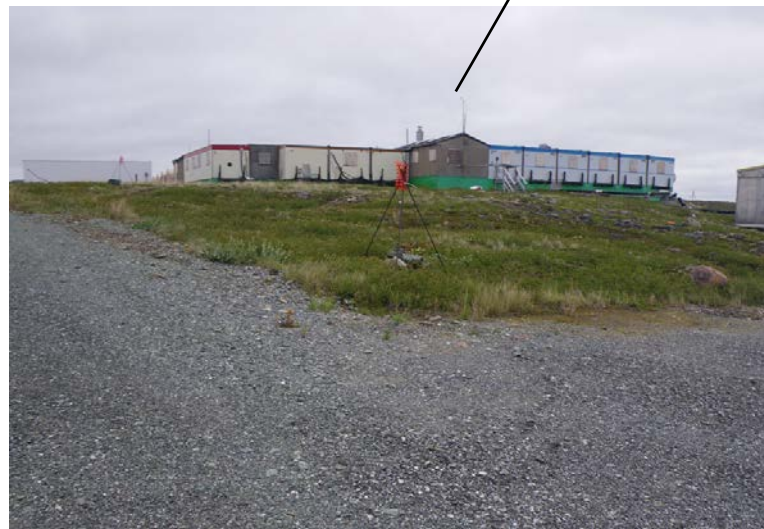
Boston Camp – looking south from the Road to Dock by the New STP

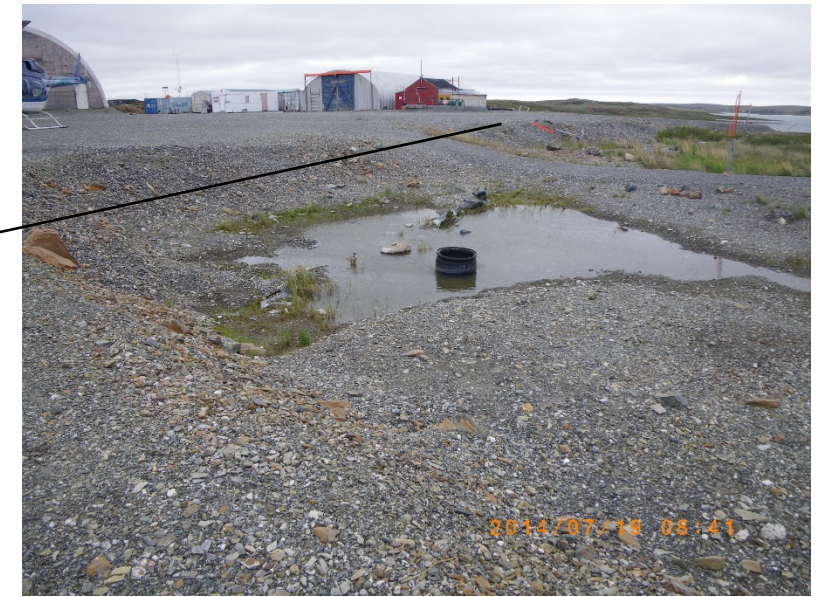
Historic Fuel Spill Area by the Helipad – looking south towards the Machine Shop

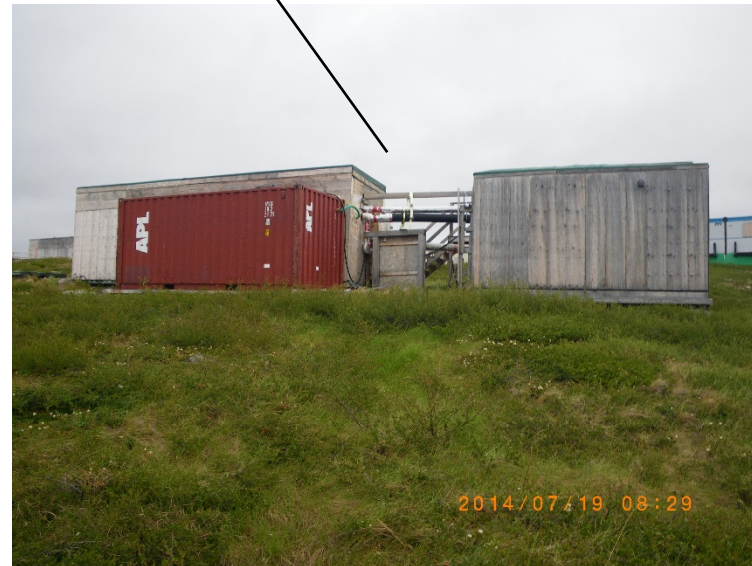
Old STP – looking east towards Boston Camp

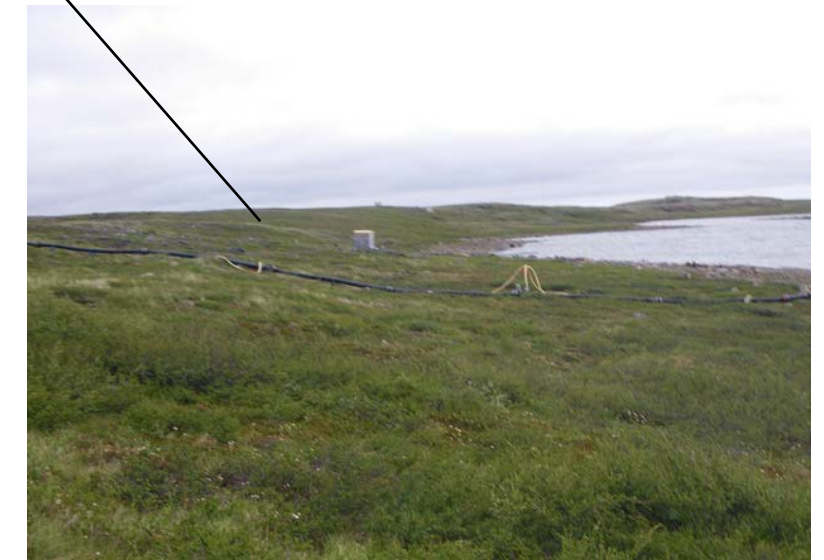
Fresh water intake pipe line – looking south
