CONSTRUCTION SUMMARY (AS-BUILT) REPORT FOR FUEL FARM ENLARGEMENT

HOPE BAY -BOSTON CAMP, NUNAVUT

Doc. N°: 6207-416-132-REP-002

APPENDIX D – TANKS INSEPCION REPORT

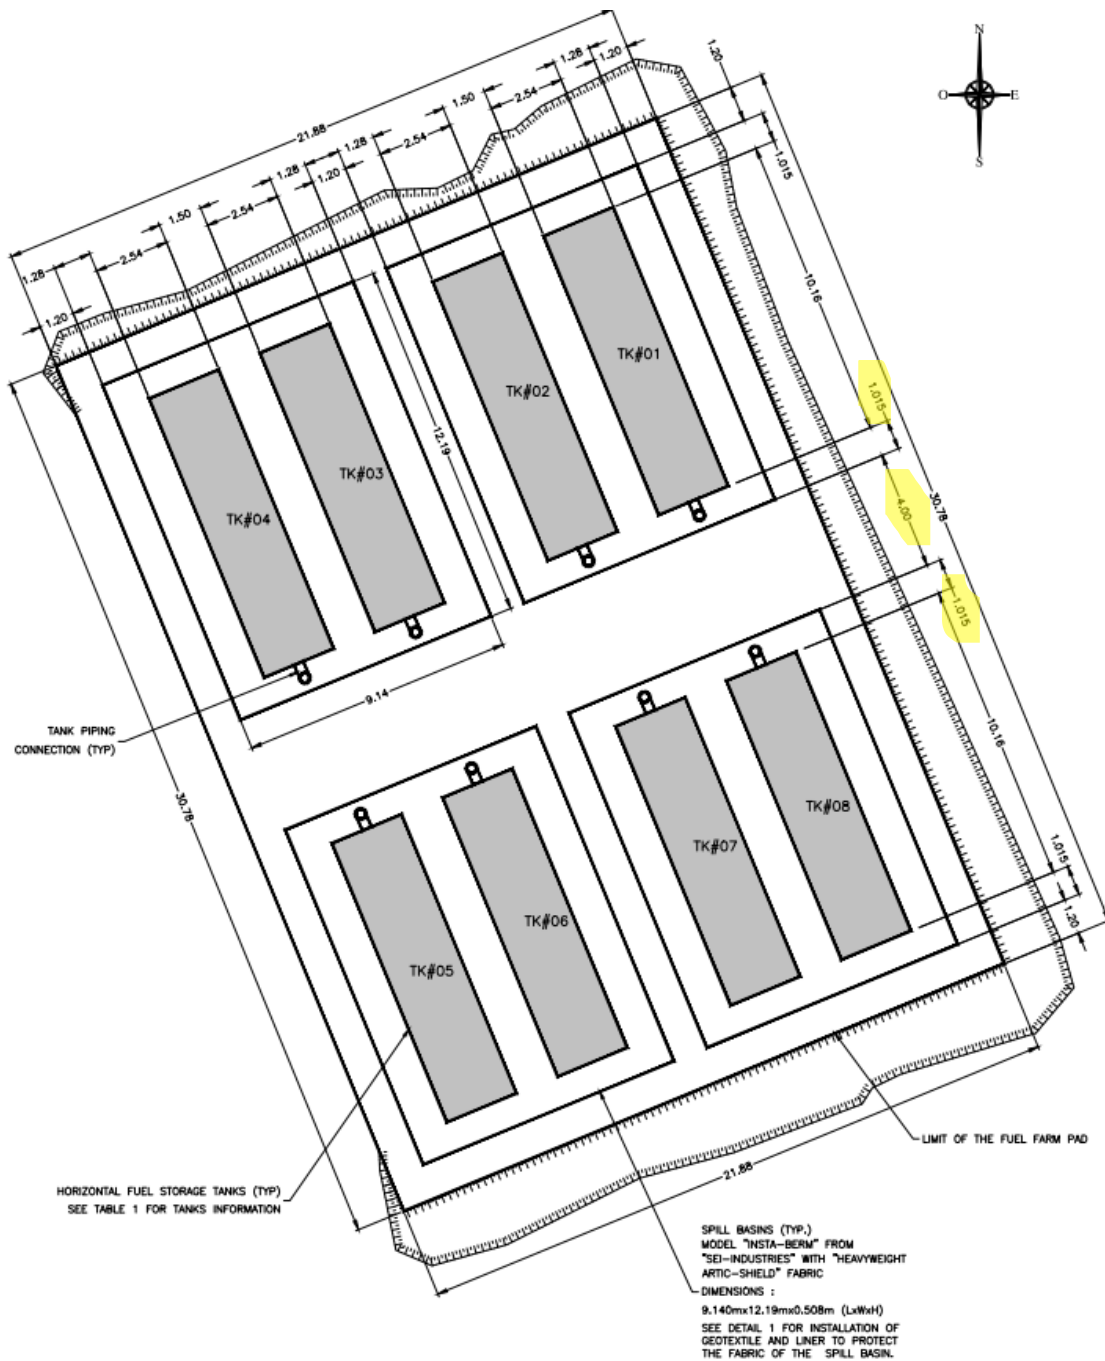
- The measurement in yellow are the only changes made to original plans
- Also tank 6 and tank 8 are 36 ' 9" long not 33' 4" like stated in plan
- The front of the tanks distance from the berm varied depending on style of ladder or stairs that were on the tanks

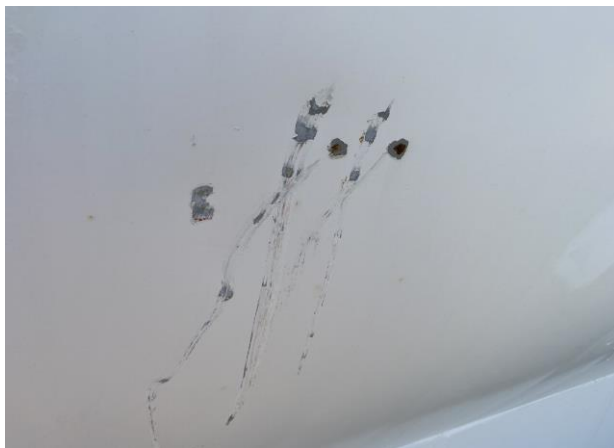
- A visual external inspection was performed on horizontal double wall fuel tank and found to be in acceptable condition
- Tank is out of service with plans of being filled by winter for start up of Boston Camp
- Tank is not grounded
- External coating is chipped/ flaking away with no signs of external atmospheric corrosion occurring on shell or head
- Ladder and platform are not properly connected/bolted to tank

External coating is chipped

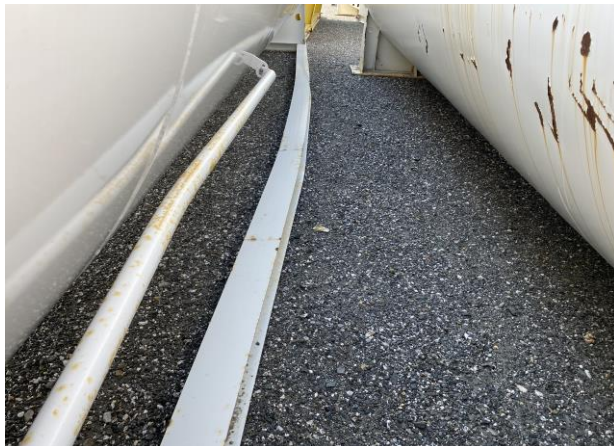
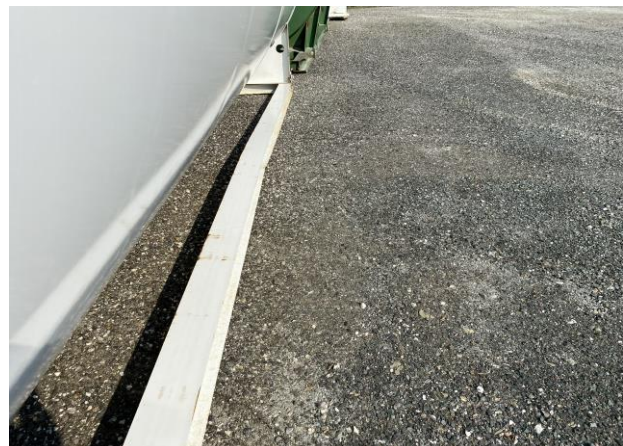
- A visual external inspection was performed on horizontal double wall fuel tank and found to be in acceptable condition
- Tank is out of service with plans of being filled by winter for start up of Boston Camp
- Tank is not grounded
- External coating is chipped/ flaking away with no signs of external atmospheric corrosion occurring on shell or head
- Missing 4" threaded cap on top of tank
- Tank skid is bent in multiple places

As New	Acceptable In-Service Condition	Continue to Monitor	Requires Repair	NA	Comments
					Skid is bent in multiple places

Skid is bent

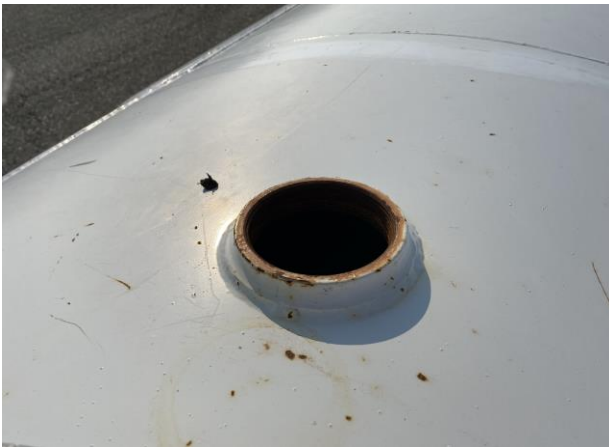
Missing 4" threaded cap

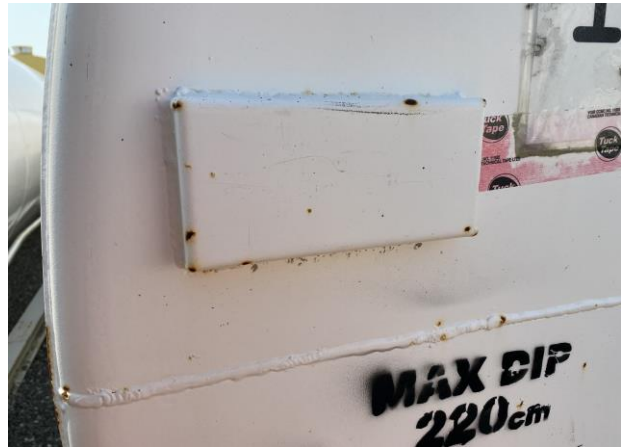
- A visual external inspection was performed on horizontal double wall fuel tank and found to be in acceptable condition
- Tank is out of service with plans of being filled by winter for start up of Boston Camp
- Tank is not grounded
- External coating is chipped/ flaking away with no signs of external atmospheric corrosion occurring on shell or head
- Minor dents noted in shell
- No nameplate attached to tank

No nameplate

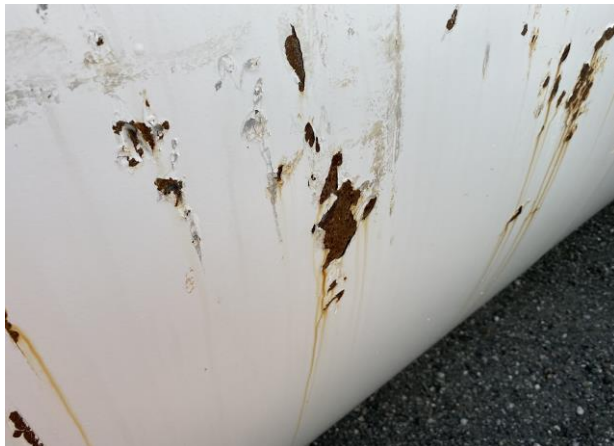
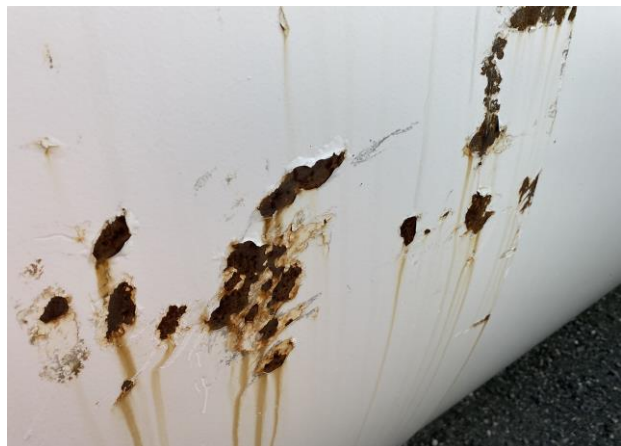
Coating is chippng

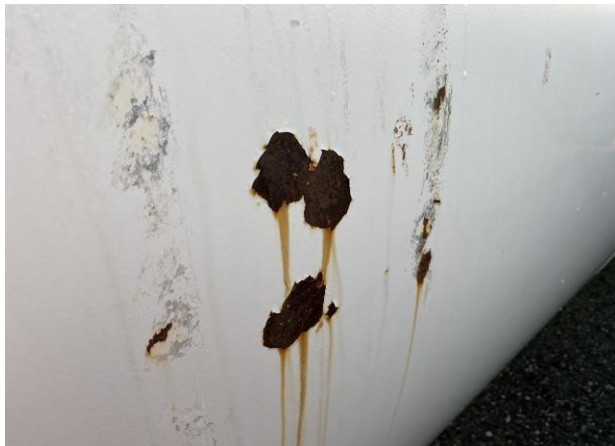
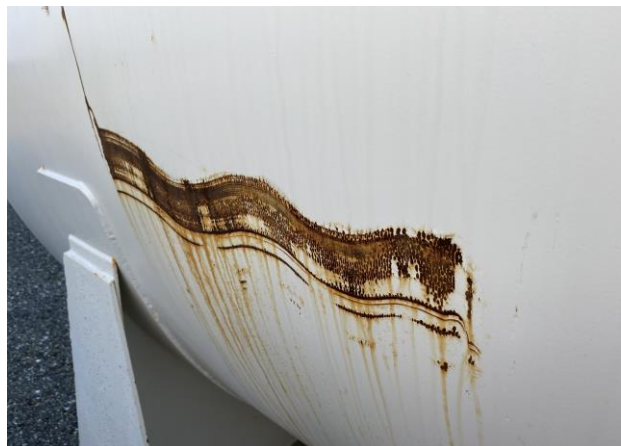
- External coating is chipped/ flaking away with no signs of external atmospheric corrosion occurring on shell or head

Coating is chipping

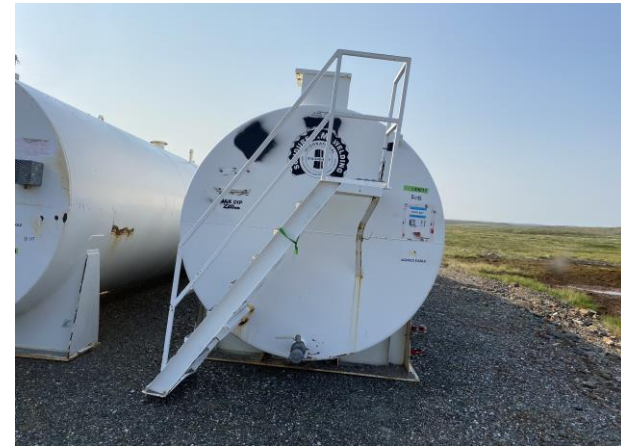
- A visual external inspection was performed on horizontal double wall fuel tank and found to be in acceptable condition
- Tank is out of service with plans of being filled by winter for start up of Boston Camp
- Tank is not grounded
- External coating is chipped/ flaking away with no signs of external atmospheric corrosion occurring on shell or head
- Platform support arm is bent and putting stress on external shell
- No nameplate on tank

Stairs and bent support arm

- Ground tank before returning tank to service
- Continue to monitor external coating
- Buff off paint around support arm attached to tank and have MT performed to identify if any cracking has occurred to shell
- Install nameplate on tank

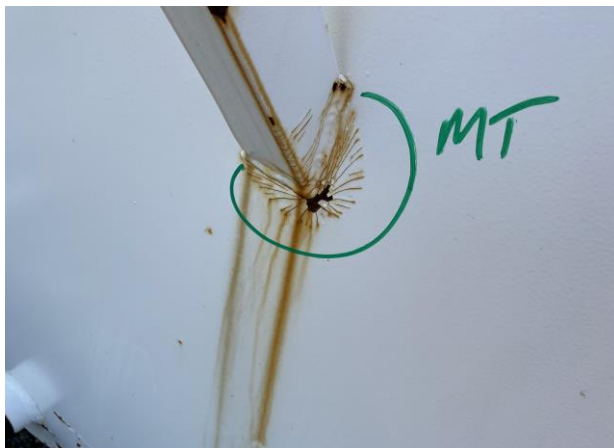
Paint cracked around support arm

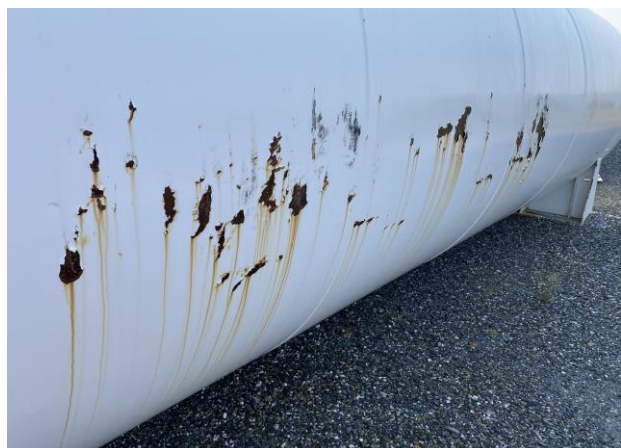
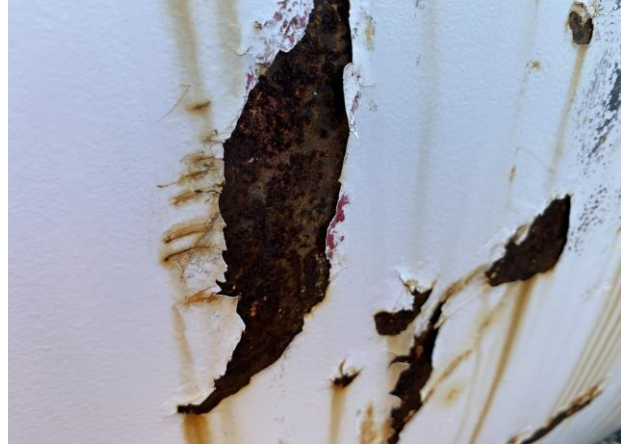
Coating is chipping

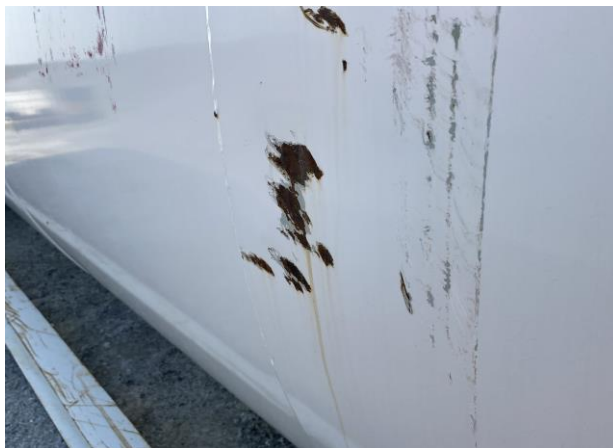
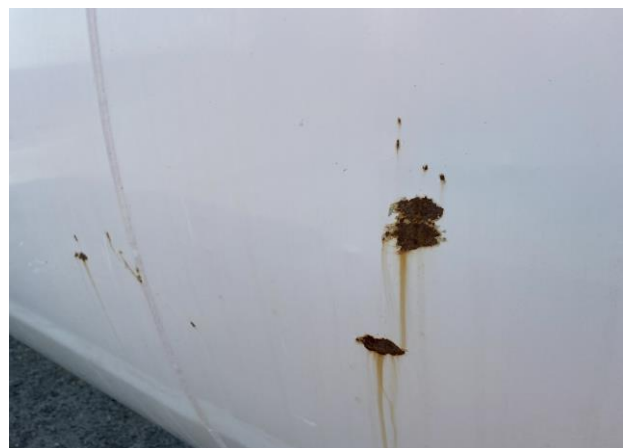
Coating is chippng

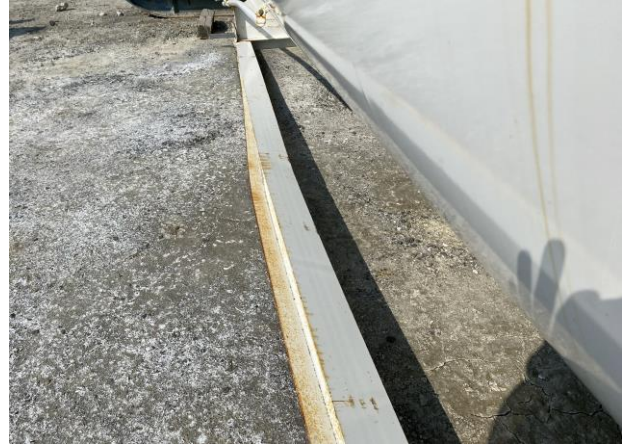
- A visual external inspection was performed on horizontal double wall fuel tank and found to be in acceptable condition
- Tank is out of service with plans of being filled by winter for start up of Boston Camp
- Tank is not grounded
- External coating is chipped/ flaking away with no signs of external atmospheric corrosion occurring on shell or head
- Skid is bent in multiple places and putting stress on external shell

As New	Acceptable In-Service Condition	Continue to Monitor	Requires Repair	NA	Comments
					Skid is bent

Skid is bent

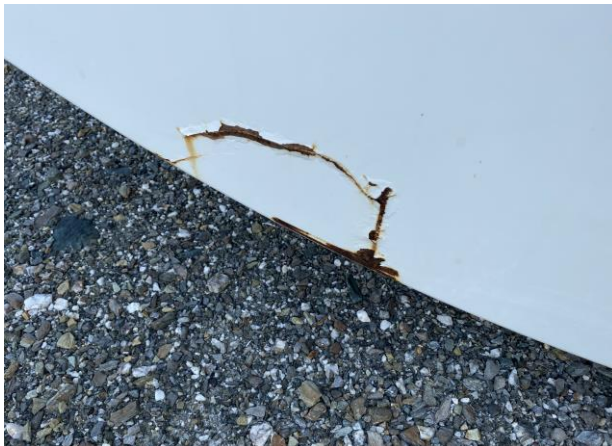
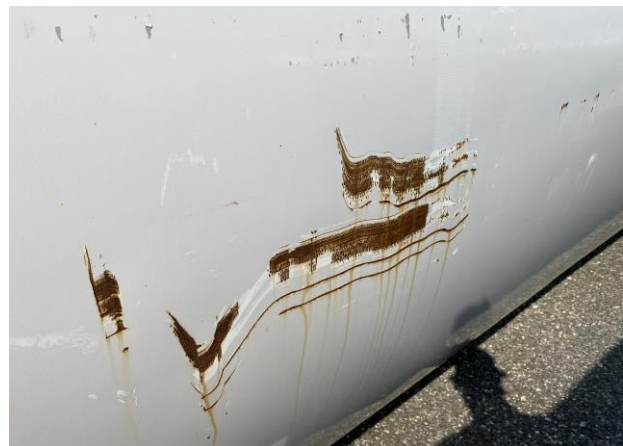
Coating is chipping

Coating is chippng

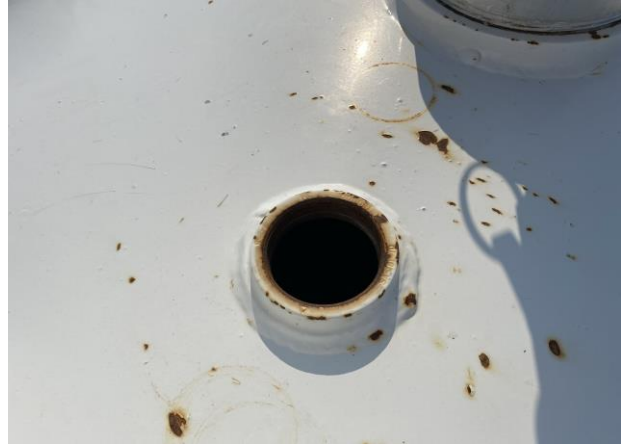
- A visual external inspection was performed on horizontal double wall fuel tank and found to be in acceptable condition
- Tank is out of service with plans of being filled by winter for start up of Boston Camp
- Tank is not grounded
- External coating is chipped/ flaking away with no signs of external atmospheric corrosion occurring on shell or head
- No 2" threaded cap on top of tank

Missing cap

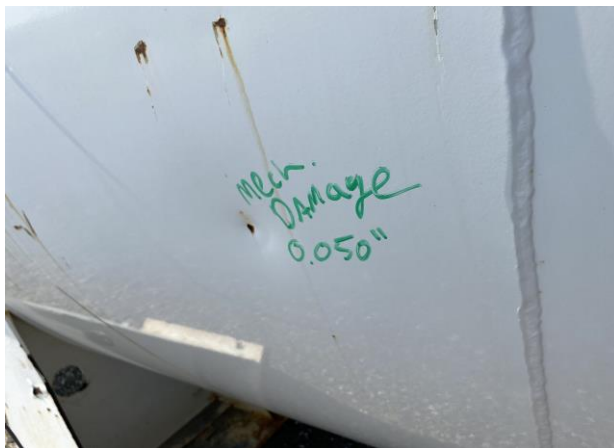
- A visual external inspection was performed on horizontal double wall fuel tank and found to be in acceptable condition
- Tank is out of service with plans of being filled by winter for start up of Boston Camp
- Tank is not grounded
- External coating is chipped/ flaking away with no signs of external atmospheric corrosion occurring on shell or head
- Mechanical damage noted on shell, 0.050" deep and other minor dents noted as well

Mech. Damage

- Ground tank before returning tank to service
- Continue to monitor external coating
- Continue to monitor dents and mechanical damage

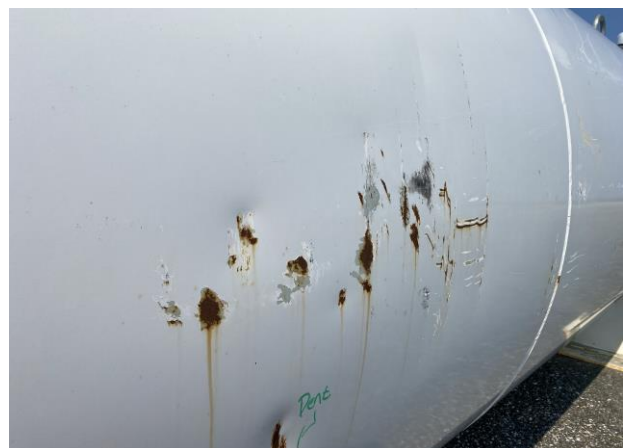
Coating is chippng

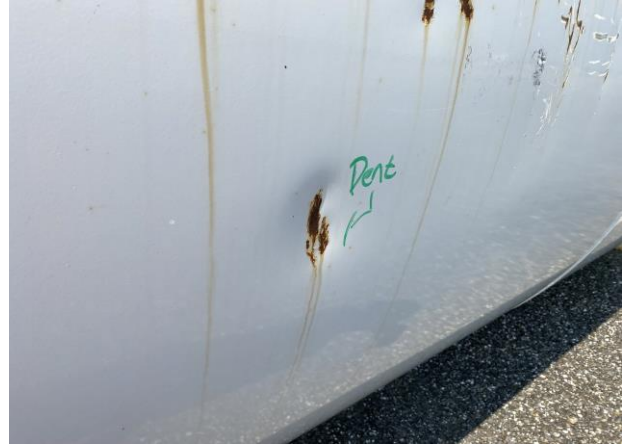
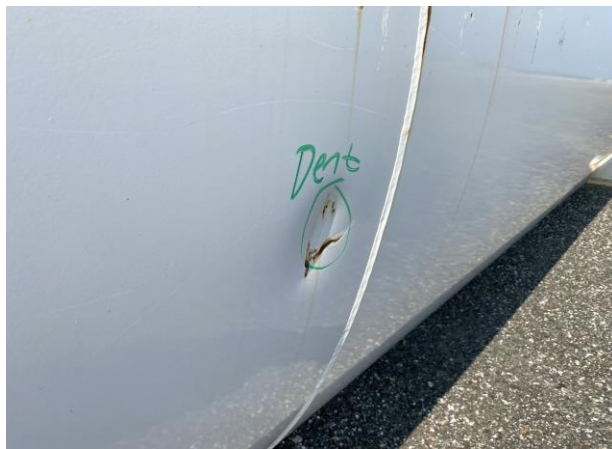
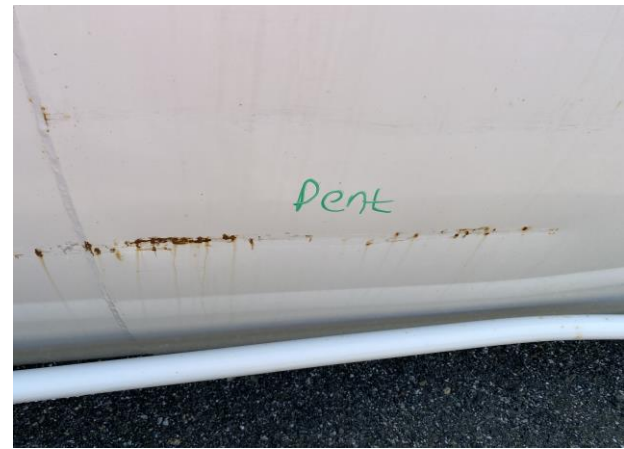
Dent in shell
