MIRAMAR HOPE BAY LTD

Re: Follow-up Report – Spill Report 02-451: Water License: NWB2HOP0207

Spill # 02-451, a spill of diesel fuel occurred at Windy Camp on August 1, 2002 at approximately 14:30 Hrs.

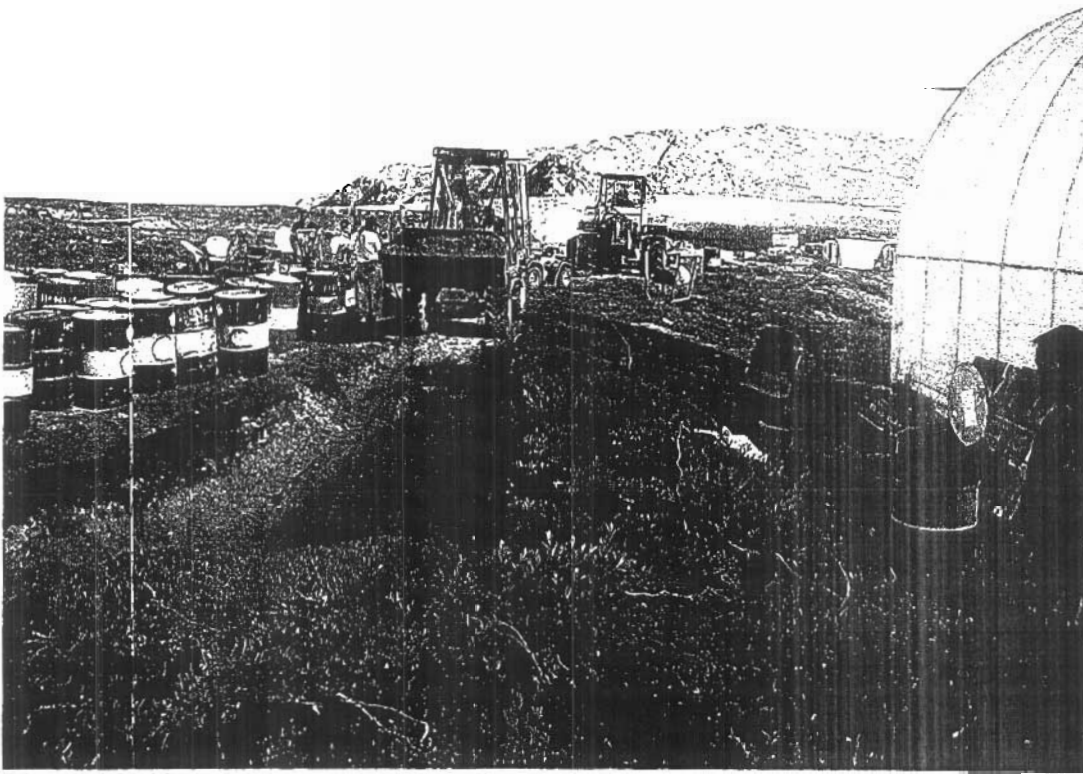
Photo #3: Kabota excavating contaminated soil.

The area of the spill was underlain by 8" grass and organics, with coarse sand underneath. The grass and organic material was cleaned using absorbent 'enviromat'. This material, along with about 60cm sand underneath, has been recovered and transferred into 45 gallon drums. Two trenches were dug down-slope of the spill site one of which ran the full length of the large storage tent. The spill area is located approximately 120m from Windy Lake.

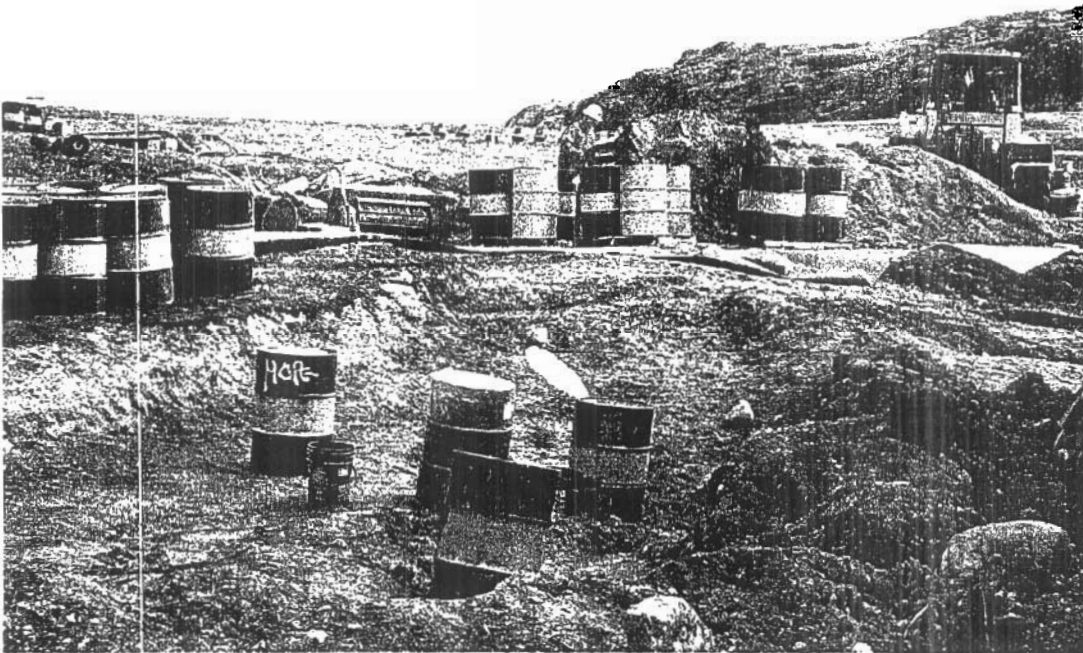
Photo #4: Transferring contaminated soil into 45 gallon drums.

All of the camp crew and geologic personnel participated in the cleanup (mostly digging trenches and filling drums with contaminated sand and soil). A helicopter was dispatched to Boston Camp to retrieve remaining geotextile fabric and HDPE liner material that was used in the construction of the tank farm at Boston. Saturated soil was excavated using the Kubota tractor and the soil was temporarily stored on the area covered by the HDPE liner material until it was transferred into 45 gallon drums (see Photo # 3). The material has since been transferred to approximately 400 - 45 gallon drums and stored in an appropriate location, and final disposal will be undertaken once various options are investigated (See Photo # 4).

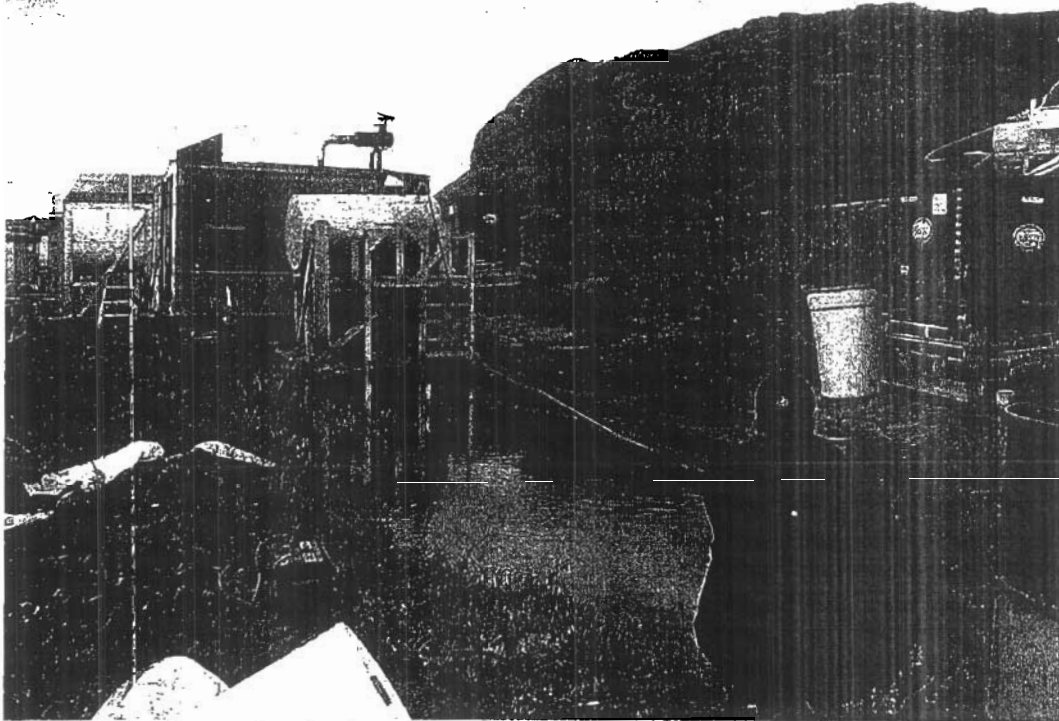
Photo #1: Generator tank and spill ponded behind natural berm.

The generator fuel tank (the tank being filled) is located above a natural berm of sand and organic material, and the fuel ponded in a small depression just south of the generator fuel tank (see Photo # 1). When the spill was discovered, fuel was just starting to overflow through a small spillway previously dug through the top of the berm, to minimize runoff catchment in the area.

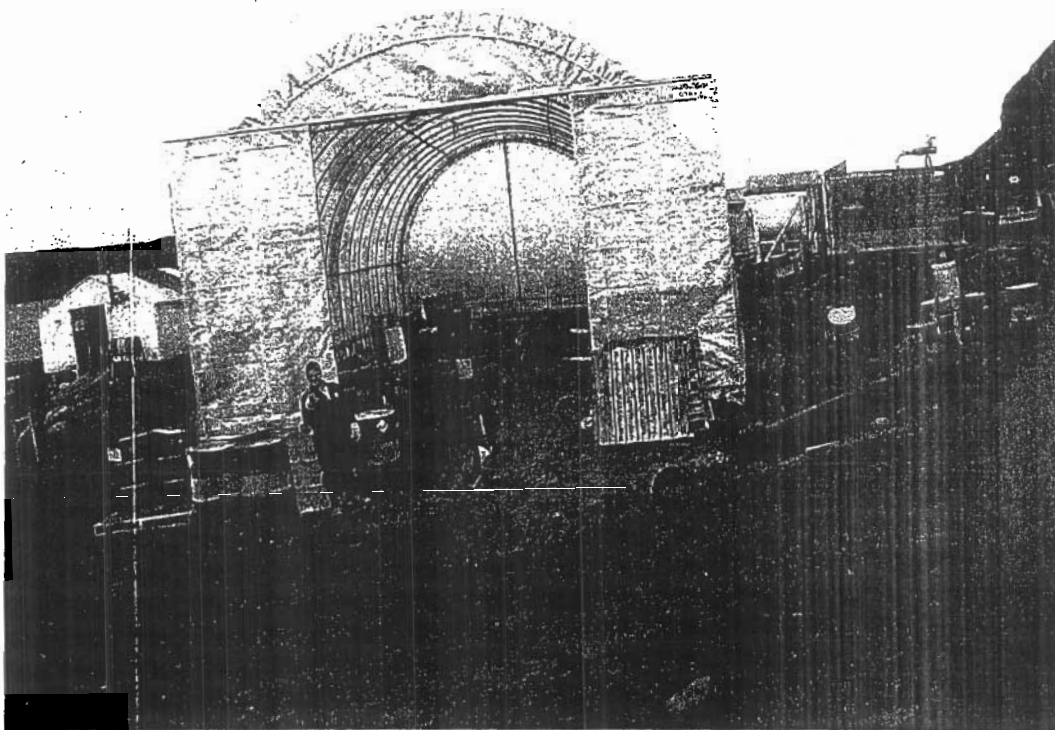
As a further monitoring tool, and as mentioned above, a cut-off trench was dug along the length of the large storage shed, including the excavation of test holes (4) within the trench and down-slope inside the storage shed as well as another test hole (1) further down-slope and outside the storage shed (see Photo # 5). "Enviro-mat" absorbent material was placed in the trench and test holes (see Photo # 6), designed to collect any diesel fuel that accumulates within these test holes. Minimal diesel fuel is being collected on the "enviro-mat" and to monitor any collection of diesel fuel, the "enviro-mat" is being monitored daily and if required, disposed of in the incinerator. Site personnel will continue to observe these locations, however; the information collected to date indicates that minimal fuel is reporting to these locations, a further indication that the remedial measures taken by site personnel in response of this spill incident, confirms that most of the diesel fuel has either been recovered as liquid or in the excavated material mentioned earlier. We estimate that 99% of the fuel spilled has been recovered, again, either as recovered liquid or in contaminated soil.

Photo #5: Trench and test holes in storage shed.

Although the potential of diesel fuel entering any water body is very remote, MHBL will monitor the site during the 2003 open water season, however; as the large storage shed is required for storage of critical equipment for the winter period, the trench and test holes will be lined with a significant amount of 'enviro-mat', empty 45 gallon drums will be placed in the test holes and the area will be backfilled with uncontaminated material and leveled to facilitate the storage of the critical equipment. One of the test holes will be excavated in the summer of 2003 and based on the findings, further remedial action will be undertaken. It should be noted, however; that based on recent results, actions in 2003 are expected to be minimal.

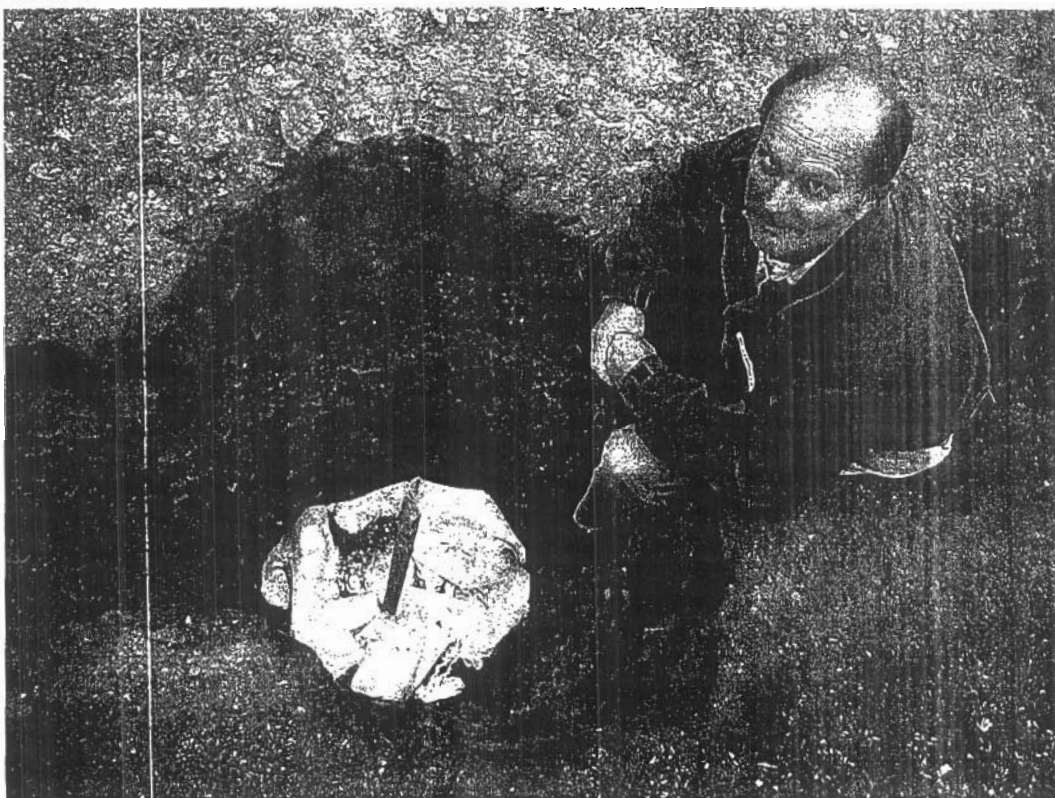
Photo #6: 'Enviro-mat' in test hole.

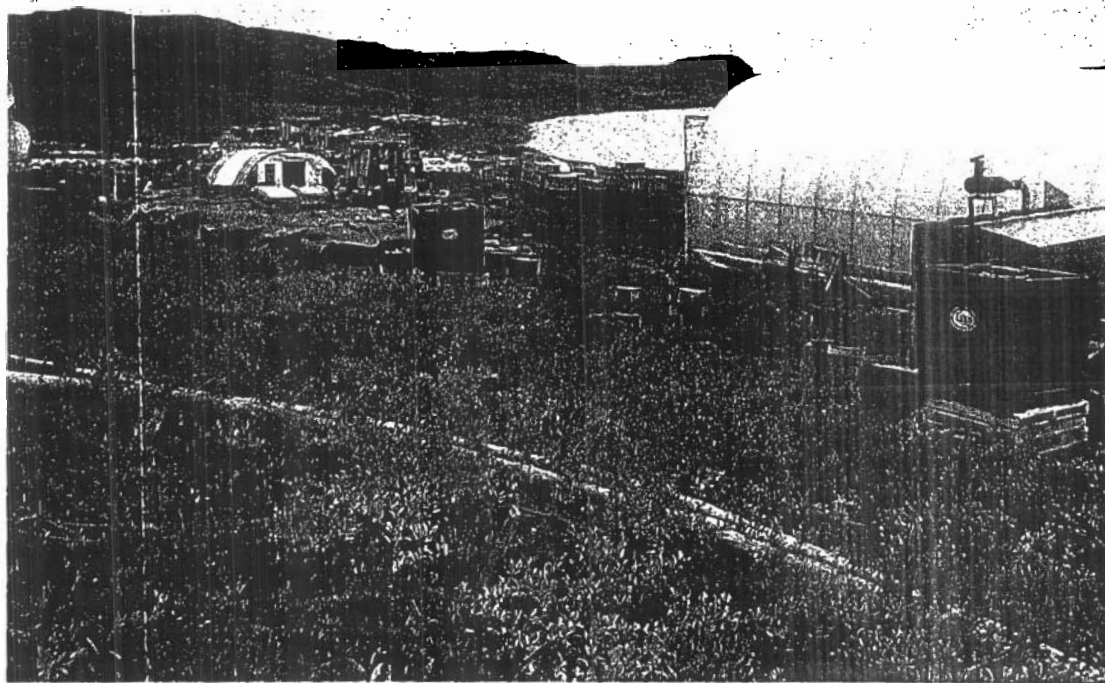
Photo #7: Drums under cover and cleaned area.

As mentioned above, contaminated soil has been transferred into 45 gallon drums (see photo # 7) for future disposal. Discussions with Environment Canada has indicated that the material could be placed on the proposed airstrip at the Doris Hinge project, once developed, as this is seen to be an acceptable method to 'land-farm' this type of contaminated material. Final disposal practices will be provided after further internal discussions.
