APPENDIX A SITE PHOTOGRAPHS

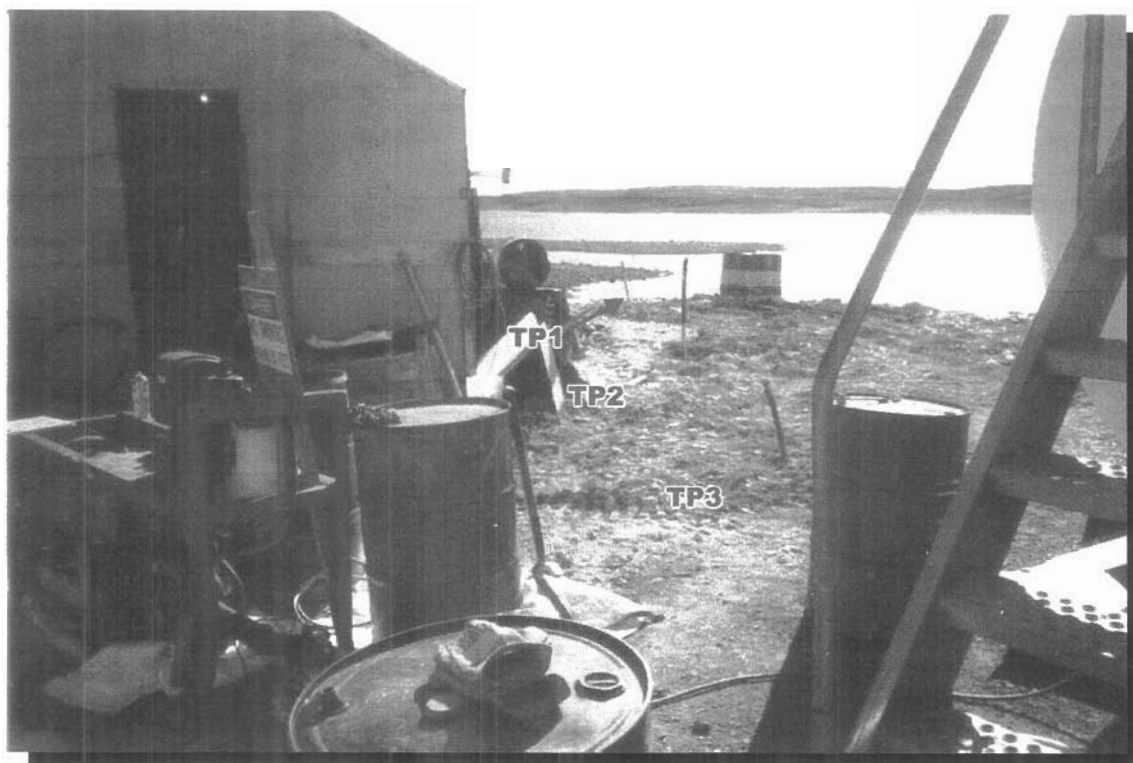
**Photo 1**

Photograph of test pit/monitoring well locations west of the maintenance shop.

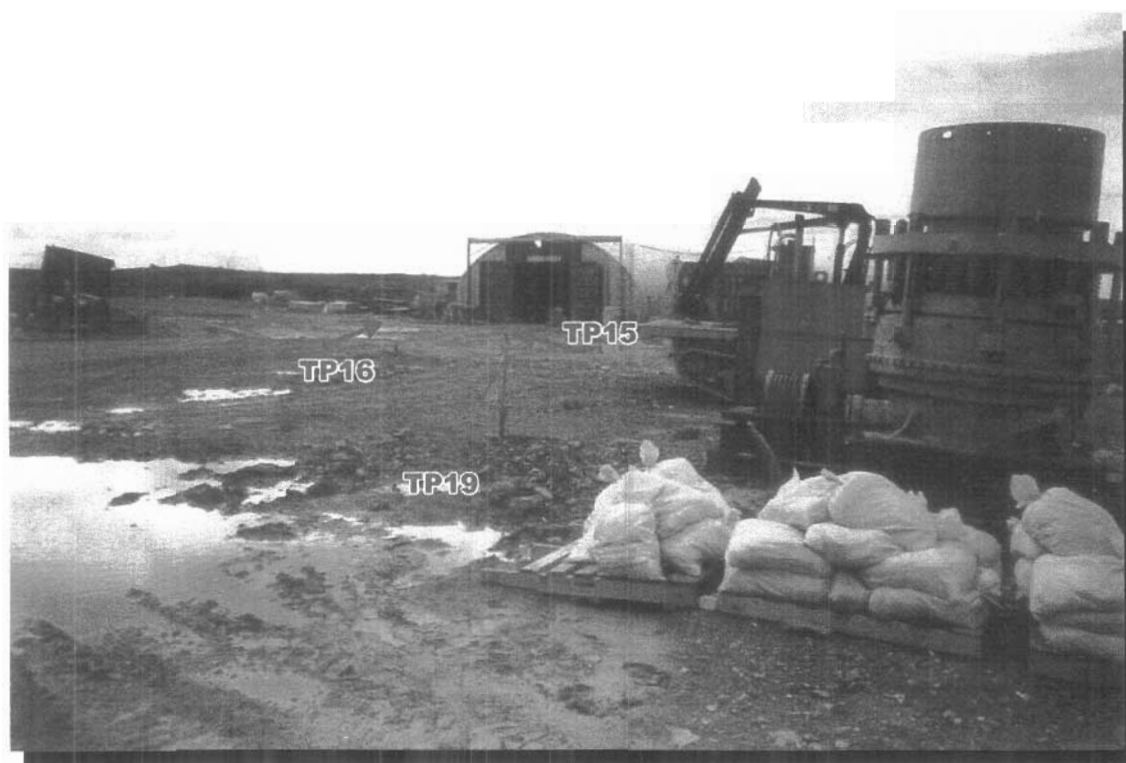
**Photo 2**

Photograph of test pits/monitoring wells in pad area. Looking south.

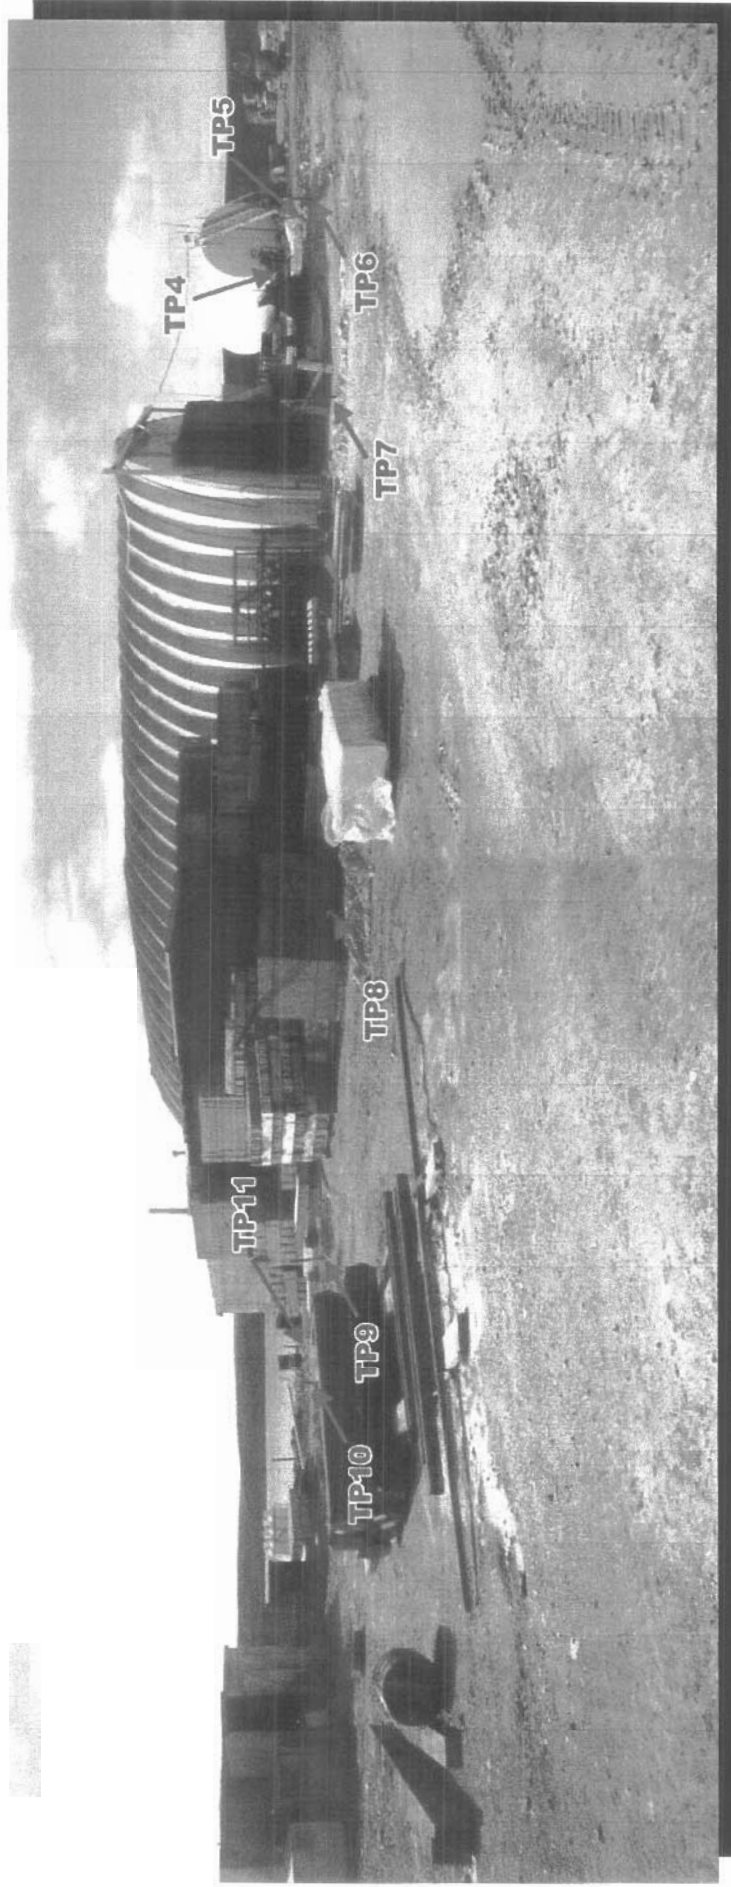
Photo 3

Photograph of test pit/monitoring well locations south and east of the maintenance shop. Looking north.

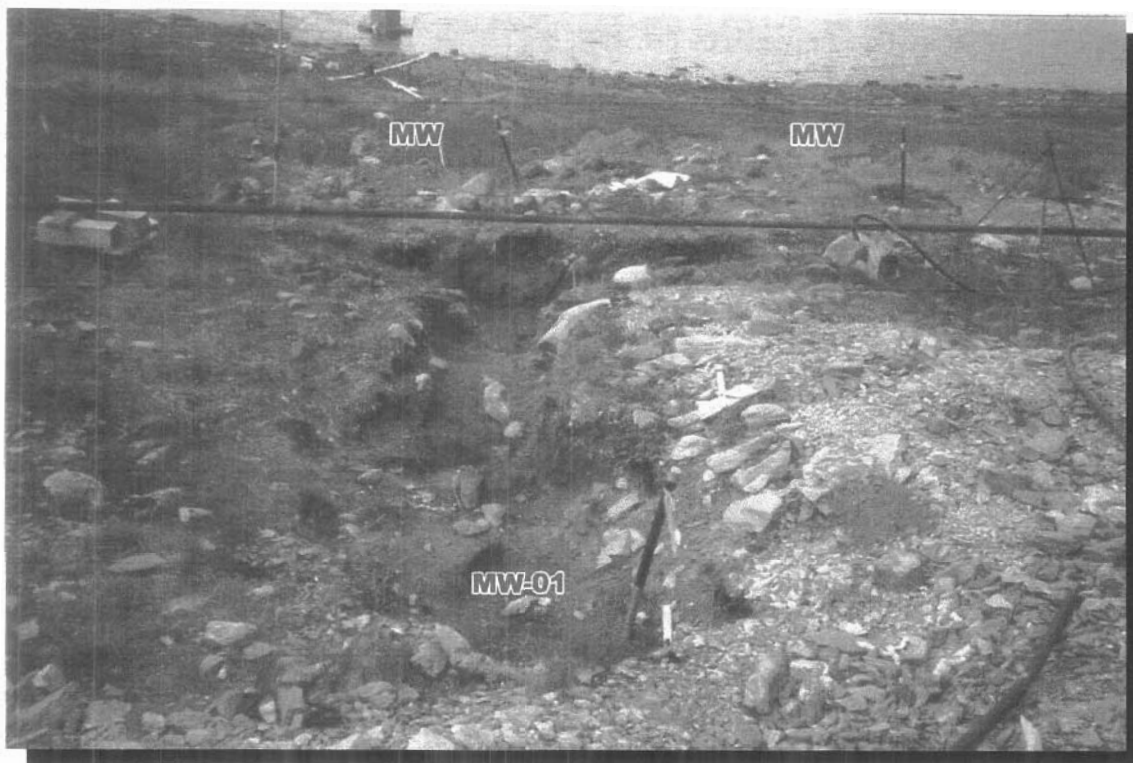
**Photo 4**

Photograph of hand excavated trench completed by Miramar staff following the discovery of the fuel spill. Looking east.

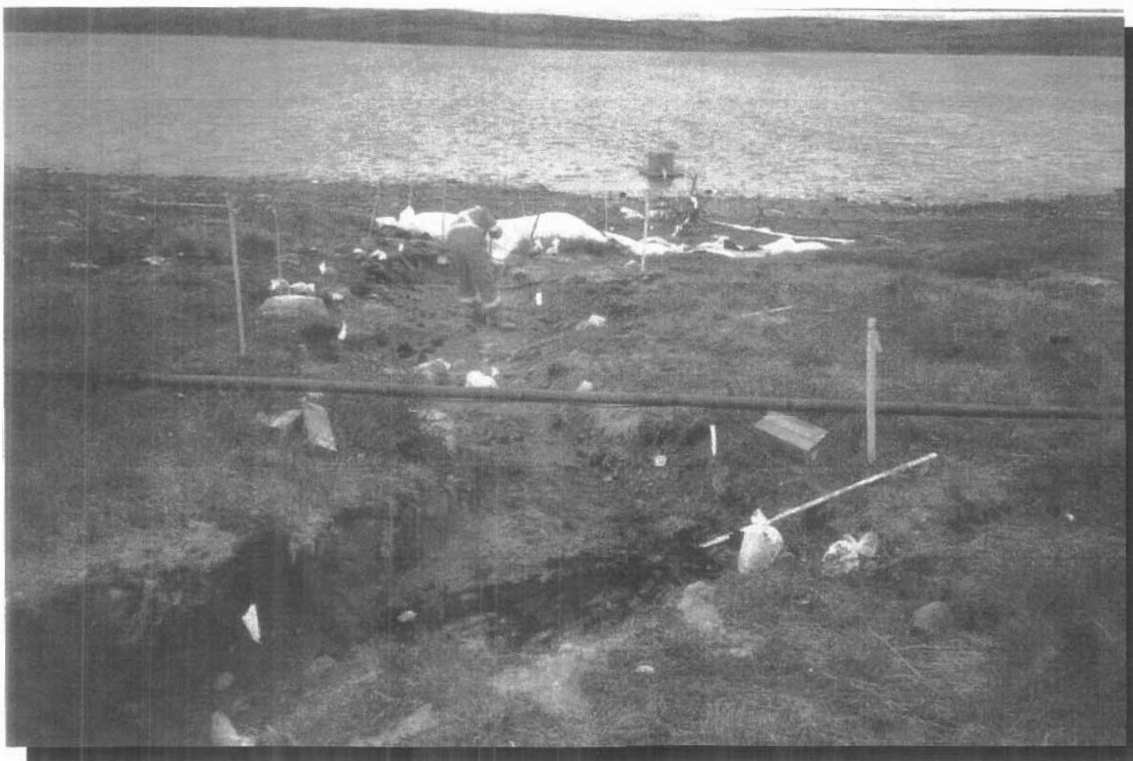
**Photo 5**

Photograph of hand excavated trench completed by Miramar staff following the discovery of the fuel spill. Looking east.

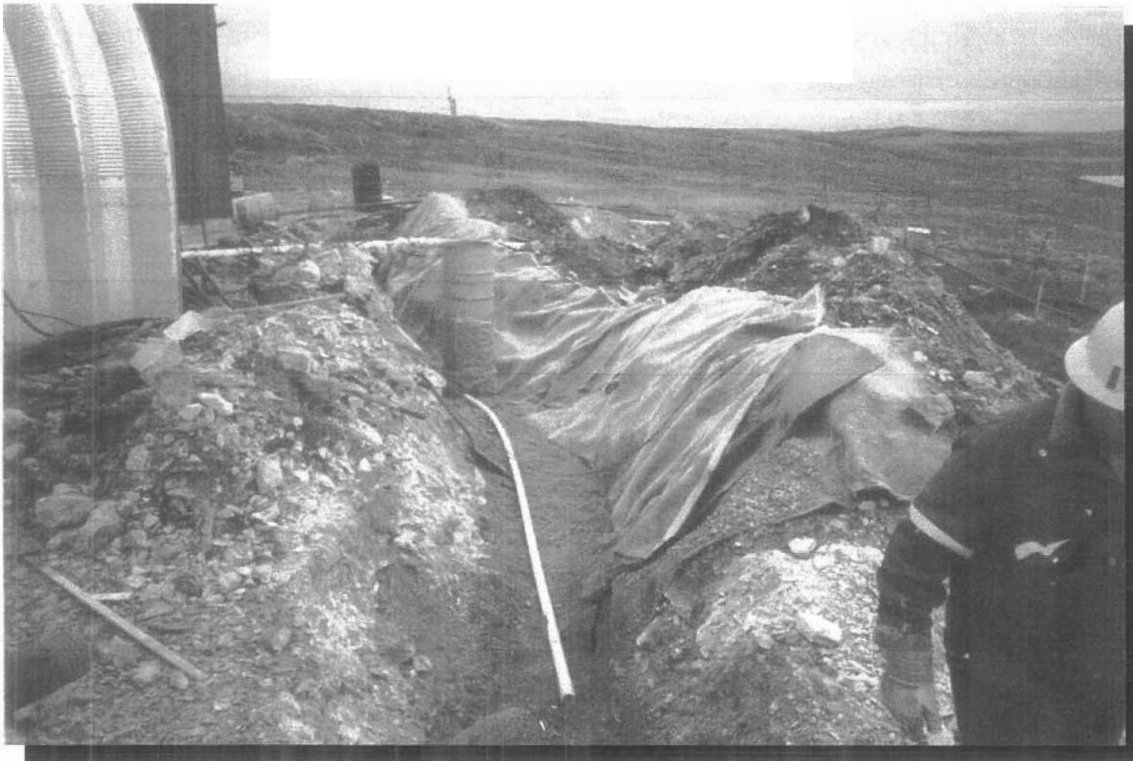
**Photo 6**

Photograph of catch barrel and piping used in maintenance shop interception trench. Looking south.

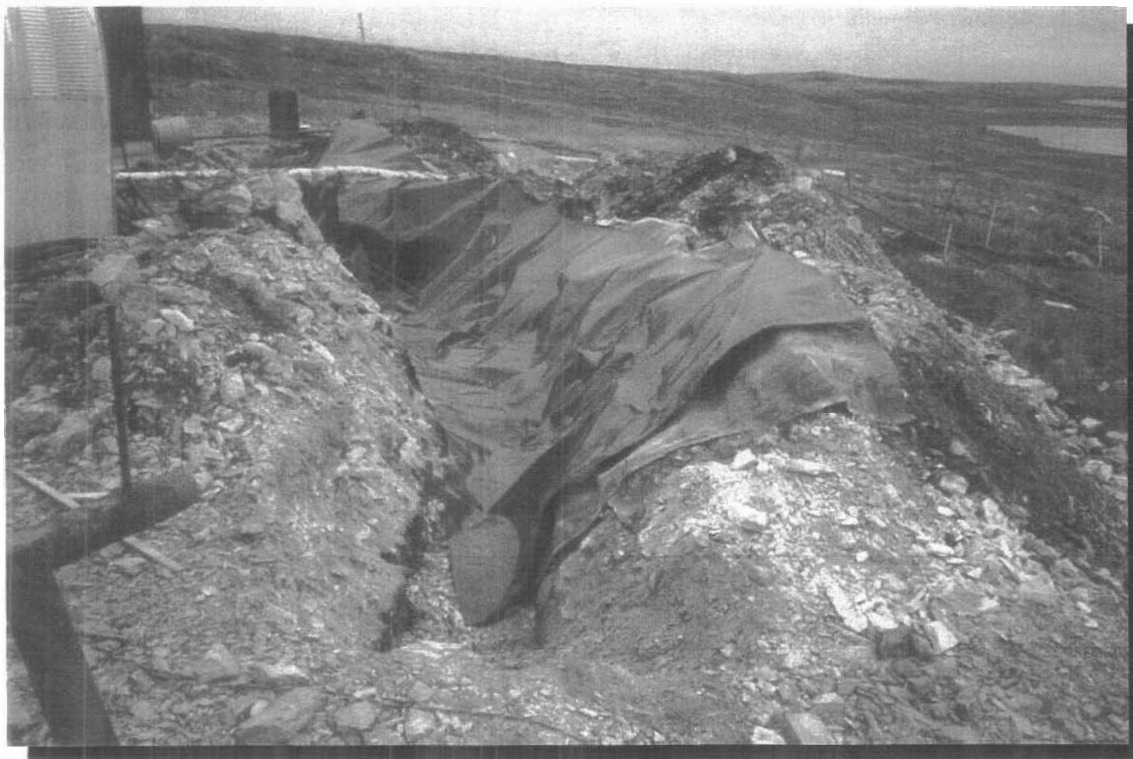
**Photo 7**

Photograph of HDPE liner used in maintenance shop interception trench. Looking south.

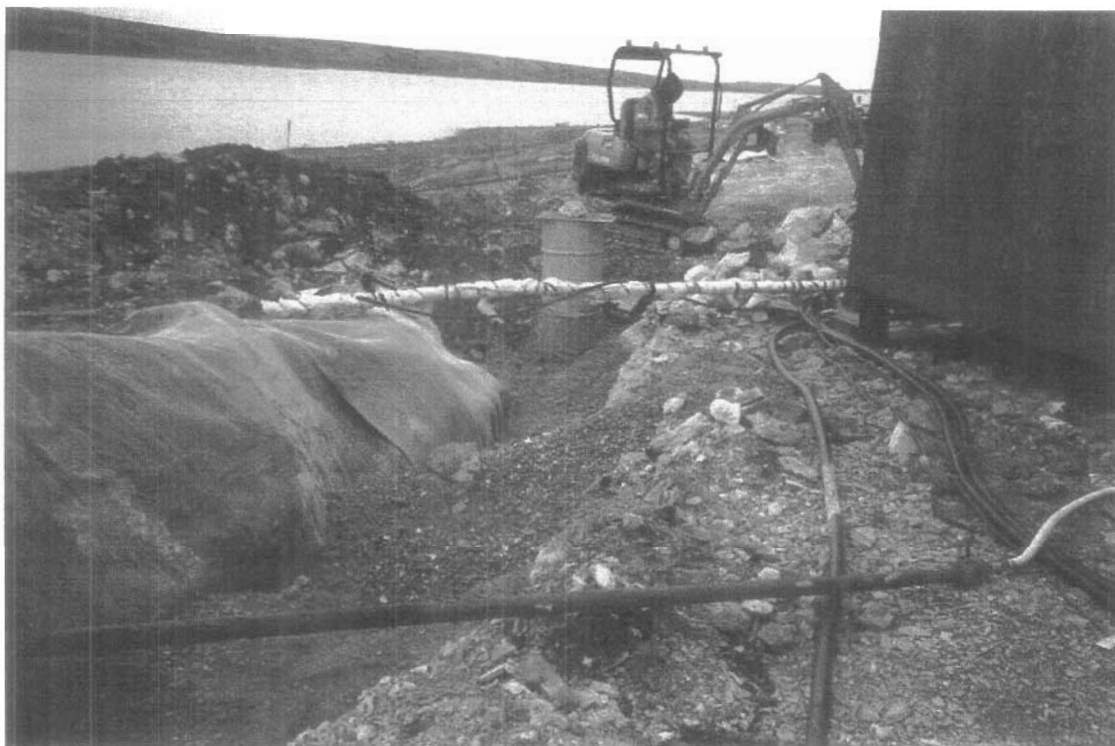
**Photo 8**

Photograph of backfill material used in maintenance shop interception trench. Looking north.

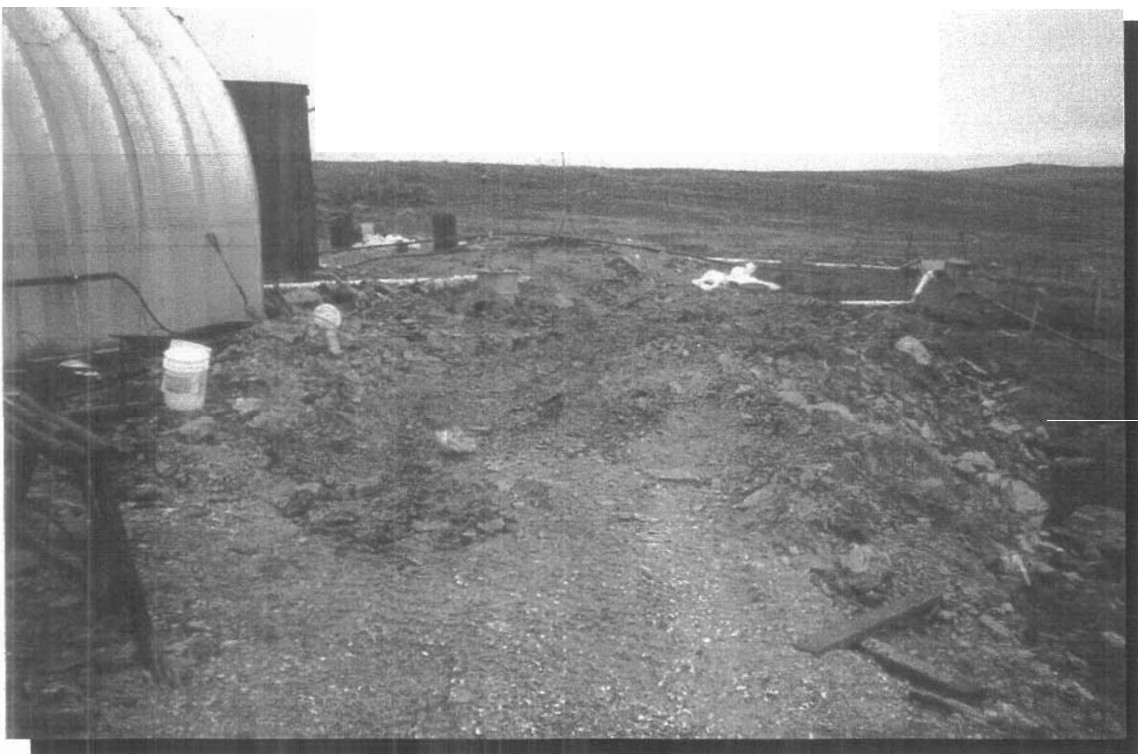
**Photo 9**

Photograph of maintenance shop interception trench post construction. Looking south.

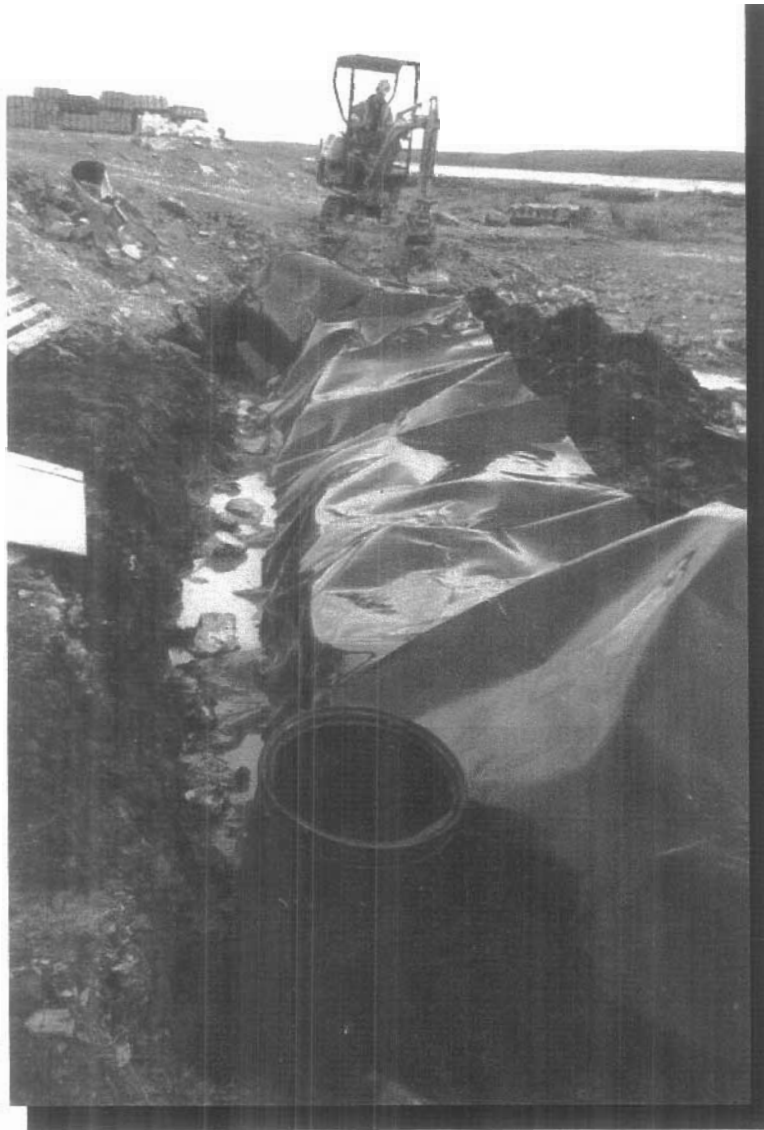
Photo 10
Construction of helipad interception trench.

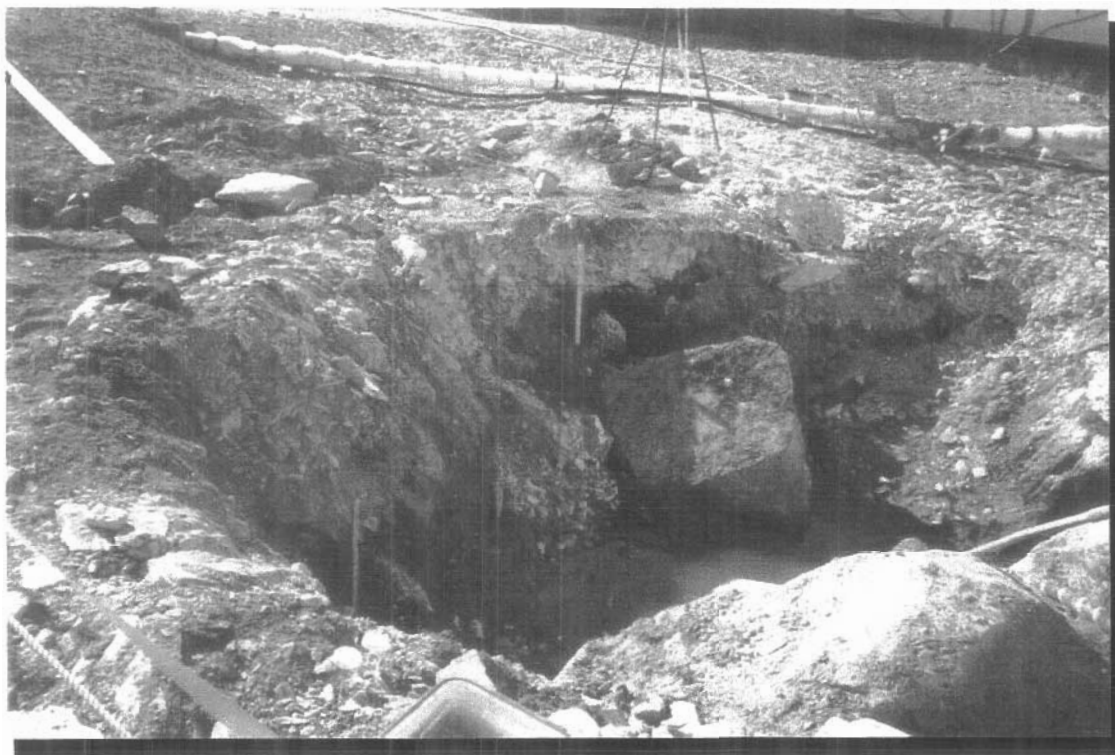
Photo 11
South wall of excavation.

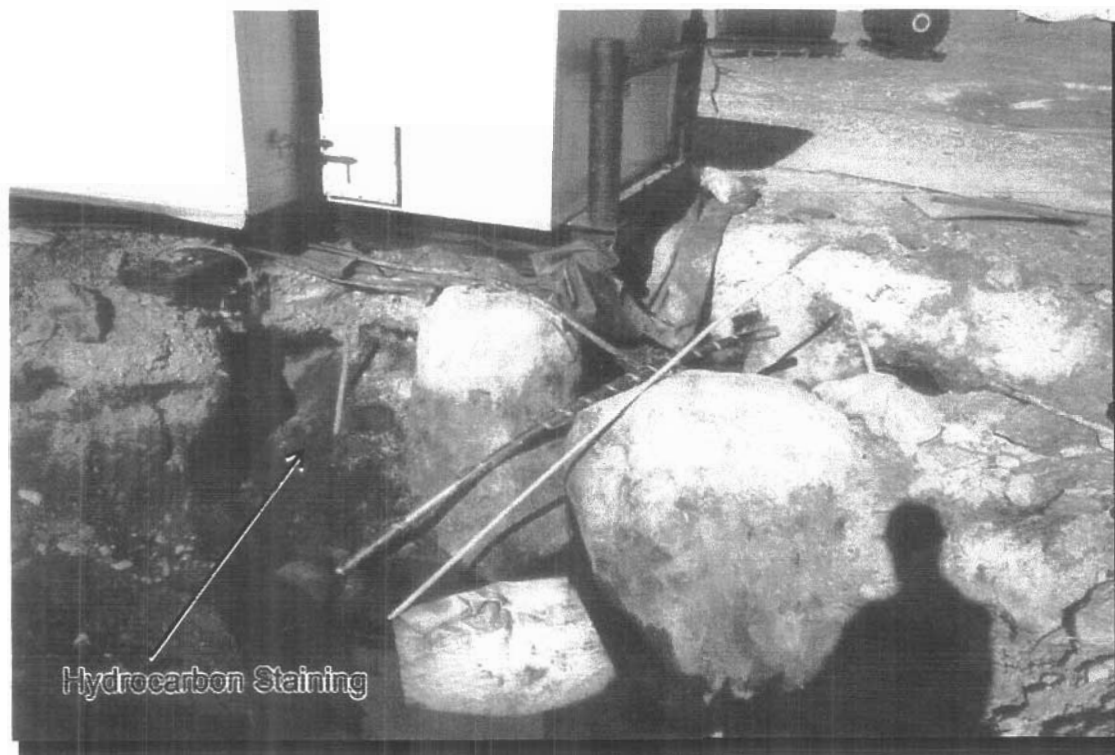
Photo 12
North wall of excavation.

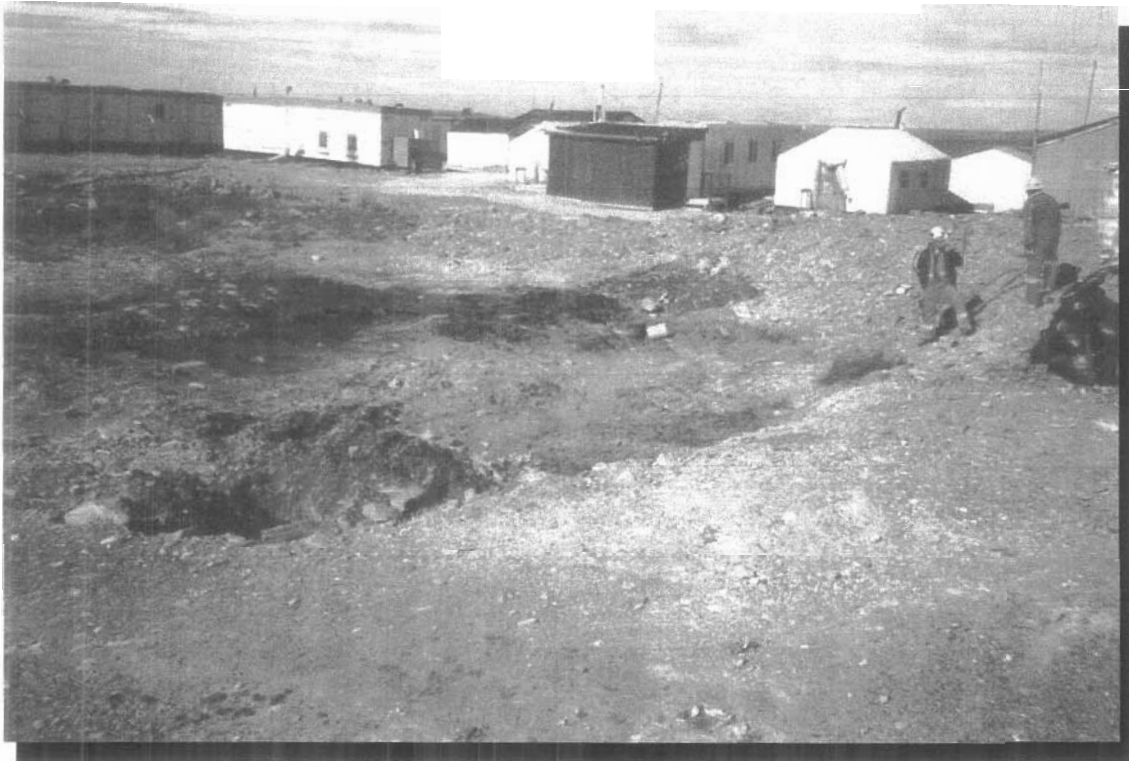
**Photo 13**

Photograph of helipad interception trench pre-construction. Looking south.

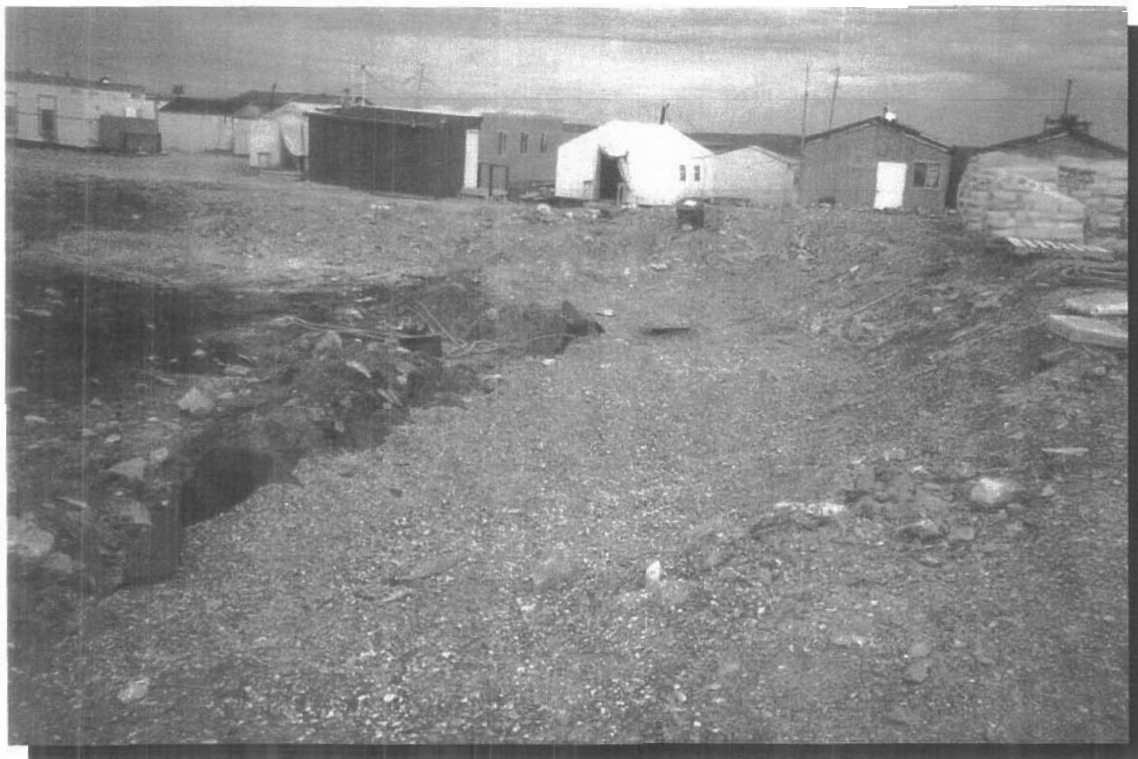
**Photo 14**

Photograph of helipad interception trench post-construction. Looking south.

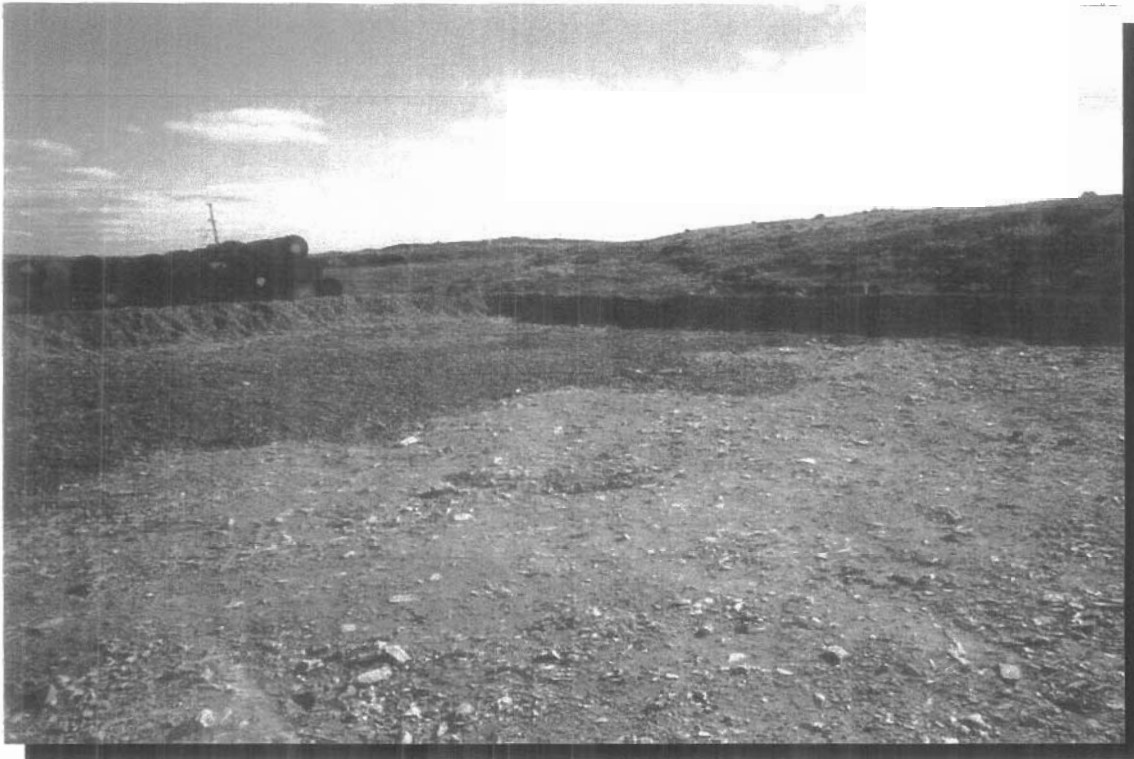
**Photo 15**

Photograph of crush material used as bedding for landfarm area.
Looking south.

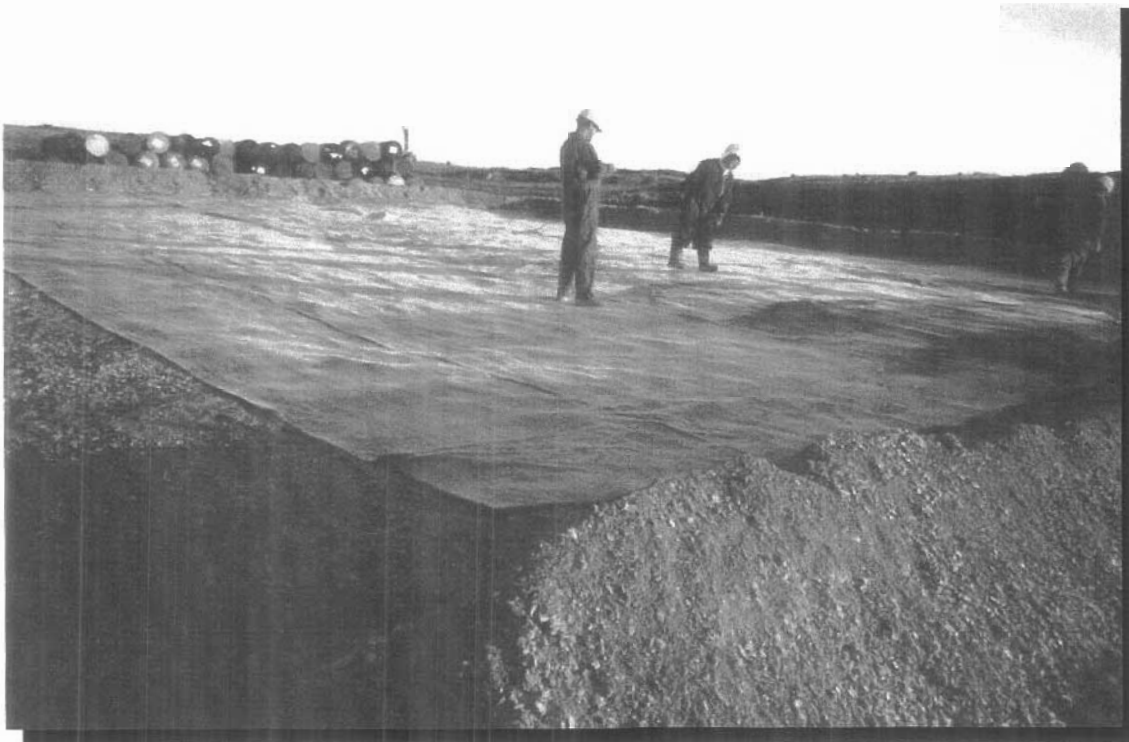
**Photo 16**

Photograph of Bentomax™ liner used as a protective barrier for
landfarm. Looking south.

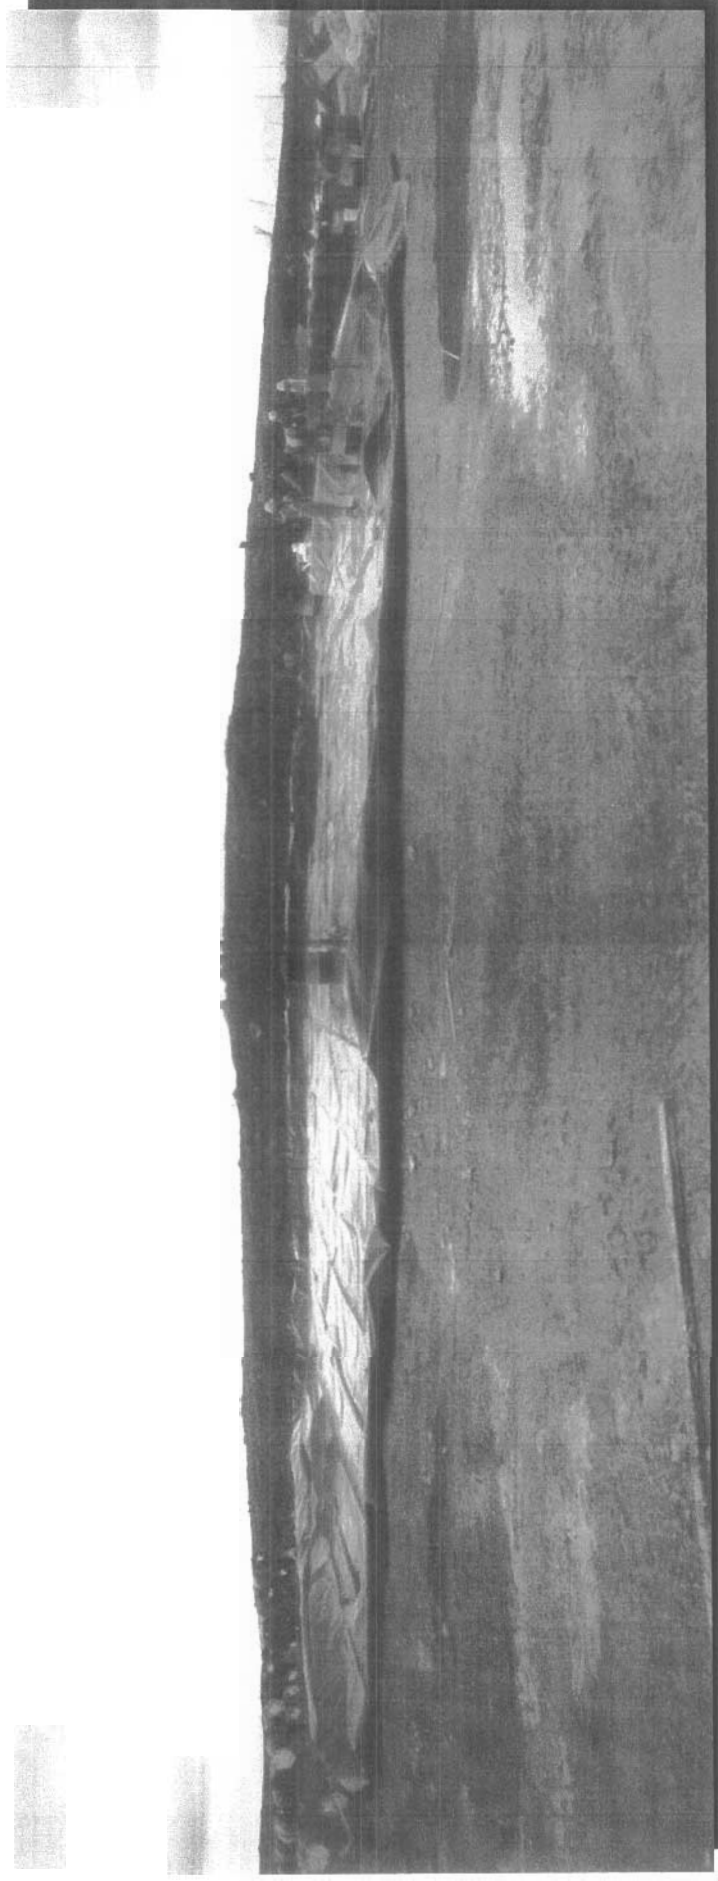
**Photo 17**

Photograph of landfarm area. Looking west.

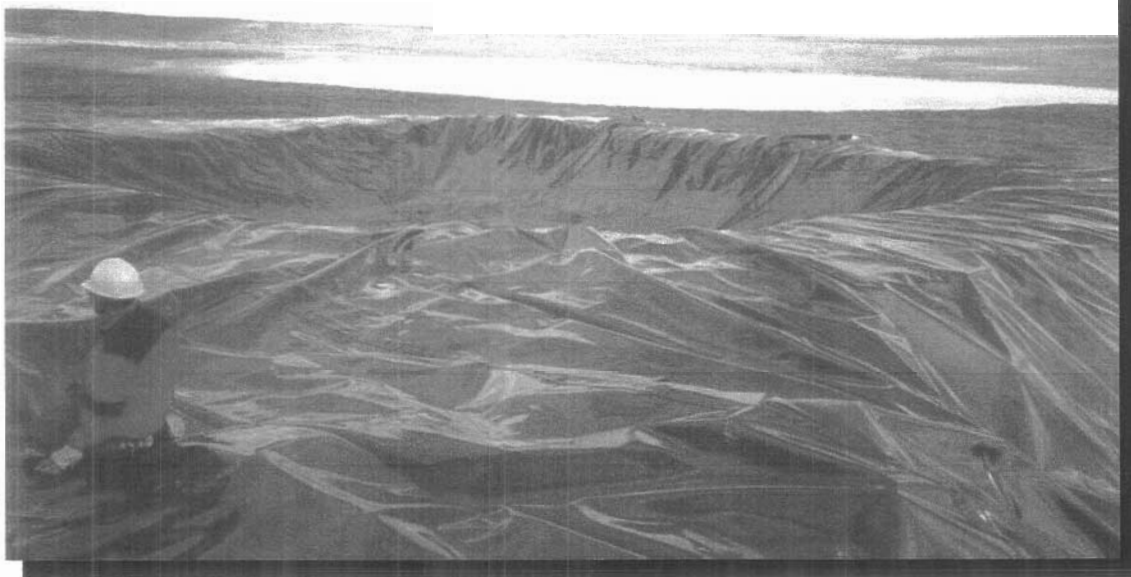
Photo 18
Lined pond.

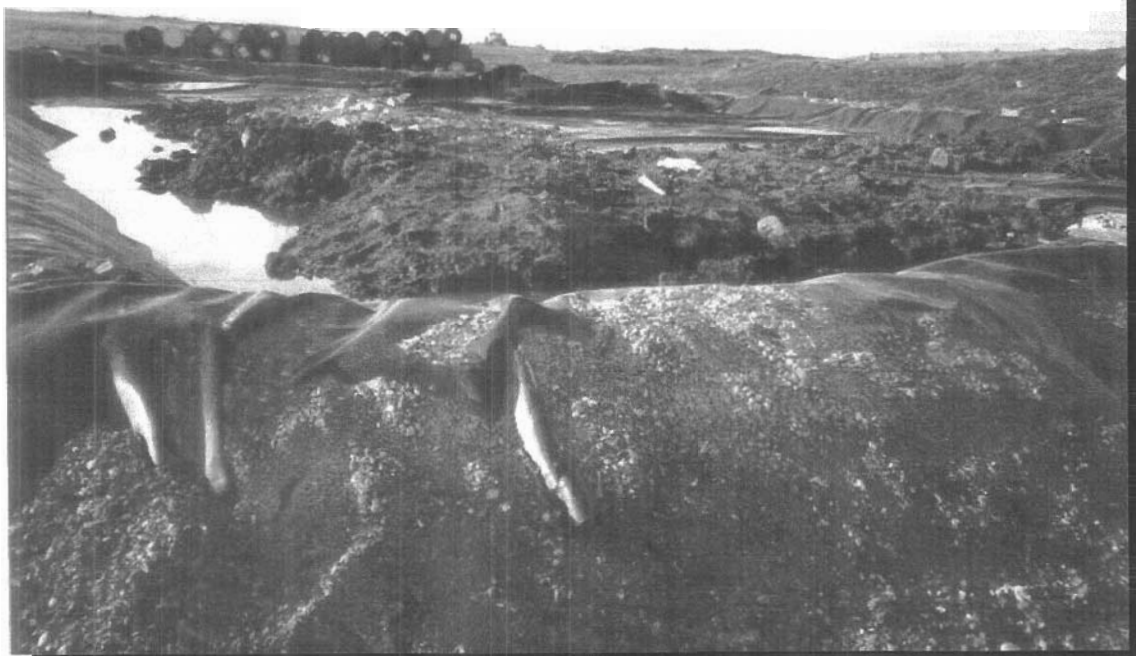
Photo 19
Land Treatment Area.

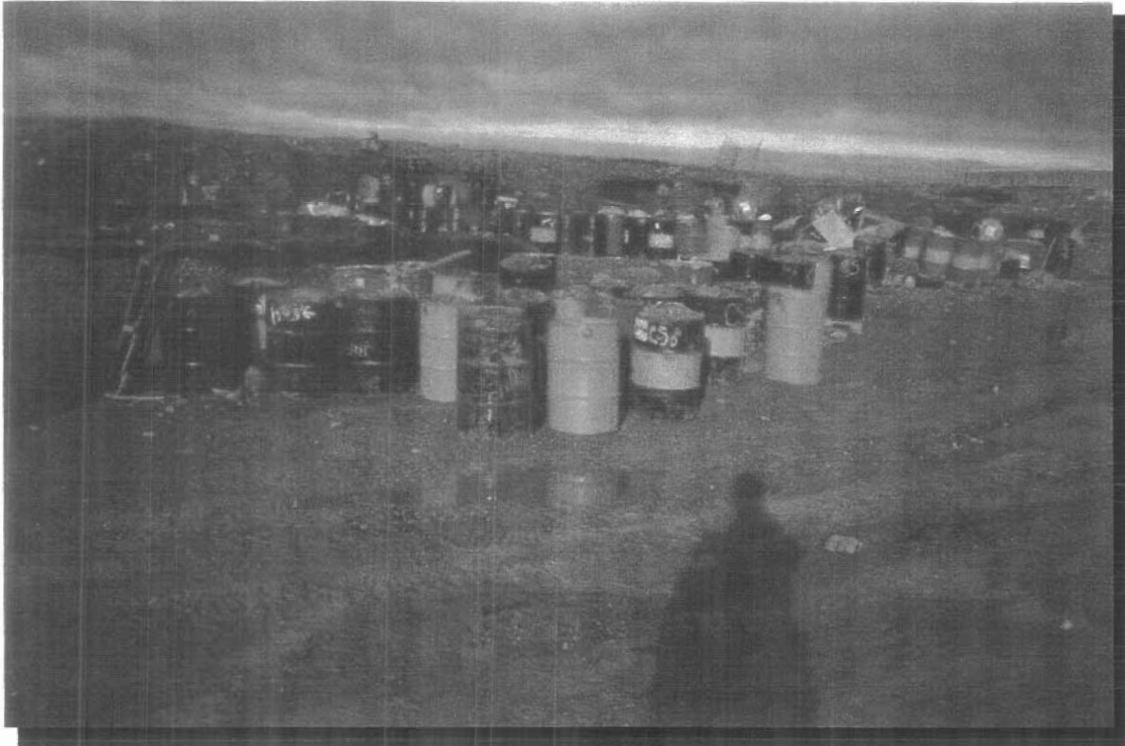
**Photo 20**

Excavated hydrocarbon impacted soil placed in LTA for remediation.
(Note upper left corner of photograph).
Barrels in background of photograph contain hydrocarbon impacted ready for
emplacement in LTA.

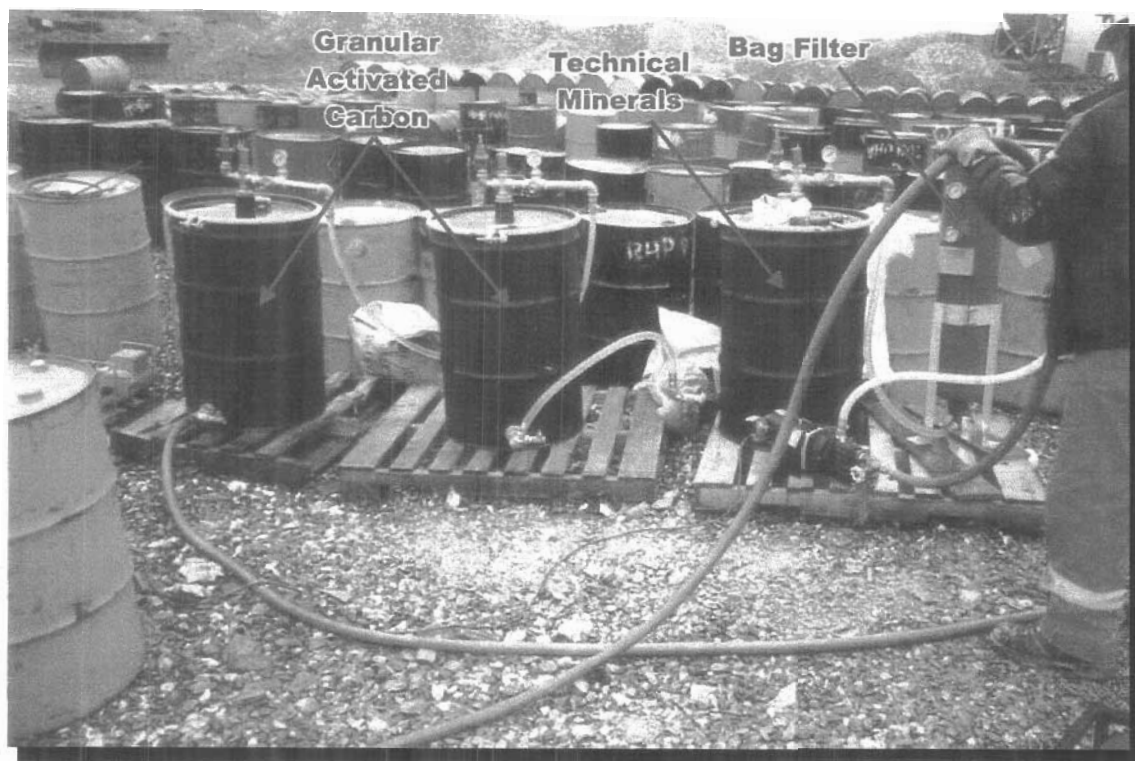
Photo 21
Photograph of water treatment system.

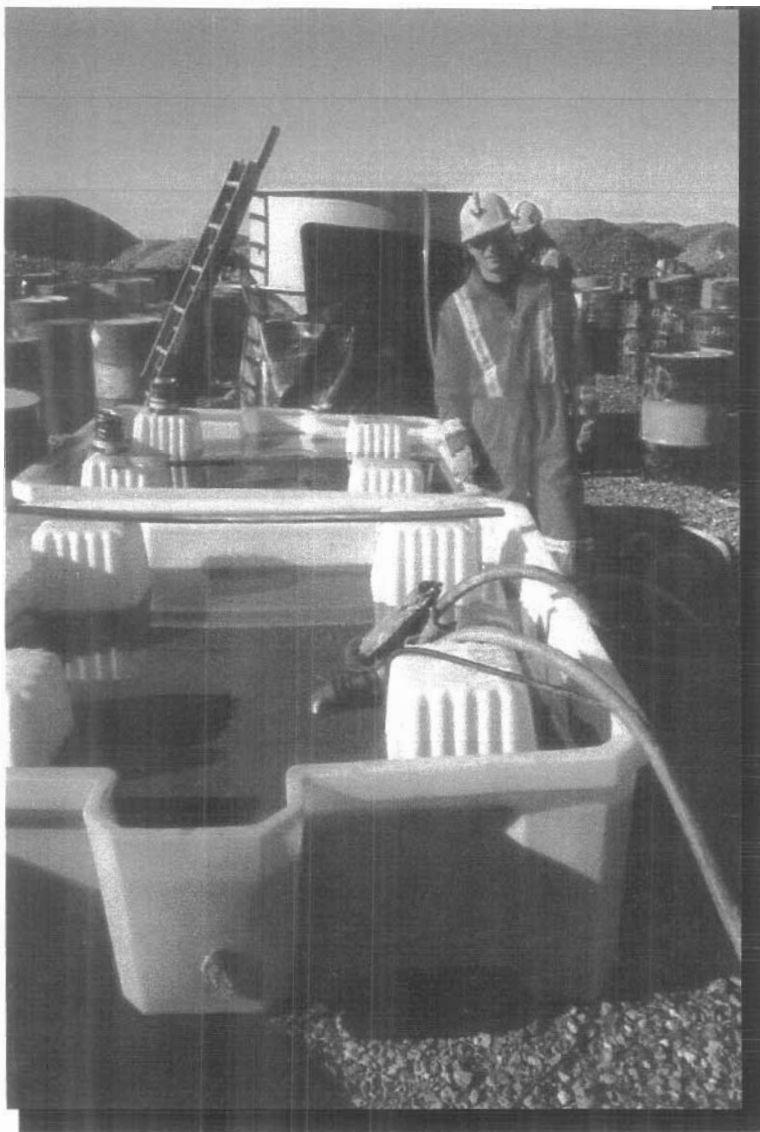
**Photo 22**

Storage basins for de-emulsification of pre-treatment liquid.

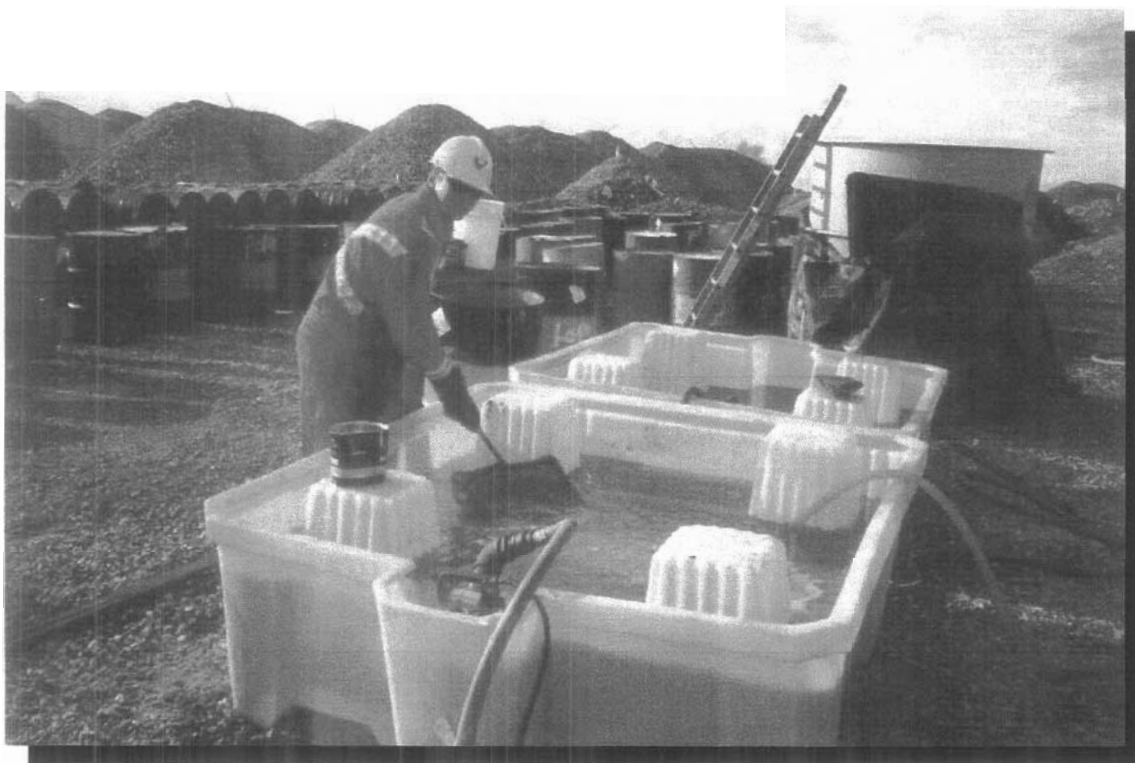
Photo 23
Removal of floating material with screen filter.

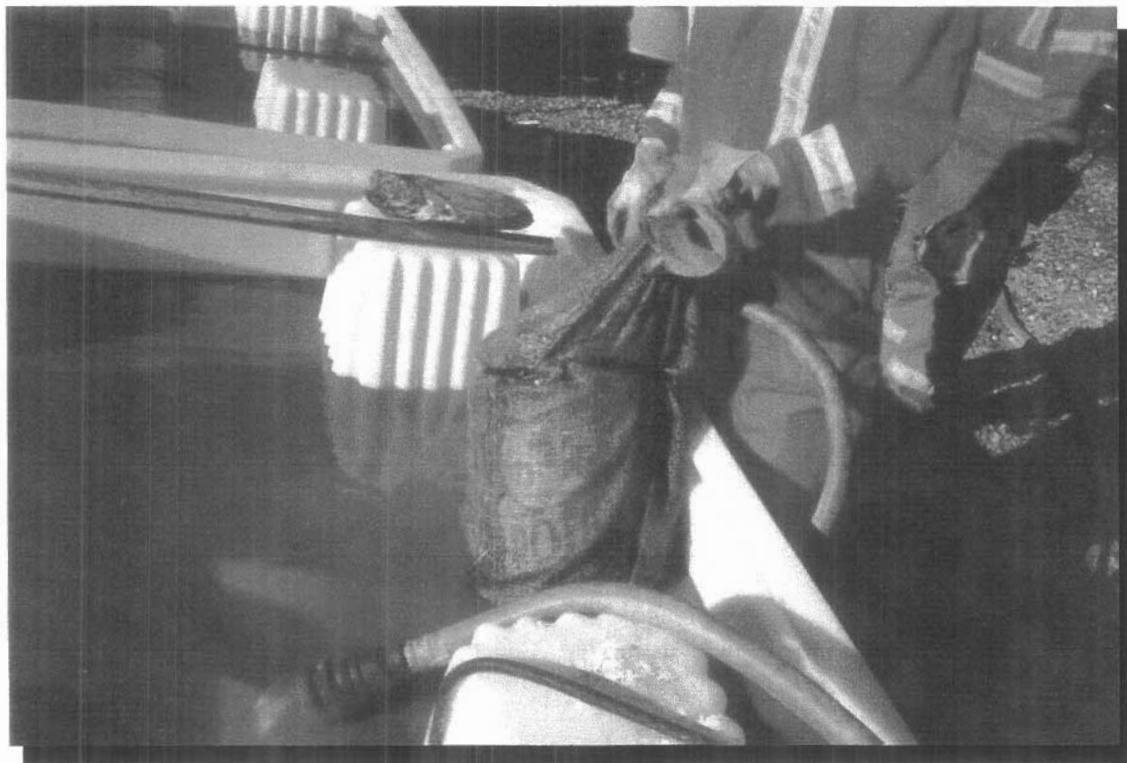
Photo 24
Coarse sediment filter.
