**AGNICO-EAGLE Mines Ltd.**

**Val d'Or, August 14th 2008**

**Reclamation of Skipper's Island, Goose South Area Meadowbank project**

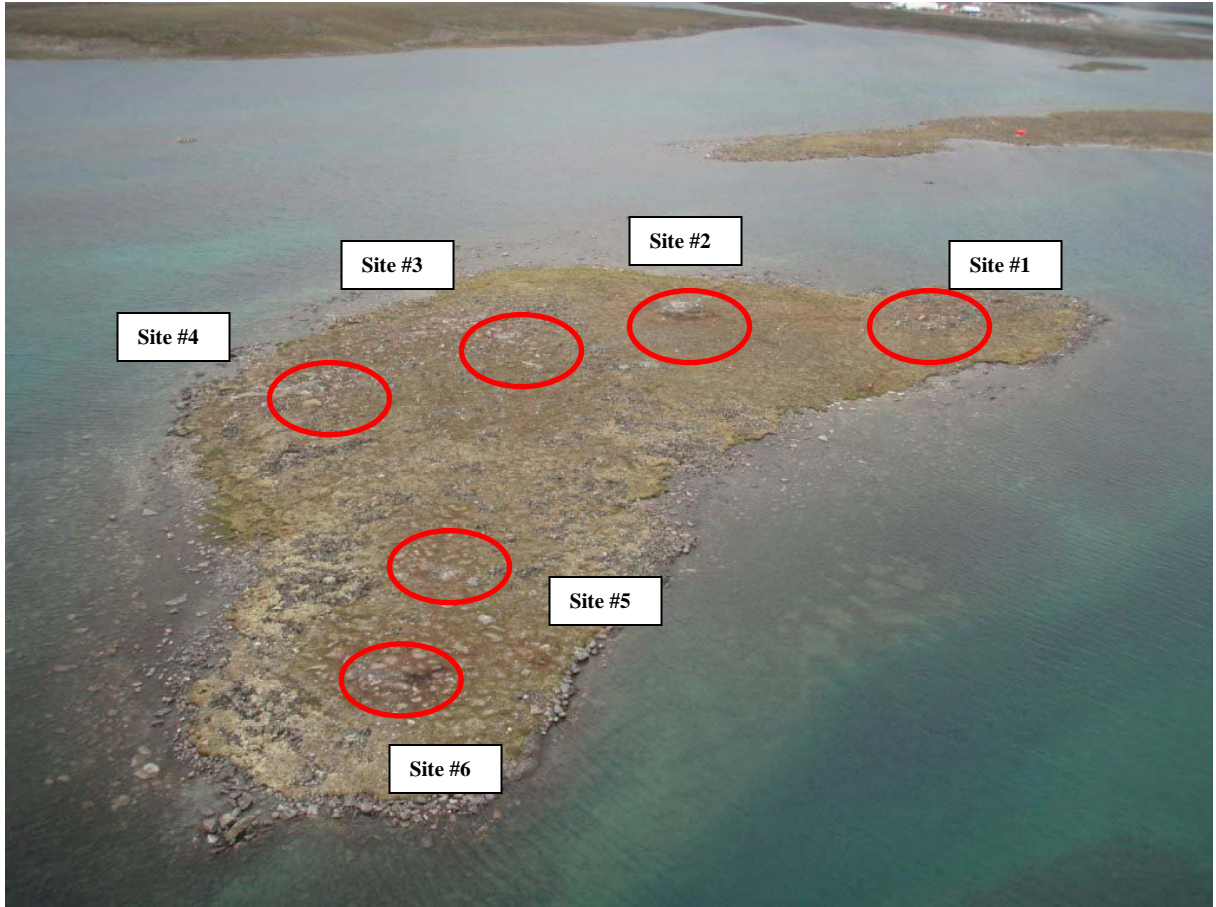
Picture taken before the reclamation activities illustrating the areas where drilling activity took place on the island

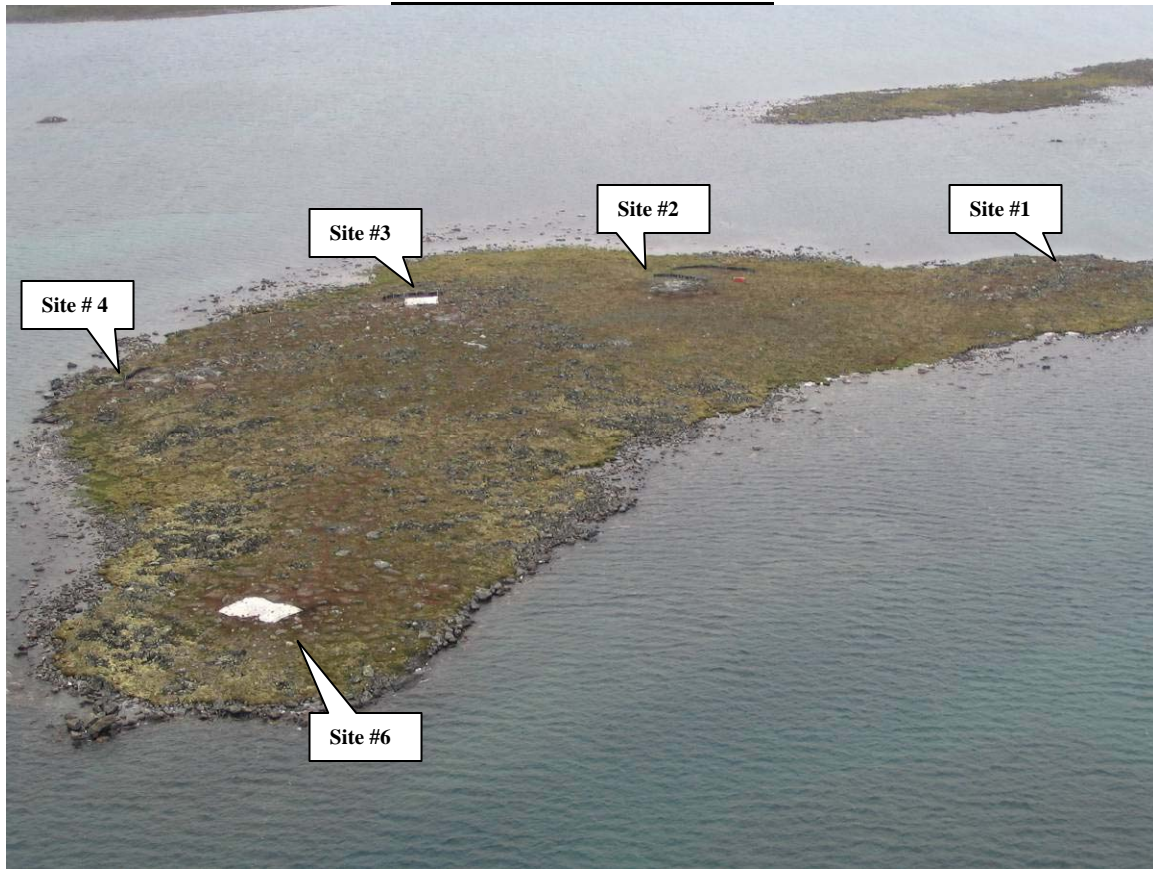
Aerial pictures taken after reclamation activities

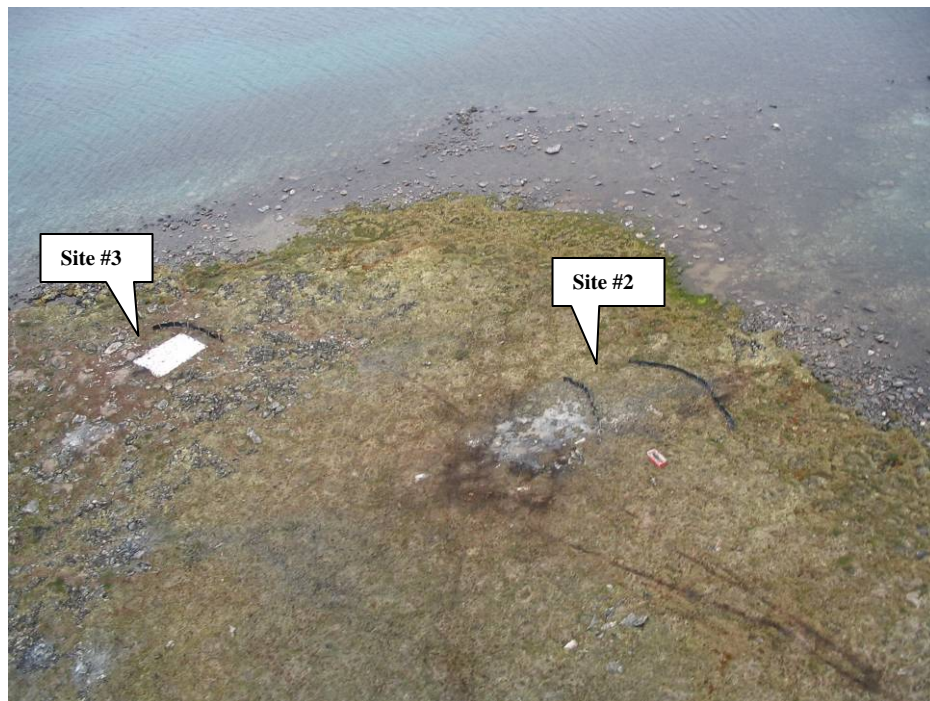
Closer aerial view of sites #2 and #3 after reclamation
