WATER LICENCE INSPECTION FORM

Licensee		Licensee Representative	
Agnico Eagle Gold Mines Limited		David Frenette	
Licence No. / Expiry		Representative's Title	
2BE-MEA1318/ March 6 th , 2018		Environmental Coordinator	
Land Authorization No. / Purpose / Expiry		Land Authorization Expiry	
N2013F0030/ Winter trail		April 15 th , 2016	
Date of Inspection		Inspector	
July 22nd, 2015		WRO Wilson	
Activities Inspected			
<input checked="" type="checkbox"/> Camp	<input checked="" type="checkbox"/> Drilling	<input type="checkbox"/> Mining	<input checked="" type="checkbox"/> Construction
<input checked="" type="checkbox"/> Roads/Hauling	<input checked="" type="checkbox"/> Other: Water Discharge		<input type="checkbox"/> Reclamation
			<input type="checkbox"/> Fuel Storage
			<input type="checkbox"/> Other:

PHOTO LOG

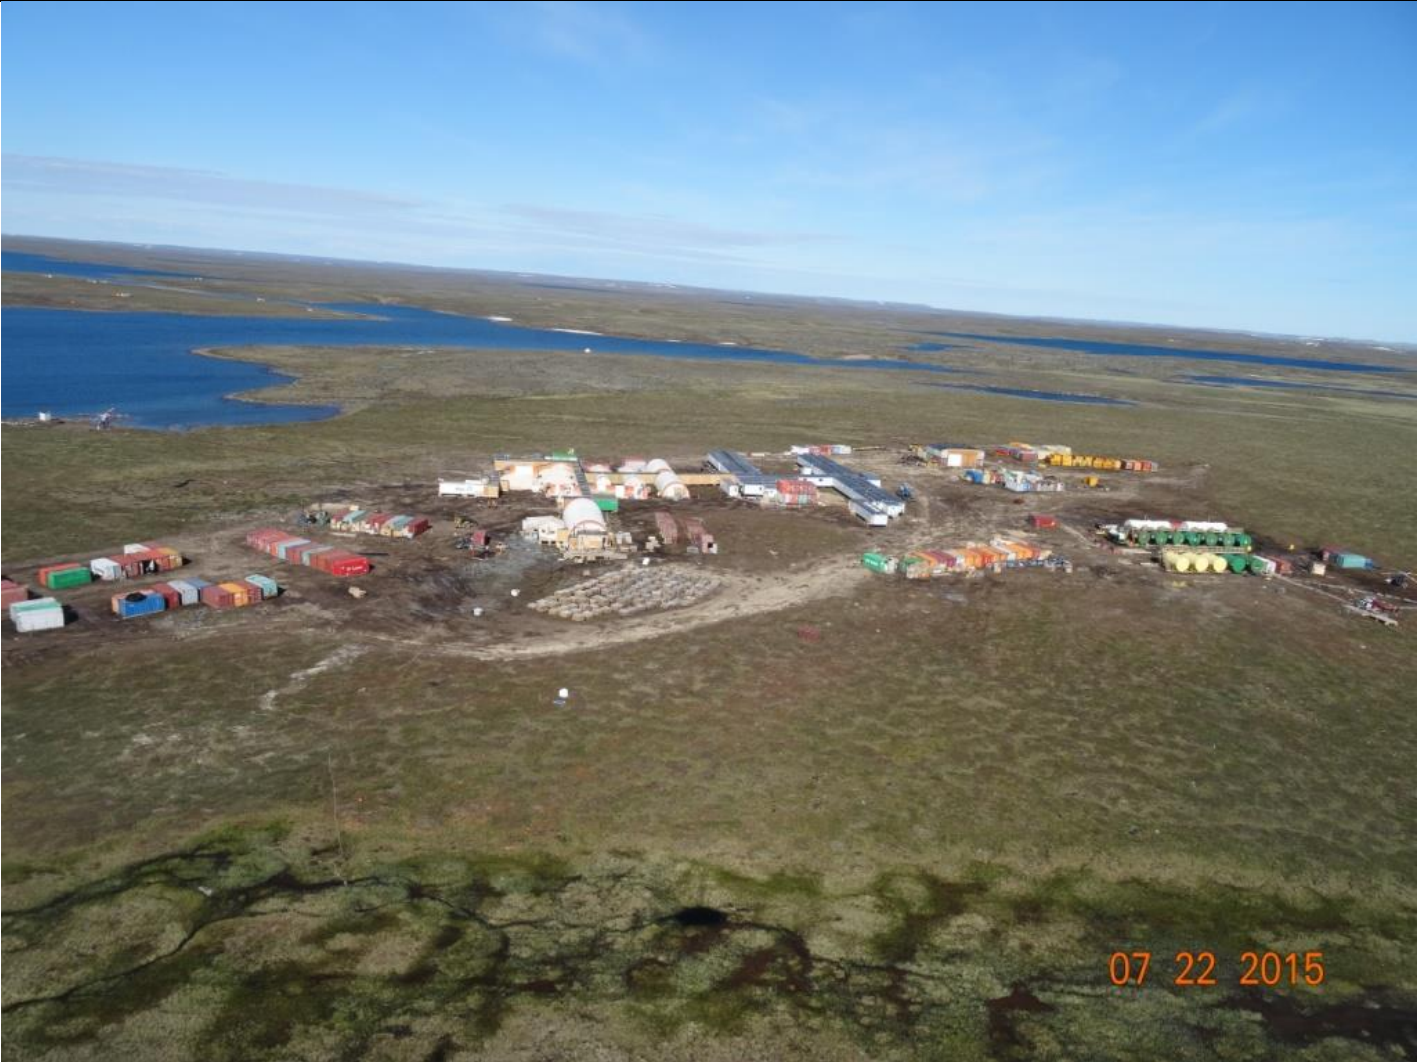
Date:	Authorization Number:	Camera/Model:	Inspector
July 23 rd , 2015	2BE-MEA1318	Sony DSC-HX50V Cyber shot	WRO Wilson
Photo No.	Lat/Long (DD.MM.SS.SS, NAD83)		
Photo 1	N65° 24' 6.6", W 96° 40' 32.6"

Description:
Amaruq camp

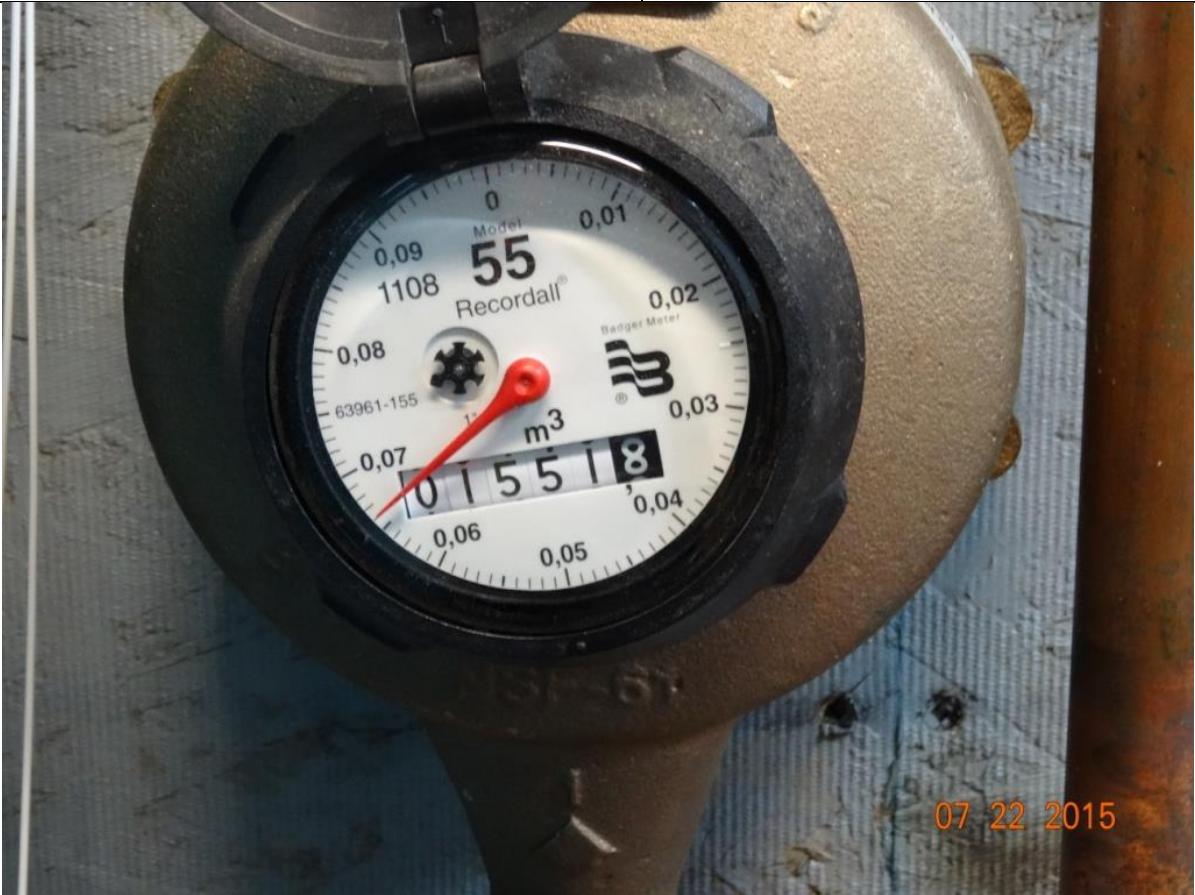
Locations name:	Lat/Long (DD.MM.SS.SS, NAD83)
Photo 2	Inside the IVR Camp

Description:
Domestic Water Use Meter

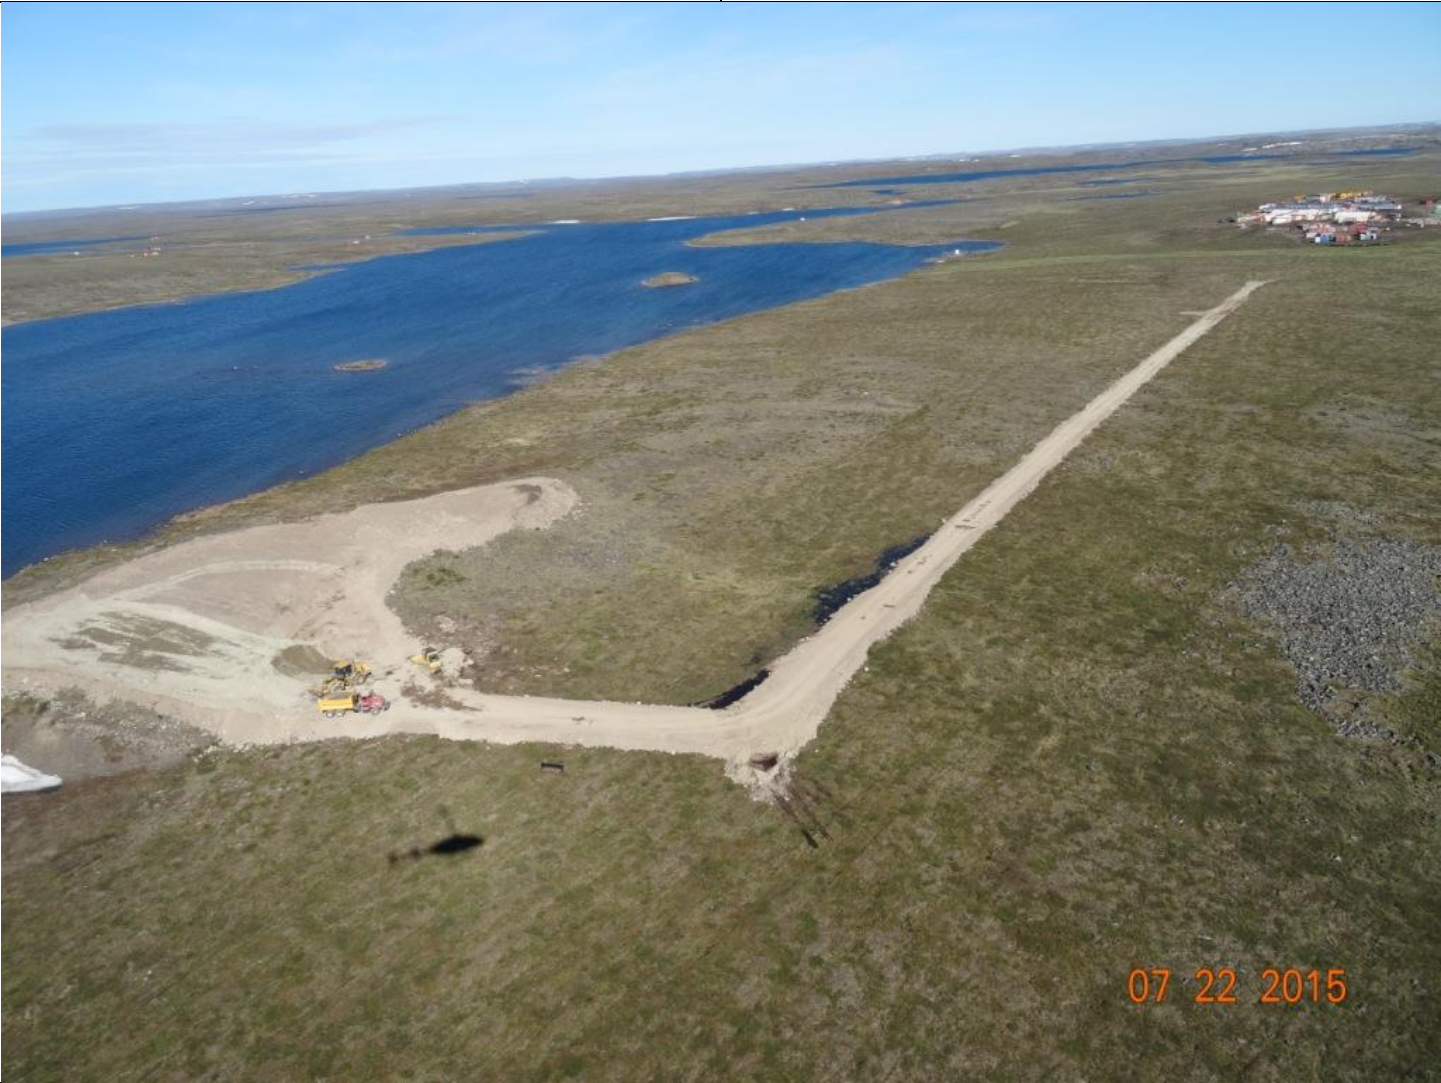
Photo No.
Photo 5

Quarry #7in the foreground, access road, with IVR camp in the background
