WATER LICENCE INSPECTION FORM

Licensee		Licensee Representative	
Agnico Eagle Gold Mines Limited		David Frenette	
Licence No. / Expiry		Representative's Title	
2BE-MEA1318/ March 6 th , 2018		Environmental Coordinator	
Land Authorization No. / Purpose / Expiry		Other Authorization	
N2013F0030/ Winter trail/ April 15 th ,2016		Amendments No. 1 and No. 2	
Date of Inspection		Inspector	
October 20th, 2015		WRO Wilson	
Activities Inspected			
<input checked="" type="checkbox"/> Camp <input checked="" type="checkbox"/> Drilling <input type="checkbox"/> Mining <input checked="" type="checkbox"/> Construction <input type="checkbox"/> Reclamation <input type="checkbox"/> Fuel Storage			
<input checked="" type="checkbox"/> Roads/Hauling <input checked="" type="checkbox"/> Other: Water Discharge <input type="checkbox"/> Other:

Attached: 2BE-MEA1318, Photo log October 20th-21st, 2015 Inspection
cc. Erik Allain, Manager Field Operations, AANDC
David Frenette, Environmental Coordinator, AEM

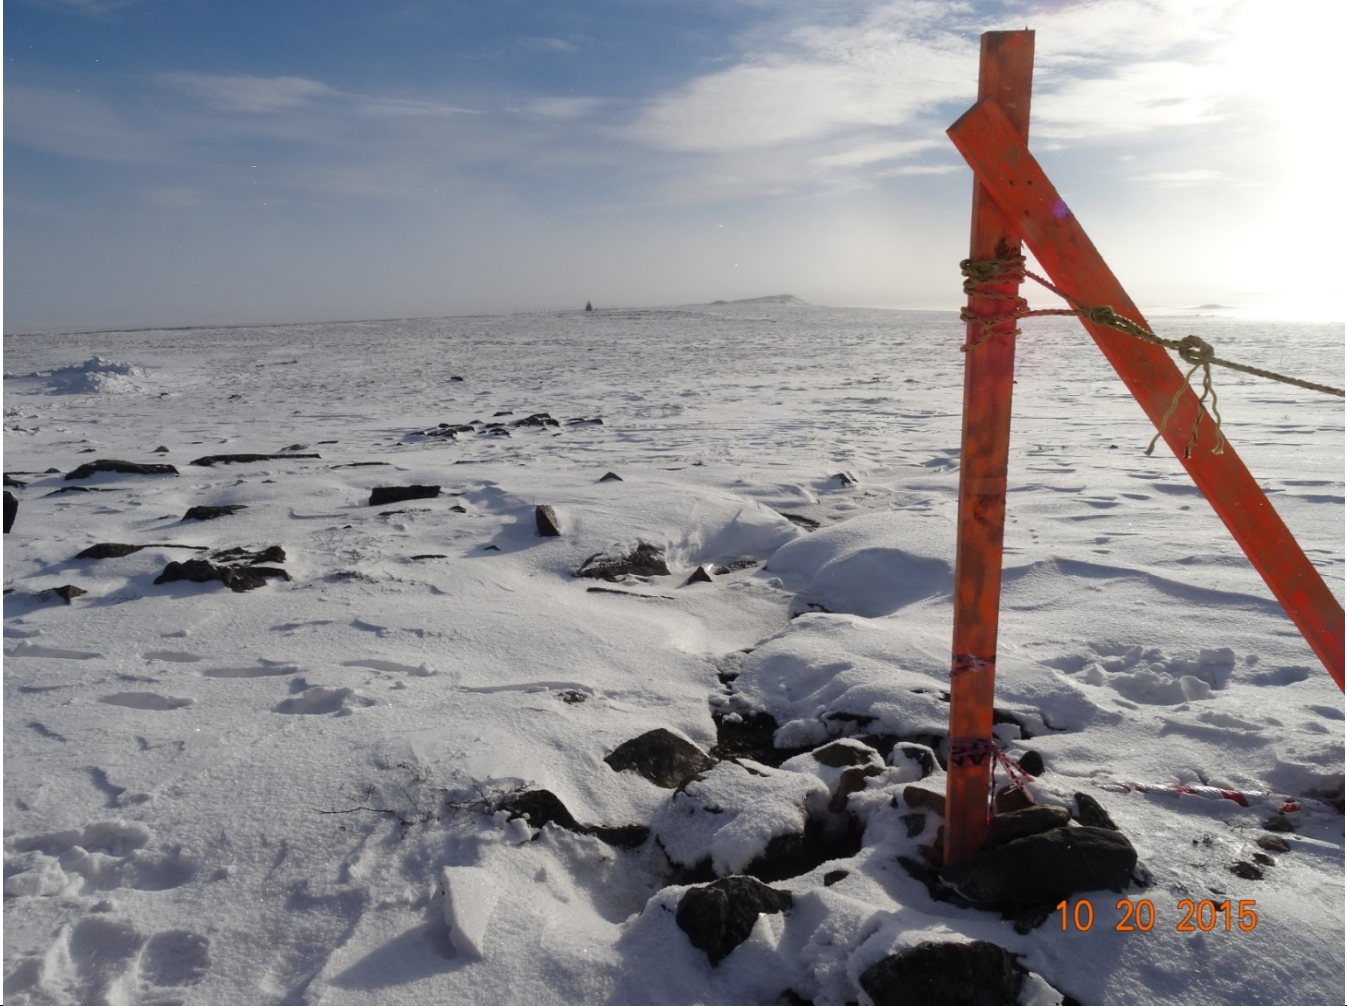
Description:
Effluent discharge from bionest

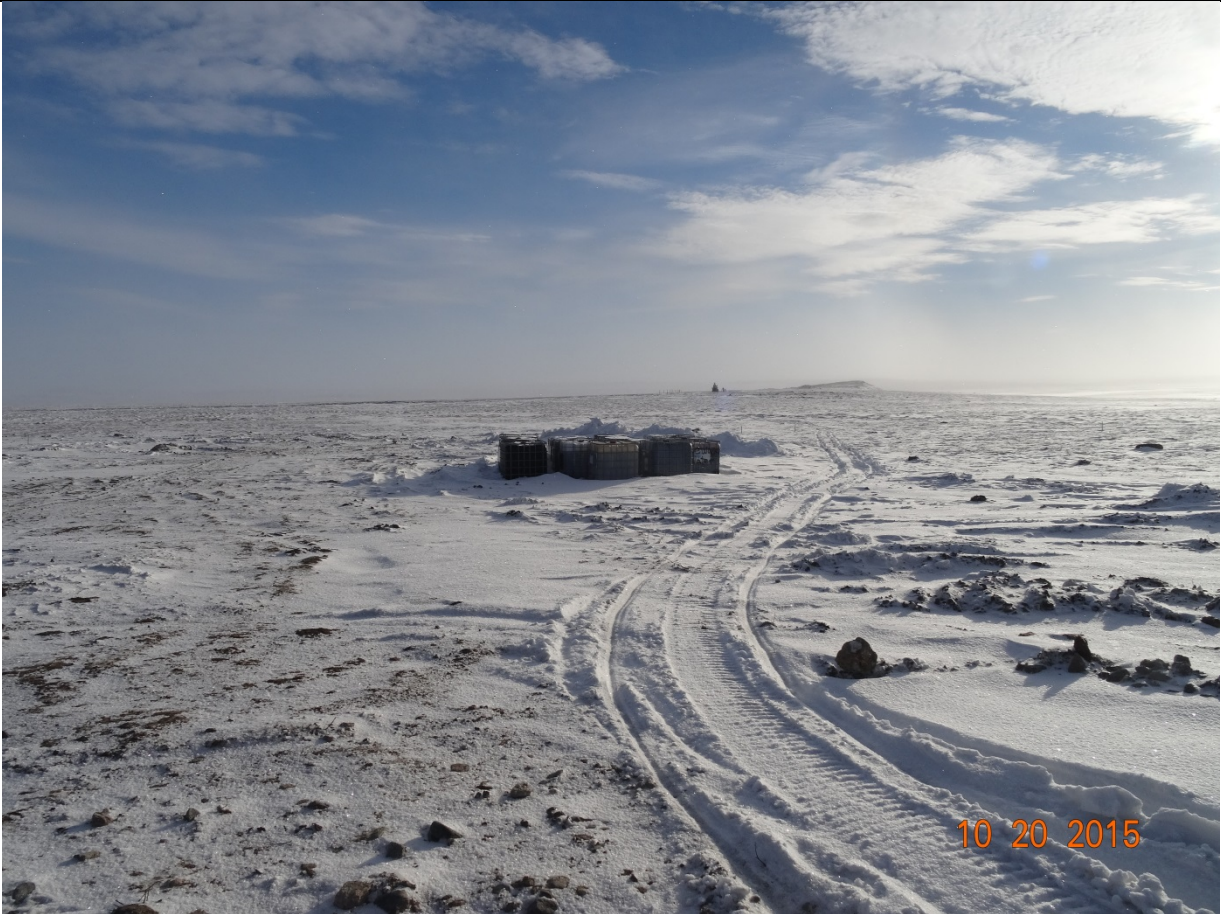
Description:
Raw sewage totes

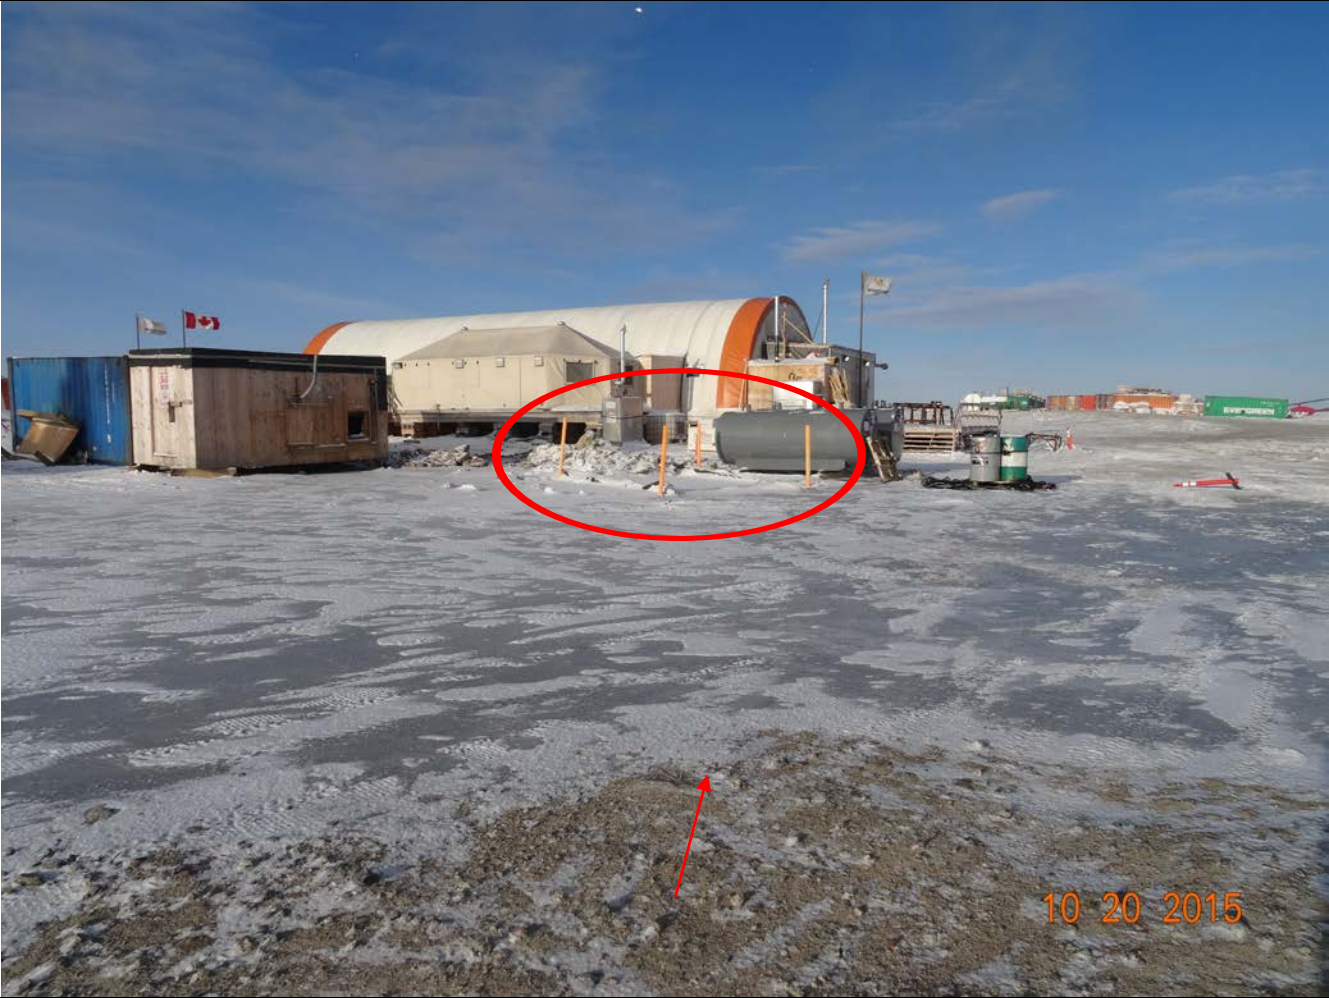
Description: Red Circle- Core cutting catchment area Red Arrow- Extent of ice cover	
--	--

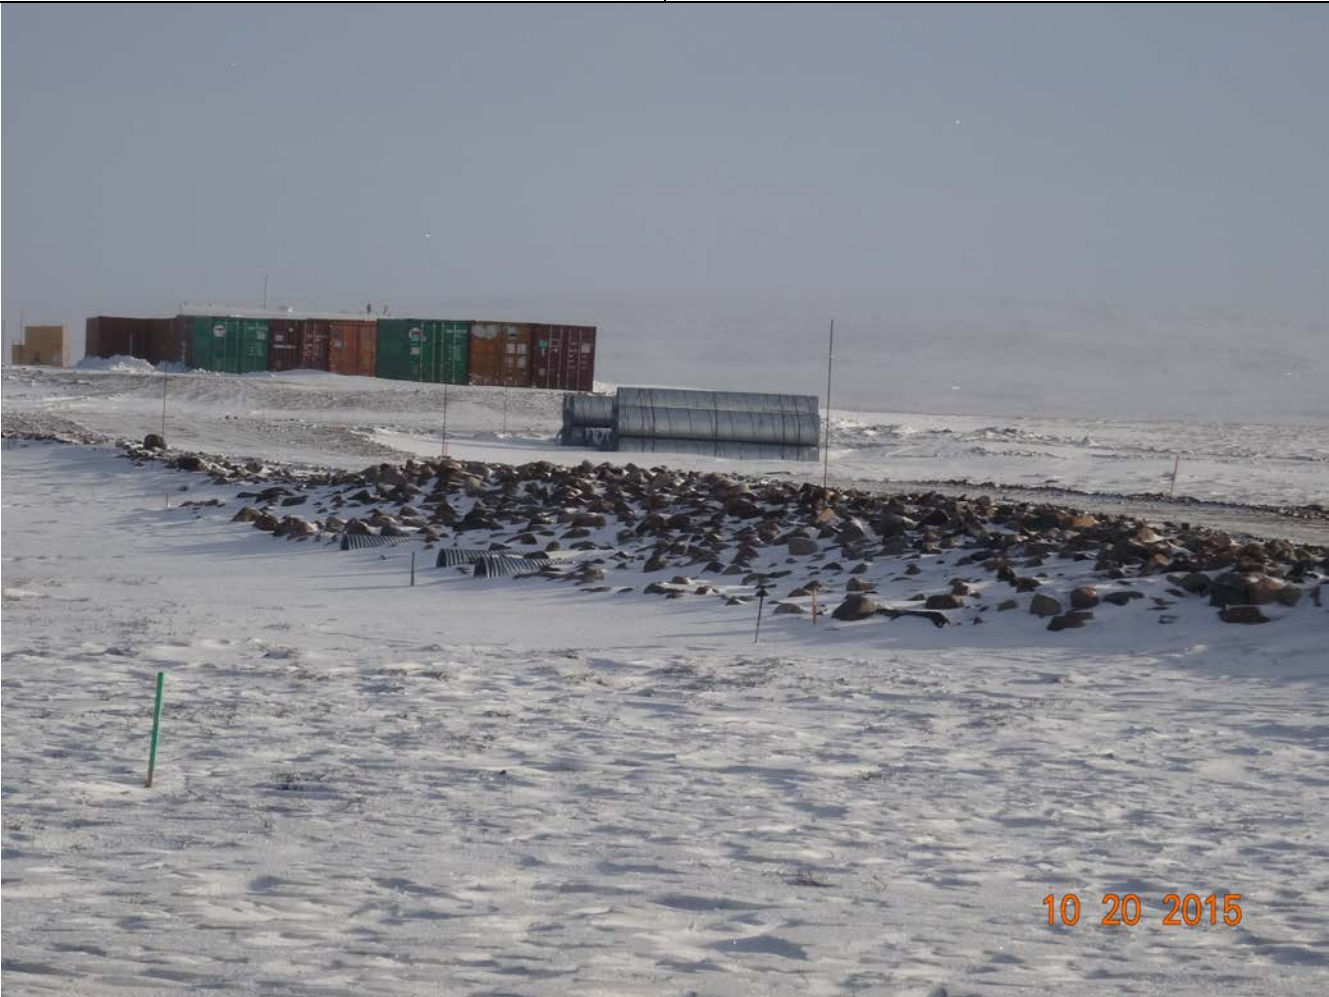
9. The road to quarry no. 7 has been completed for use. A total of four culverts were installed across the water way (photo 4).
- a. AEM informed the inspector that construction was not completed this fall as anticipated; the south side of the culverts system was not covered with rip-rap. A construction summary report as required in part E item 8 will be submitted within 90 days once completed.

b. The inspector was concerned that the lack of guard stone on the downstream side of the structure allows for a greater potential of erosion and sedimentation into the water way.

Description: Culverts for road construction to quarry no. 7	
---	--

c. The inspector requests all information collected during the inspection and maintenance program as required in part J item 14 and 15 be recorded and made available for review upon request.

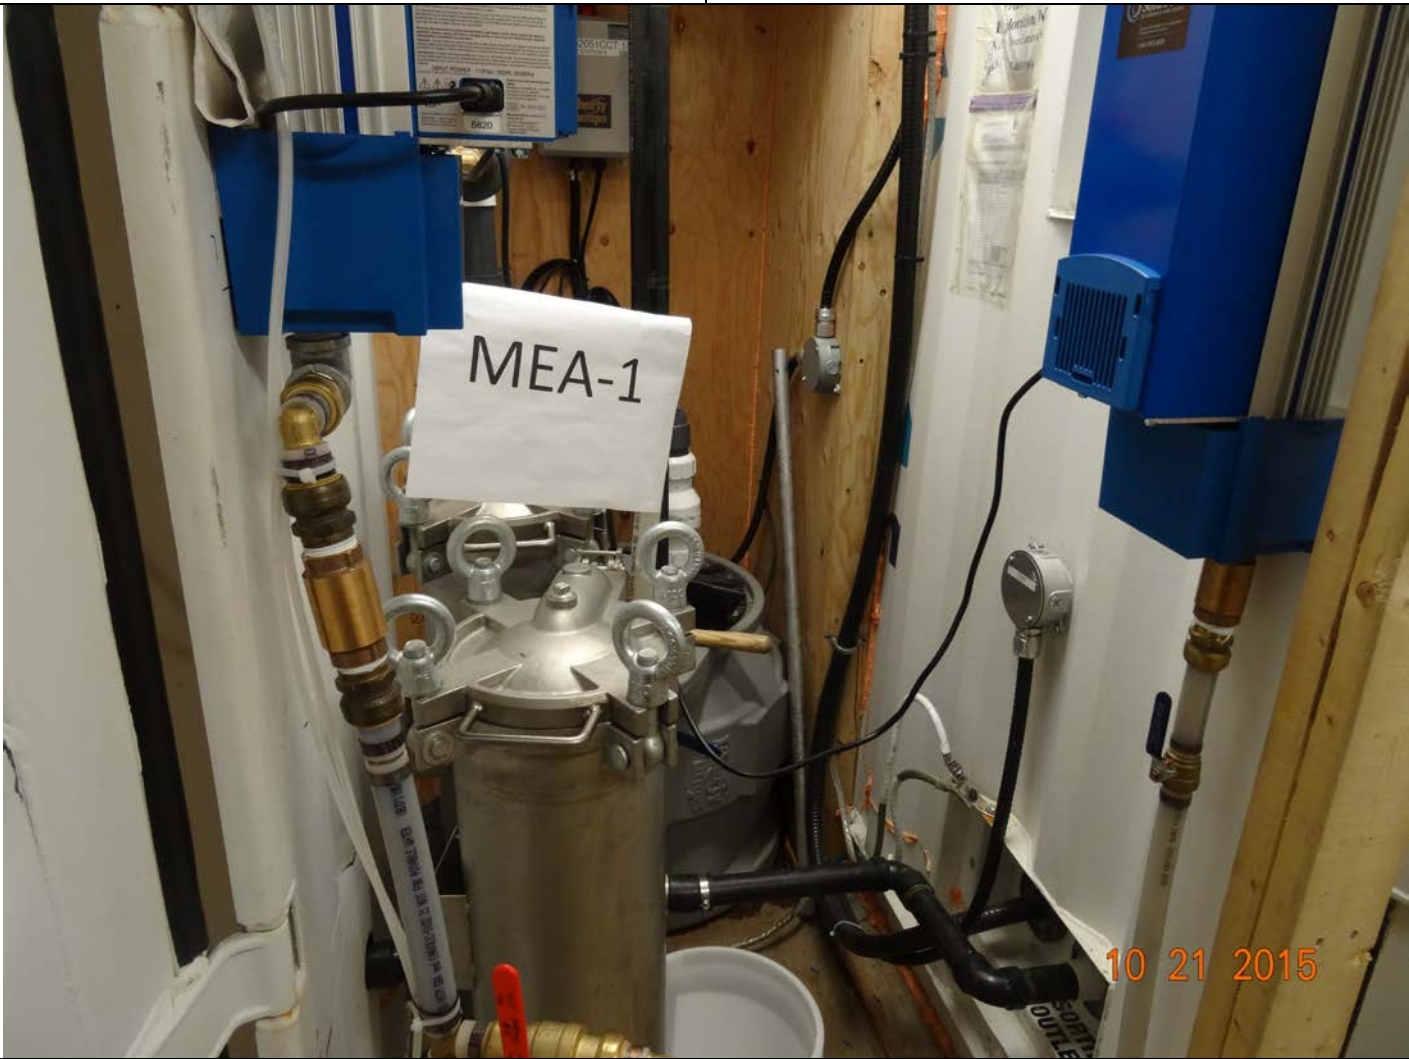
13. AEM has installed signage at the sampling station MEA-1 (photo 5).
14. The inspector sampled at sampling station MEA-1 for the parameters found in the licence.
- a. The samples were found to meet the criteria as identified in part E item 13.

Description:
Photo taken on October 21st, 2015 – signage at sampling station MEA-1

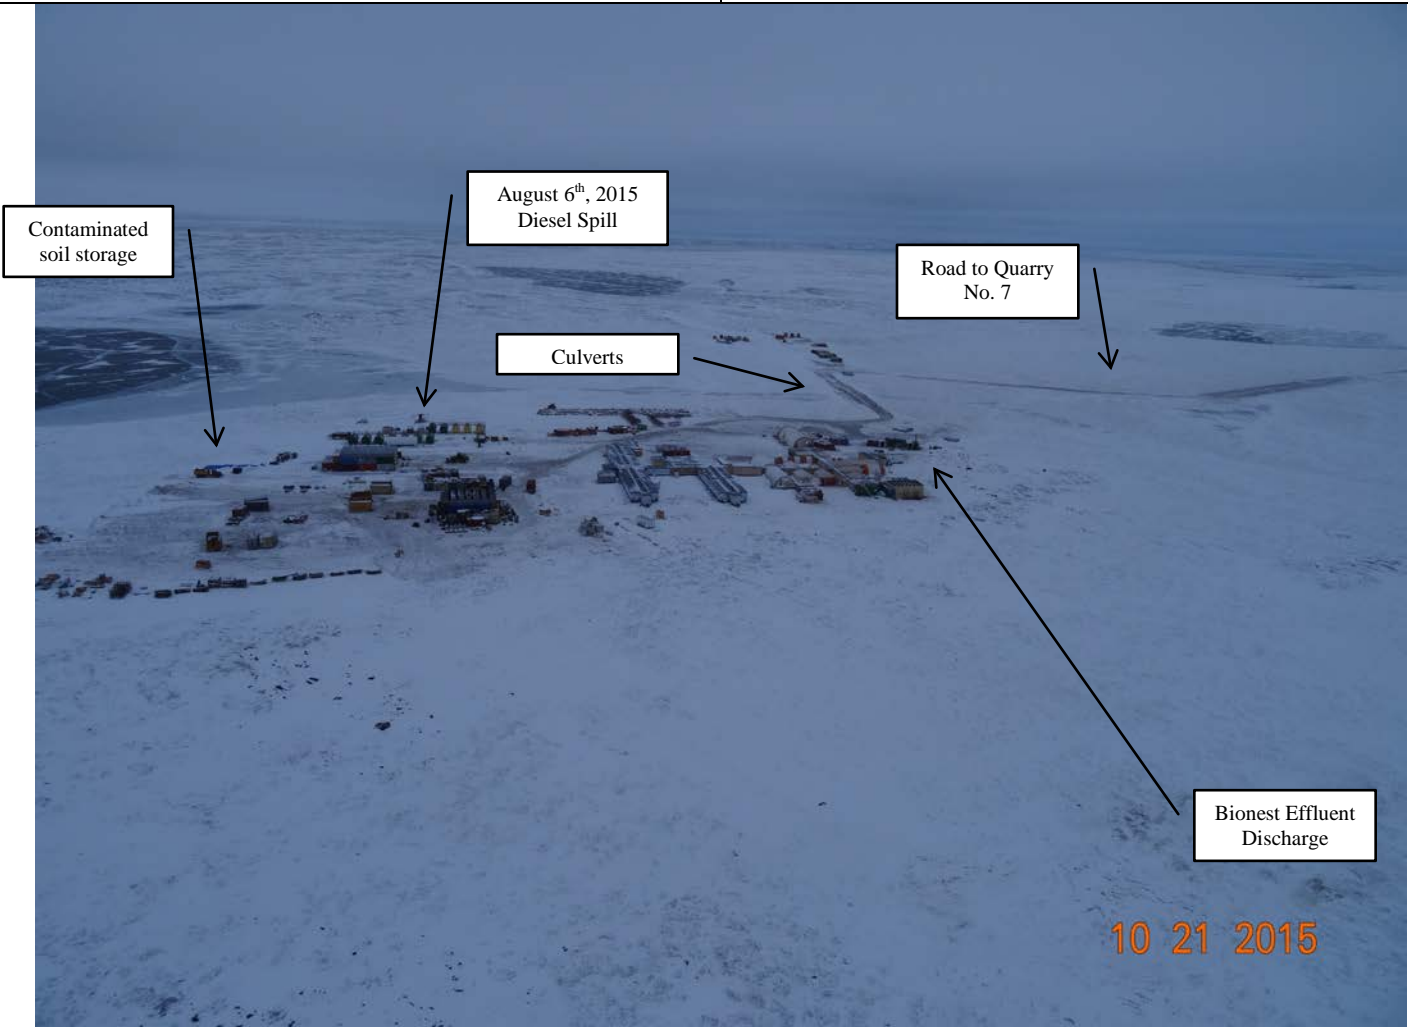
Description:
Photo taken October 21st, 2015 - Overview reference
