WATER LICENCE INSPECTION FORM

Licensee	Licensee Representative
Agnico Eagle Mines Limited	David Frenette
Licence No. / Expiry	Representative's Title
2BB-MEA1318/ March 6 <sup>th</sup> , 2018	Environmental Coordinator
Land Authorization No. / Purpose / Expiry	Land Authorization Expiry
N2013F0030/ Winter trail	April 15 <sup>th</sup> , 2019
Date of Inspection	Inspector
May 10 <sup>th</sup> , 2017	WRO Wilson
Activities Inspected	
<input checked="" type="checkbox"/> Camp	<input type="checkbox"/> Drilling
<input type="checkbox"/> Roads/Hauling	<input type="checkbox"/> Mining
<input checked="" type="checkbox"/> Other: Water Discharge	<input checked="" type="checkbox"/> Construction
	<input type="checkbox"/> Reclamation
	<input checked="" type="checkbox"/> Fuel Storage
	<input type="checkbox"/> Other:

Date:	Authorization Number:	Camera/Model:	Inspector
May 10 2017	2BB-MEA1318	Sony DSC-HX50V Cyber shot	WRO Wilson
Photo No.	Lat/Long (DD.MM.SS.SS, NAD83)		
Photo 1	N65° 24' 2.34", W 96° 40' 50.69"

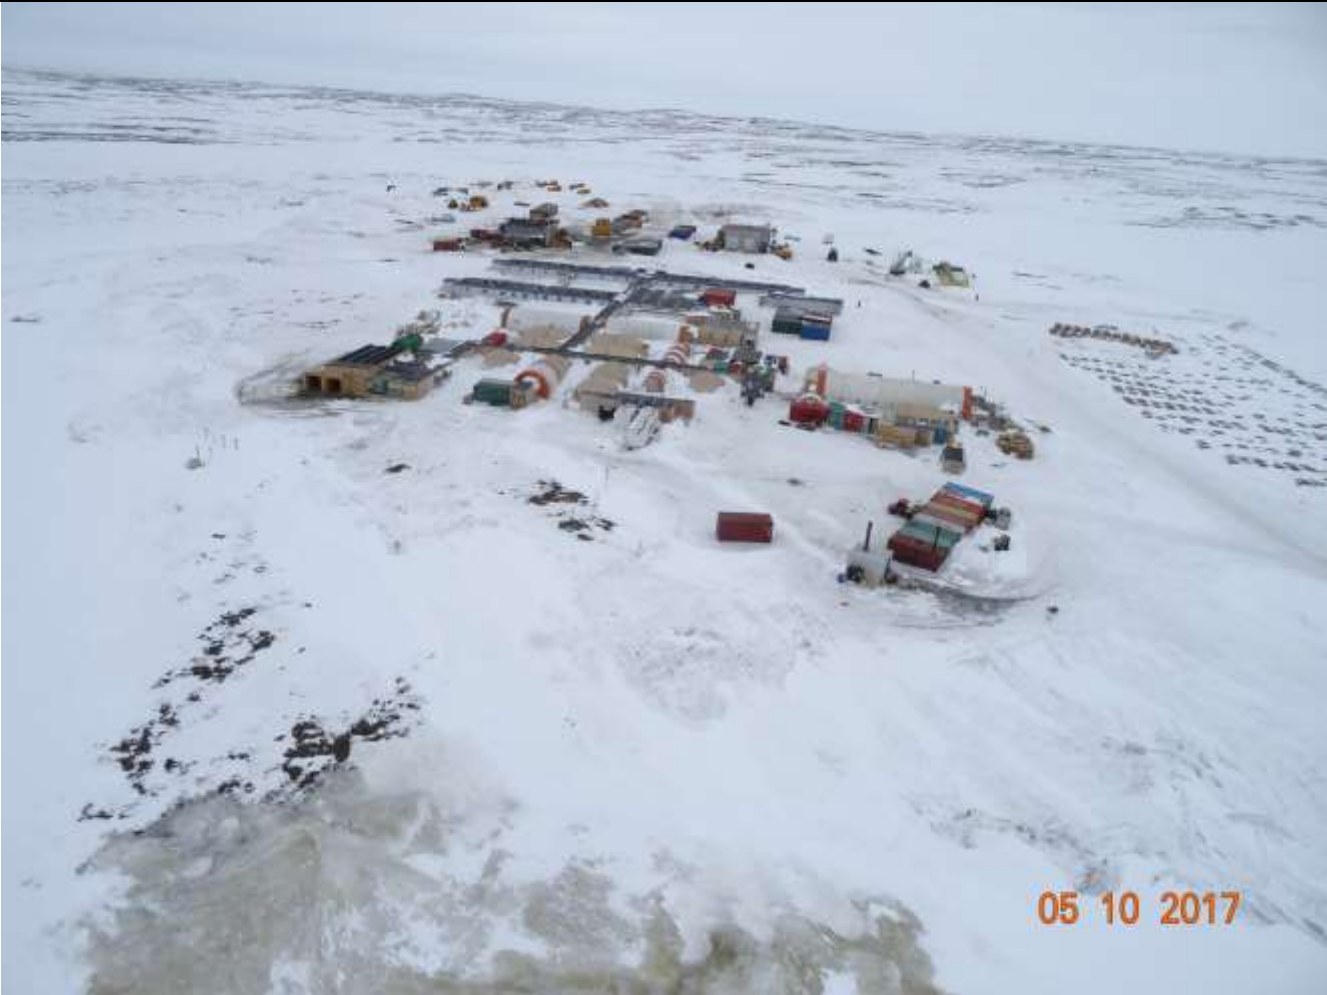
Description:  
Amaruq Camp

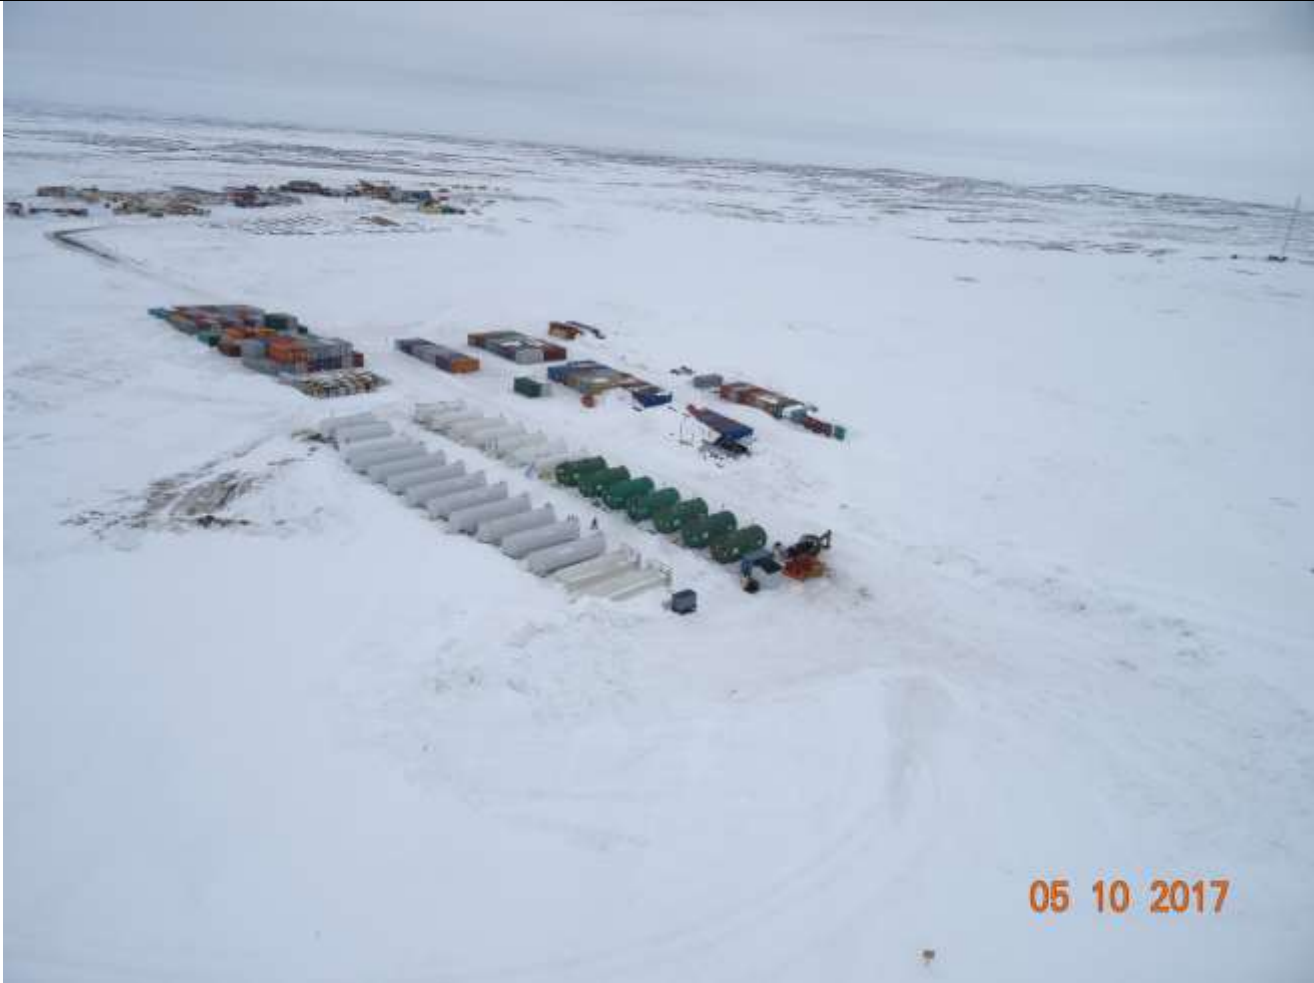
Photo No.	Lat/Long (DD.MM.SS.SS, NAD83)
Photo 2	N65° 23' 55.073" W 96° 40' 14.86"

Description:  
Seacan Lay down and fuel farm

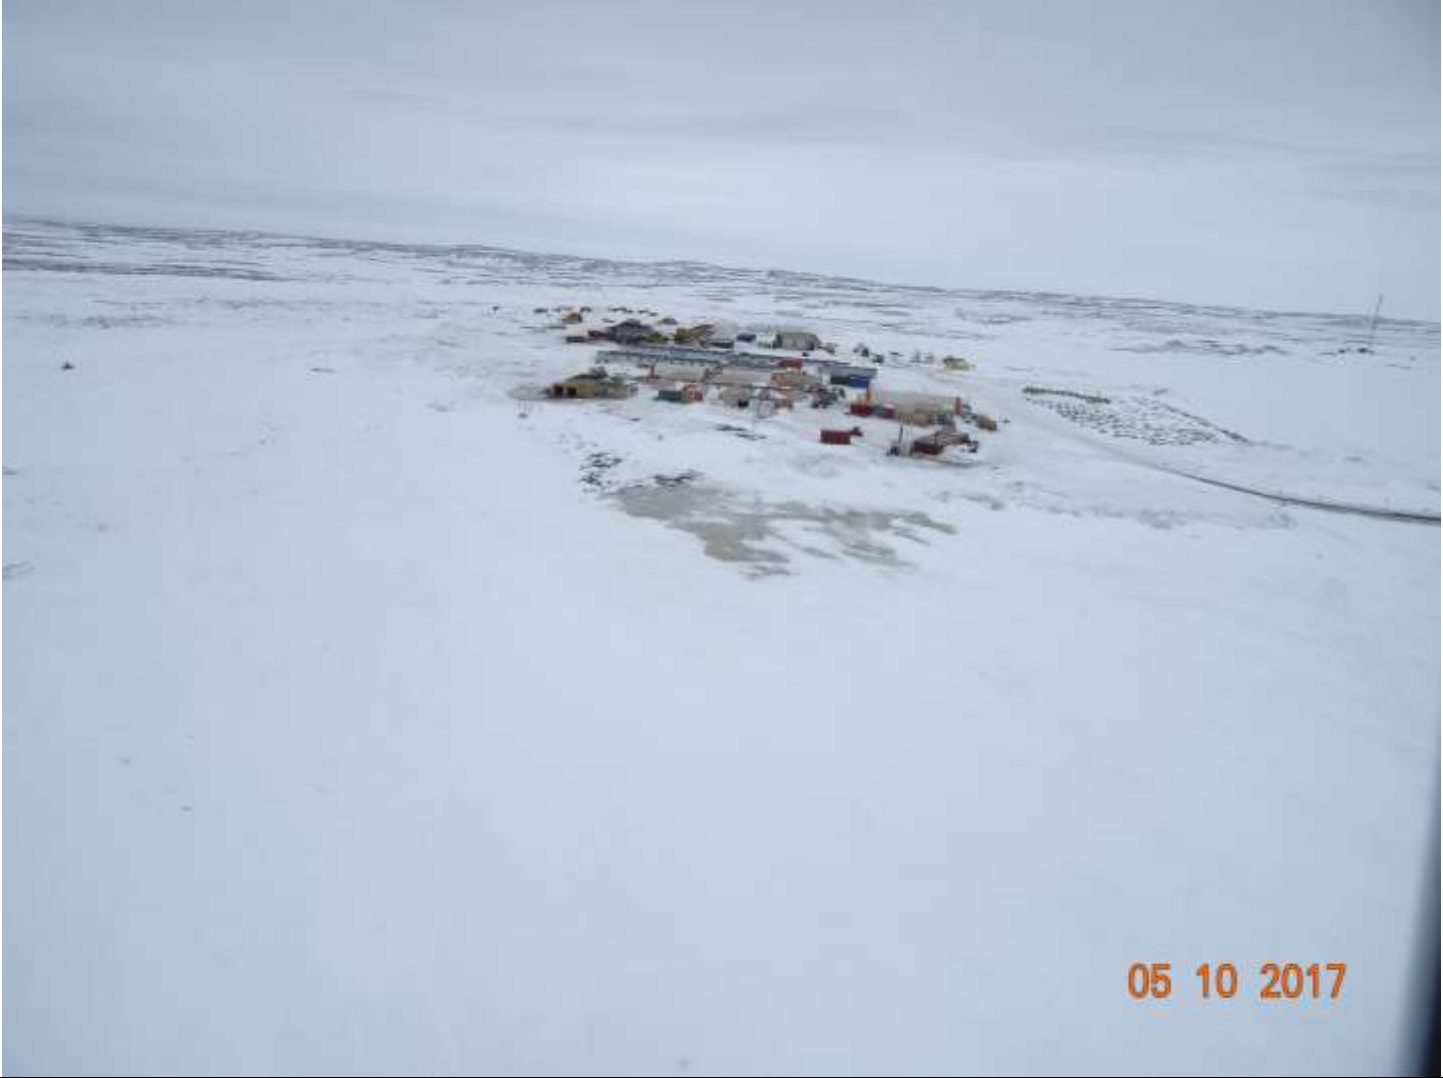
Photo No.	Lat/Long (DD.MM.SS.SS, NAD83)
Photo 3	N65° 23' 58.42", W 96° 40' 55.91"

Description:
Ice near the bionest outfall
