WATER LICENCE INSPECTION FORM

Licensee	Licensee Representative
Agnico Eagle Mines Limited	David Frenette
Licence No. / Expiry	Representative's Title
2BB-MEA1318/ March 6 th , 2018	Environmental Coordinator
Land Authorization No. / Purpose / Expiry	Land Authorization Expiry
N2013F0030/ Winter trail	April 15 th , 2019
Date of Inspection	Inspector
July 12th, 2017	WRO Wilson
Activities Inspected	
<input checked="" type="checkbox"/> Camp <input type="checkbox"/> Drilling <input type="checkbox"/> Mining <input checked="" type="checkbox"/> Construction <input type="checkbox"/> Reclamation <input checked="" type="checkbox"/> Fuel Storage	
<input type="checkbox"/> Roads/Hauling <input checked="" type="checkbox"/> Other: Water Discharge <input type="checkbox"/> Other:

Attached: Photo Log 2BB-MEA1318, - July 12th, 2017

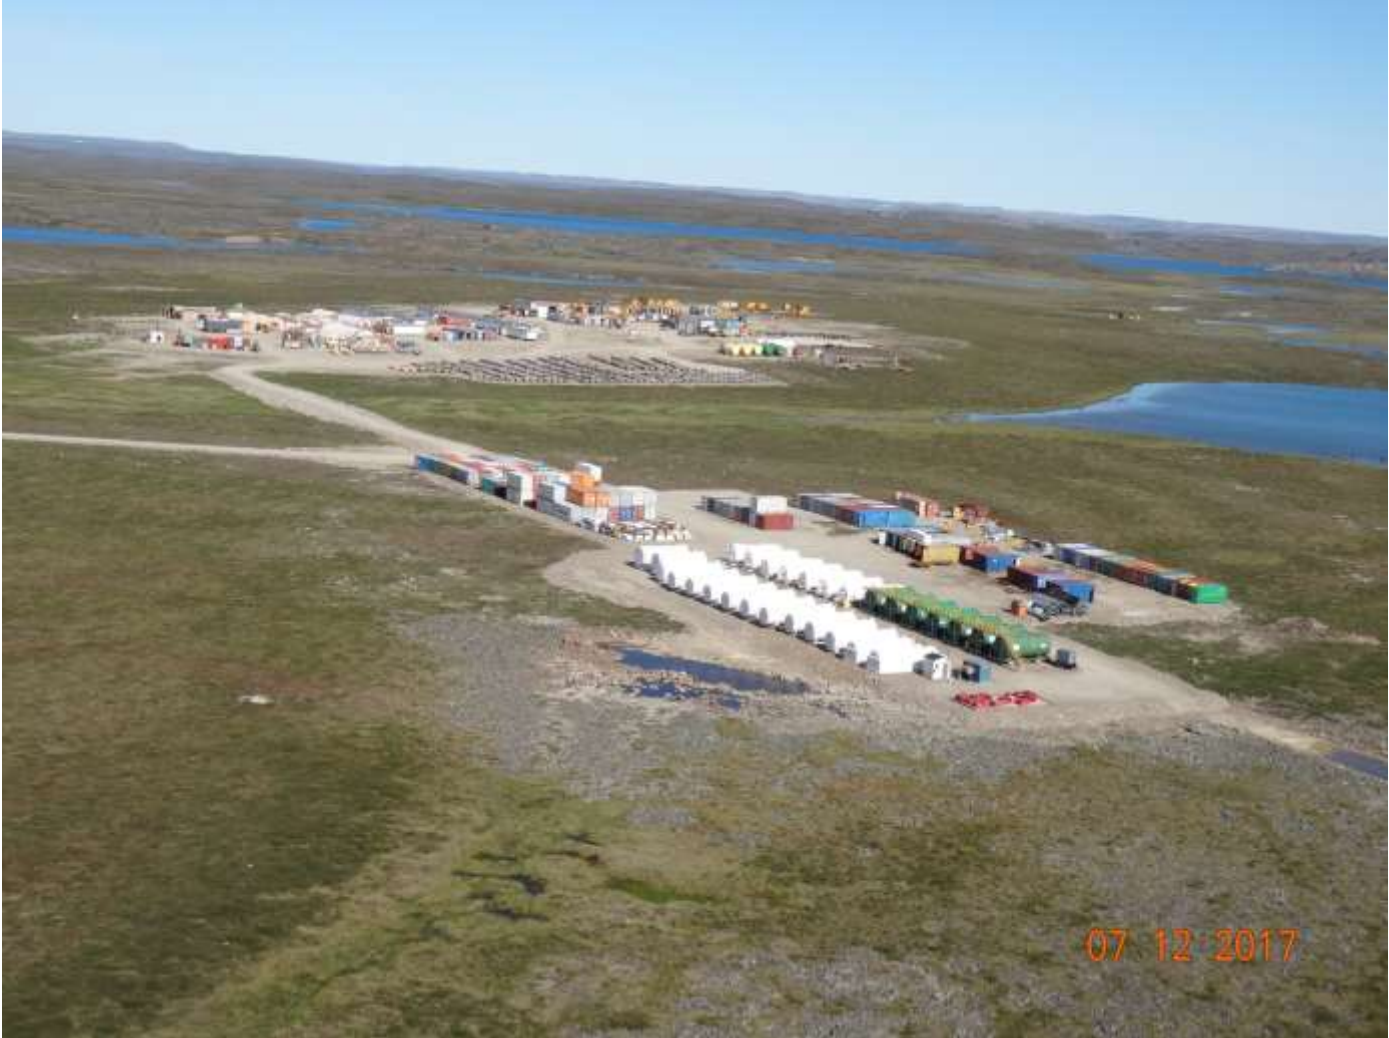
Date:	Authorization Number:	Camera/Model:	Inspector
July 12 2017	2BB-MEA1318	Sony DSC-HX50V Cyber shot	WRO Wilson
Photo No.	Lat/Long (DD.MM.SS.SS, NAD83)		
Photo 1	N65° 24' 2.34" , W 96° 40' 50.69"

Description:
Facing West- Amaruq Camp, tank farm/laydown

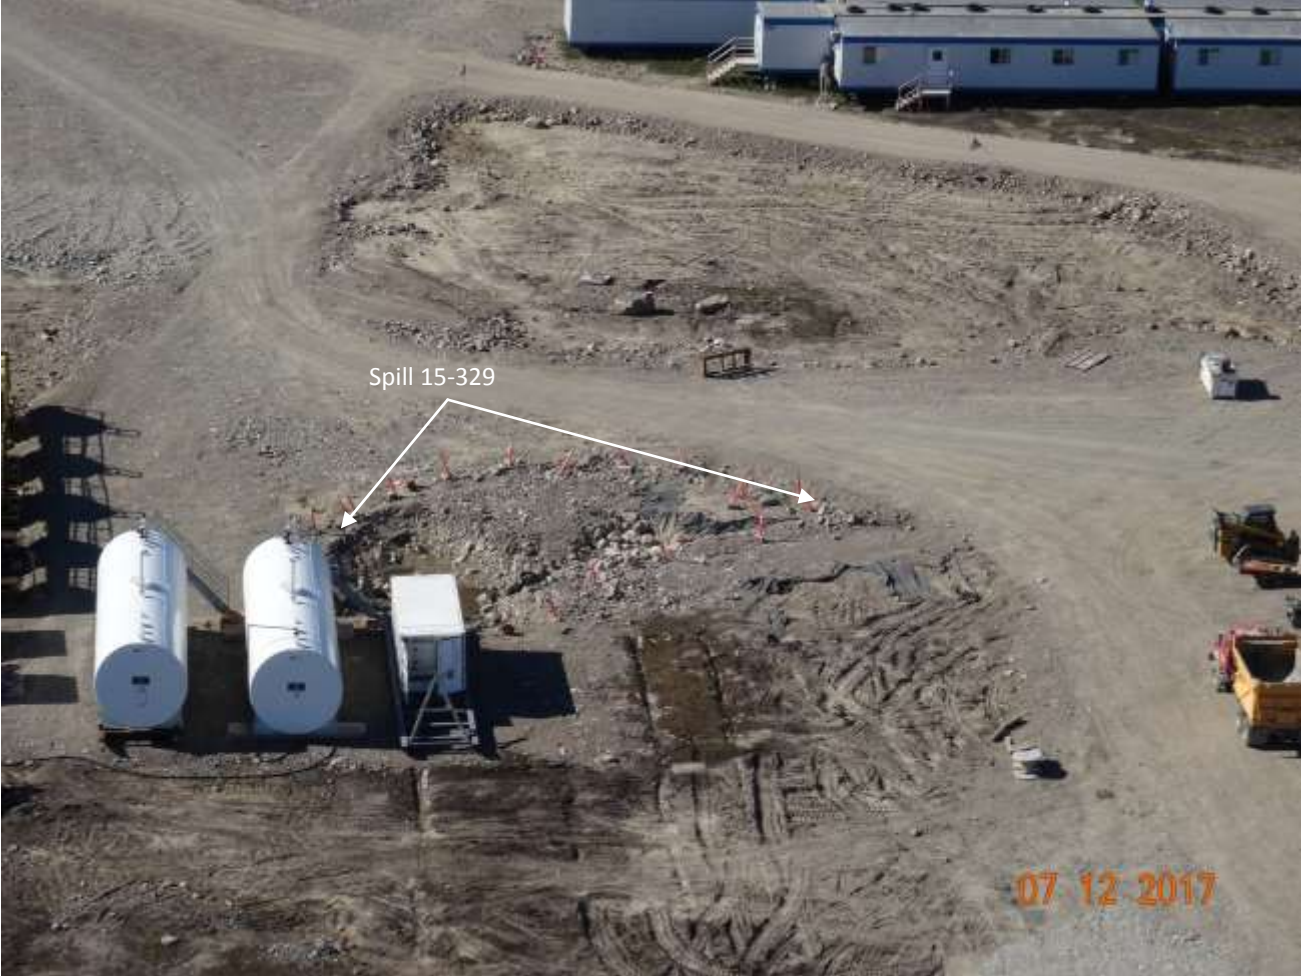
Photo No.	Lat/Long (DD.MM.SS.SS, NAD83)
Photo 2	N65° 23' 55.073" W 96° 40' 14.86"

Description:
Spill 15-329

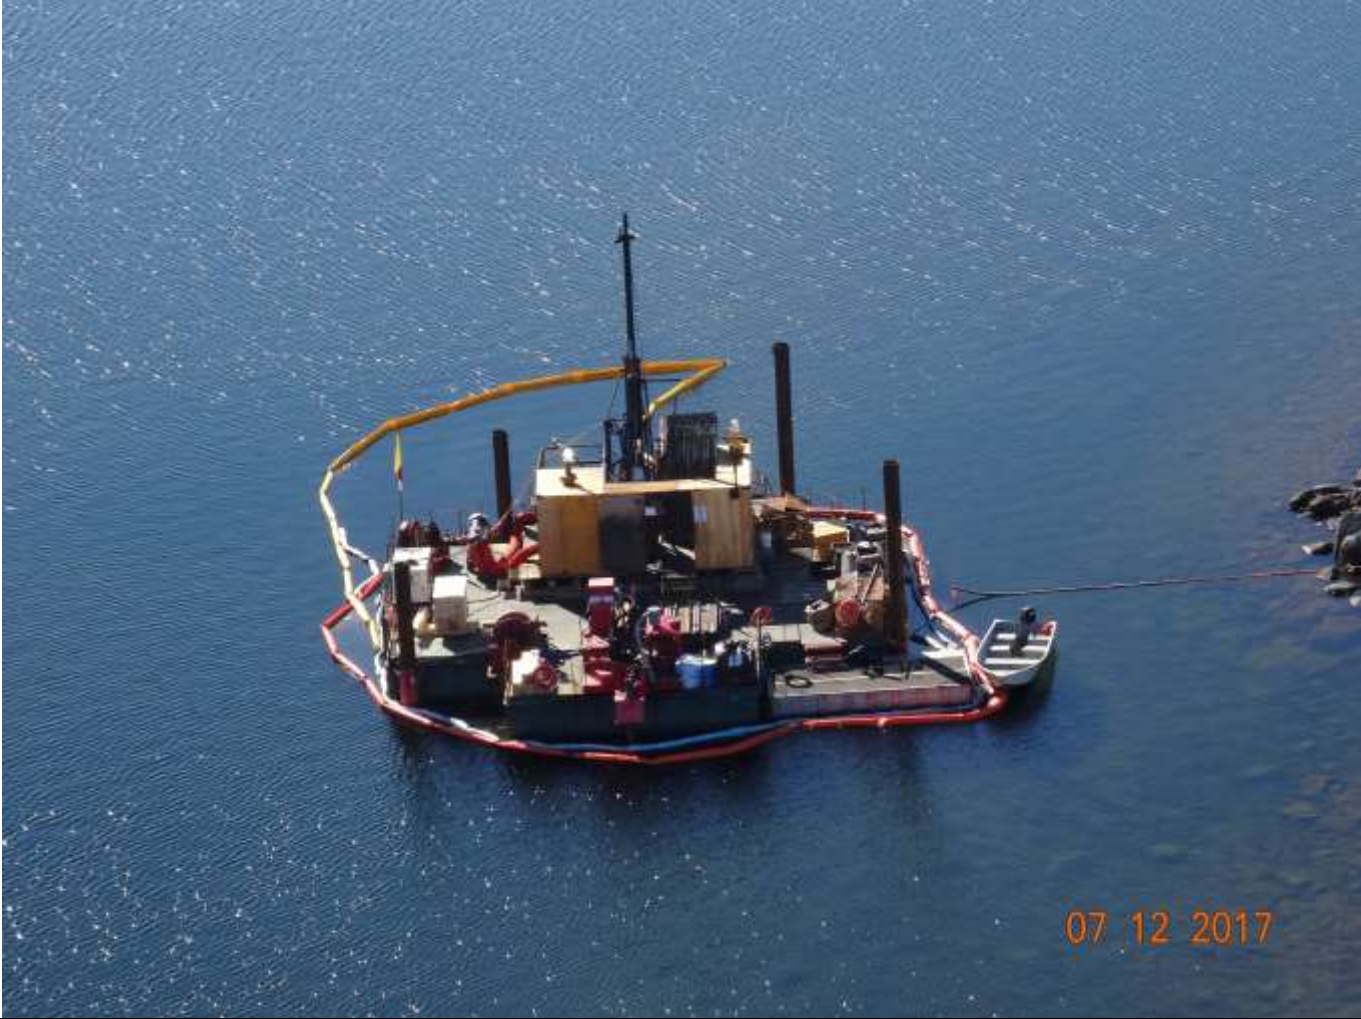
Photo No.
Photo 4

Description:
Barge on Whale Tail Lake

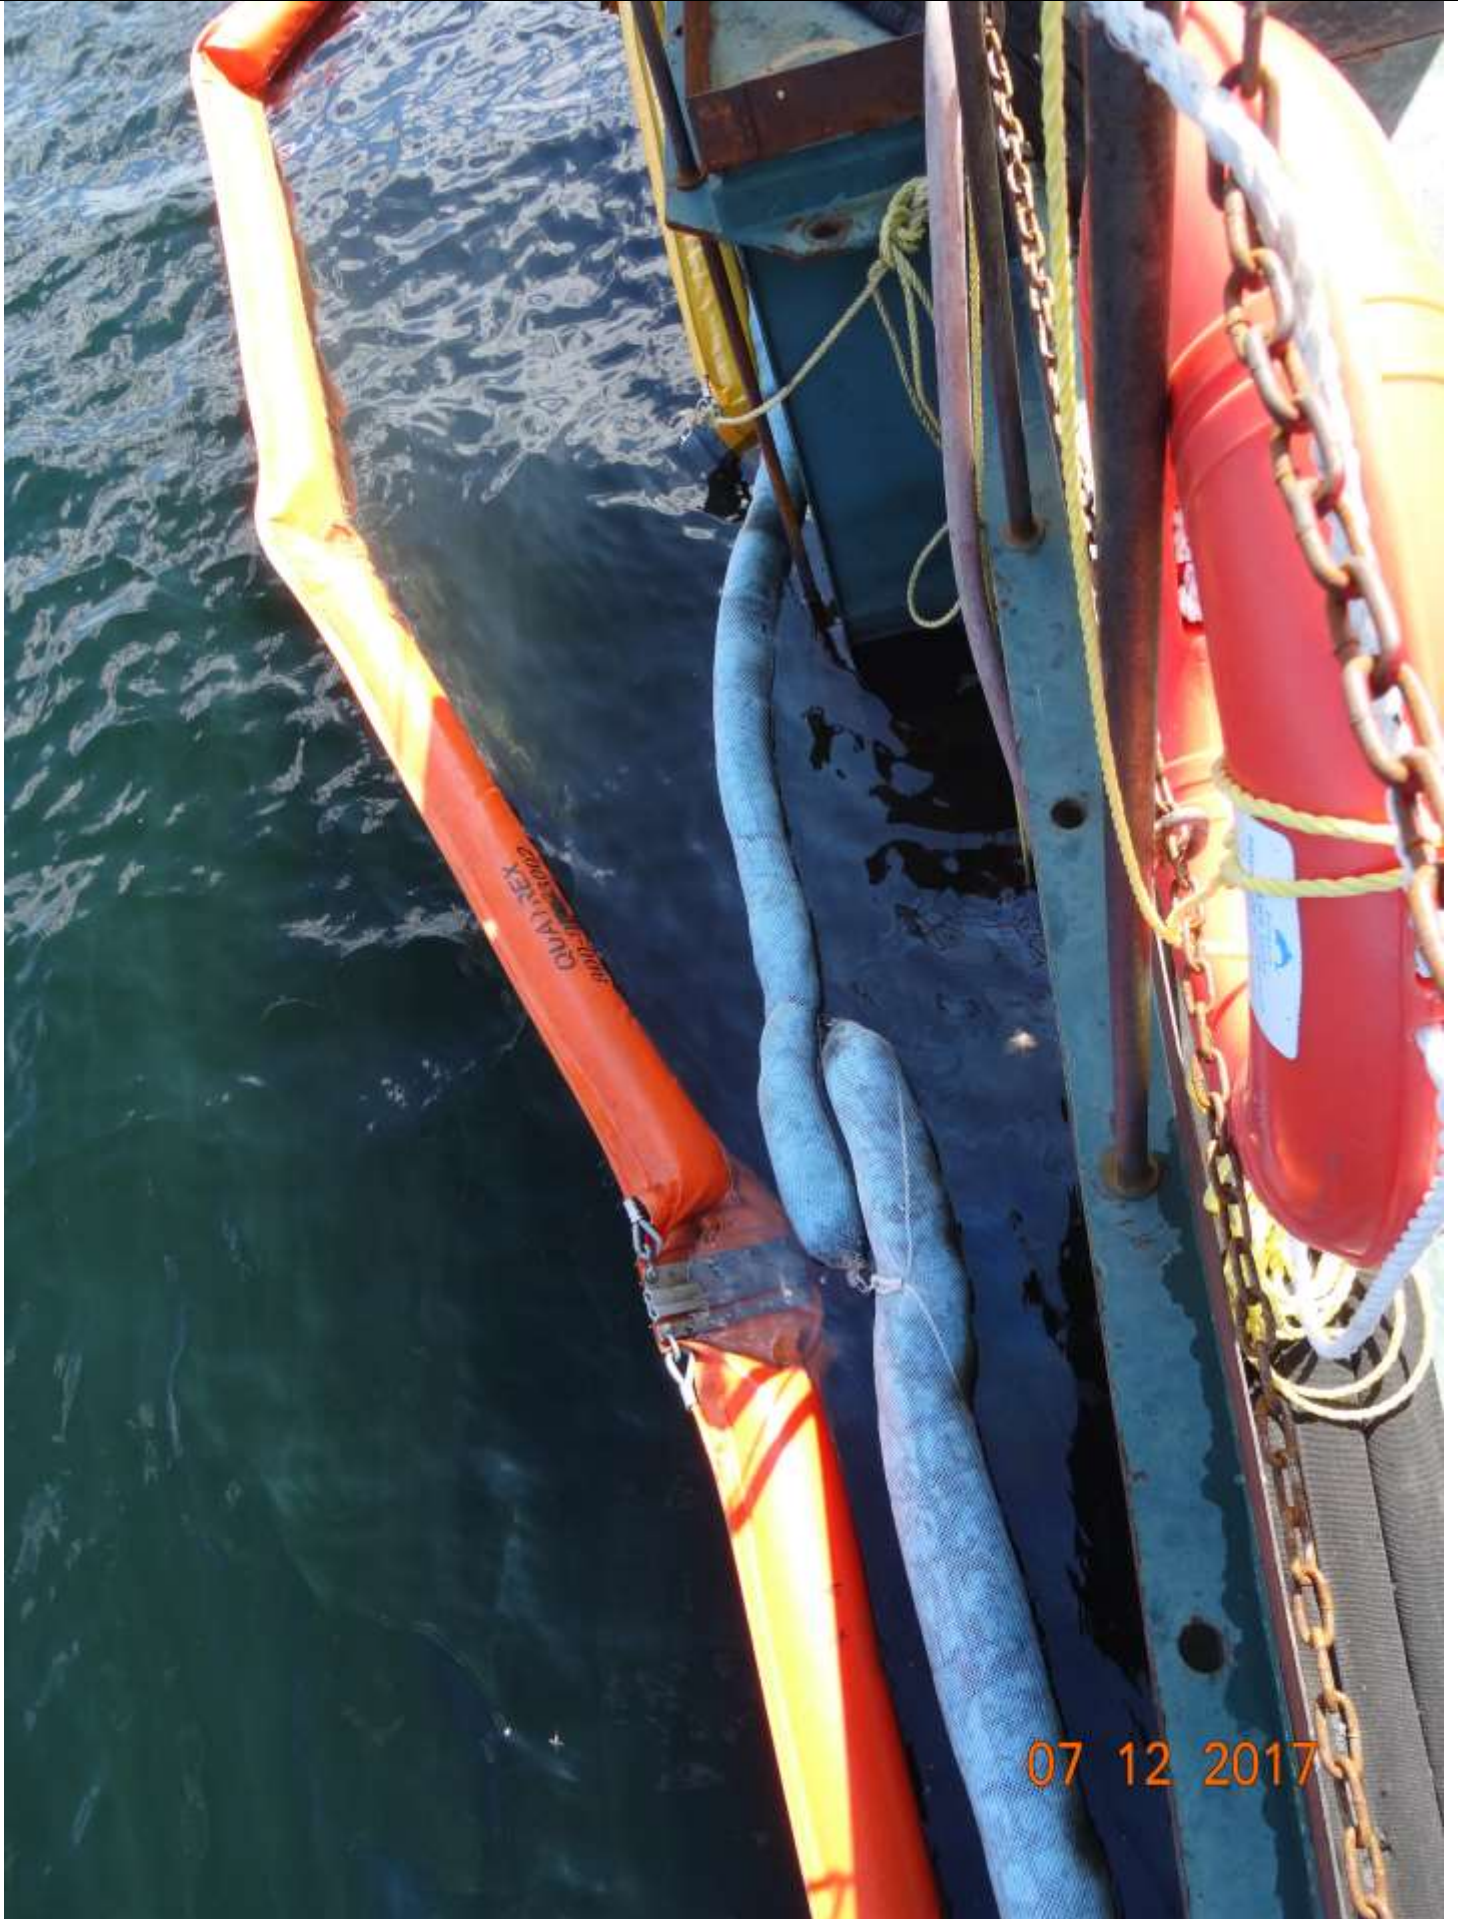
Photo 5

Floating berm and absorbent boom around barge. Visible sheen inside and outside of booms.

SECTION 2	<input type="checkbox"/> Comments (s. __)	<input checked="" type="checkbox"/> Non-Compliance with Act or Licence (s.2)	<input type="checkbox"/> Action Required (s. __)
<p>AEM will provide more information to the inspection regarding the corrective measures taken to address the hydrocarbon transfer from the barge to Whale Tail Lake in the annual report.</p>			
SECTION 3	<input type="checkbox"/> Comments (s. __)	<input type="checkbox"/> Non-Compliance with Act or Licence, (s. __)	<input checked="" type="checkbox"/> Action Required (s.3)
<p>— AEM will provide a date of completion for the removal of the contaminated soil being stored temporarily at the Amaruq exploration camp, to the inspector before August 25th, 2017.</p>

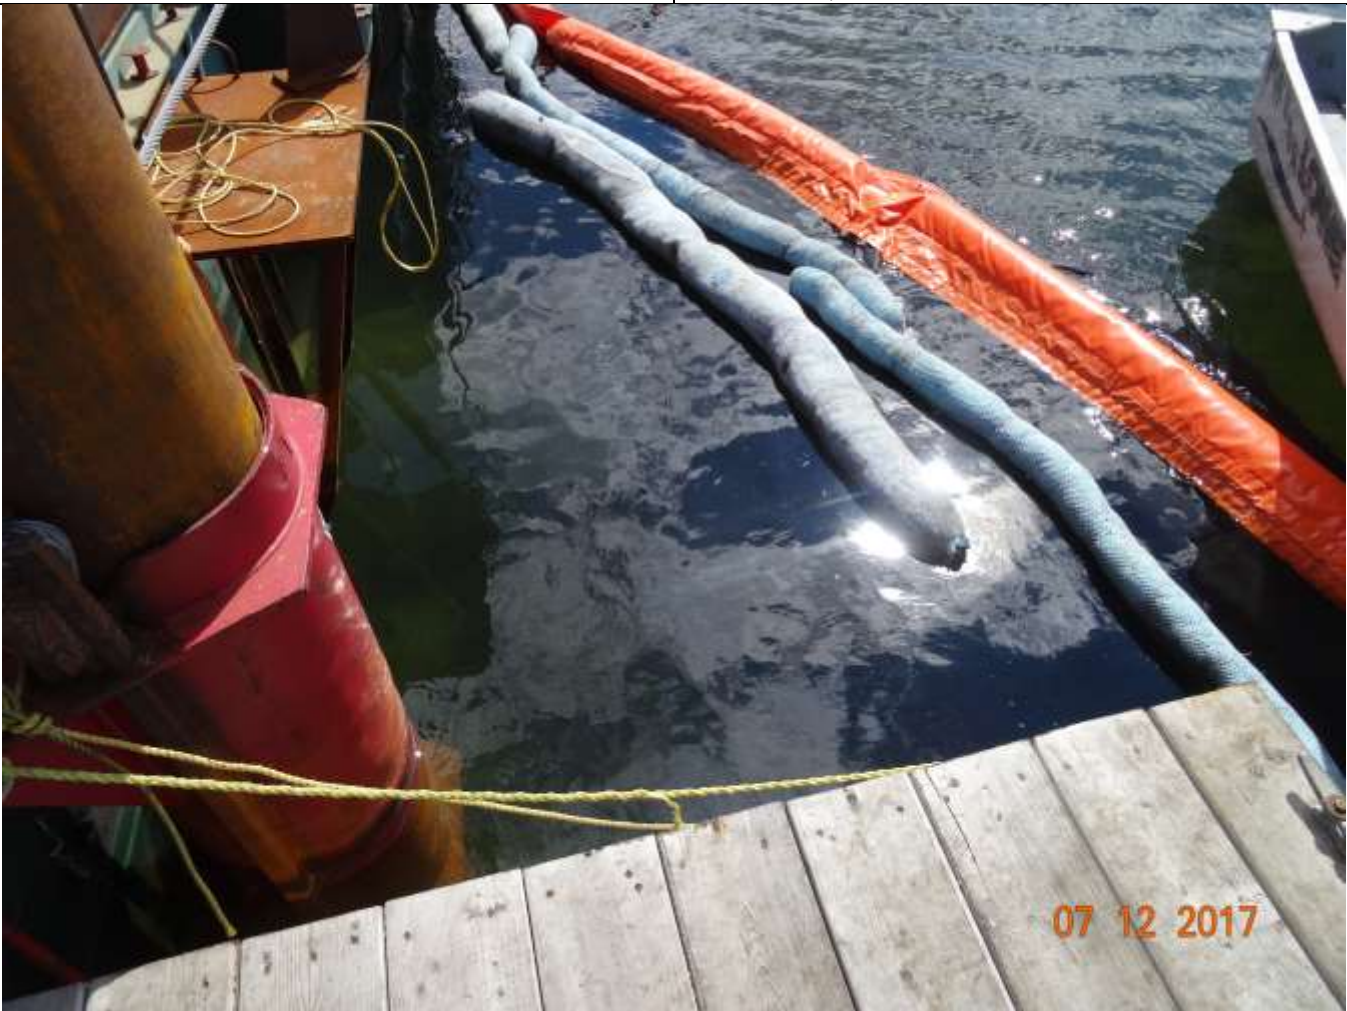
Photo No.
Photo 6

Description:
Sheen in water around barge

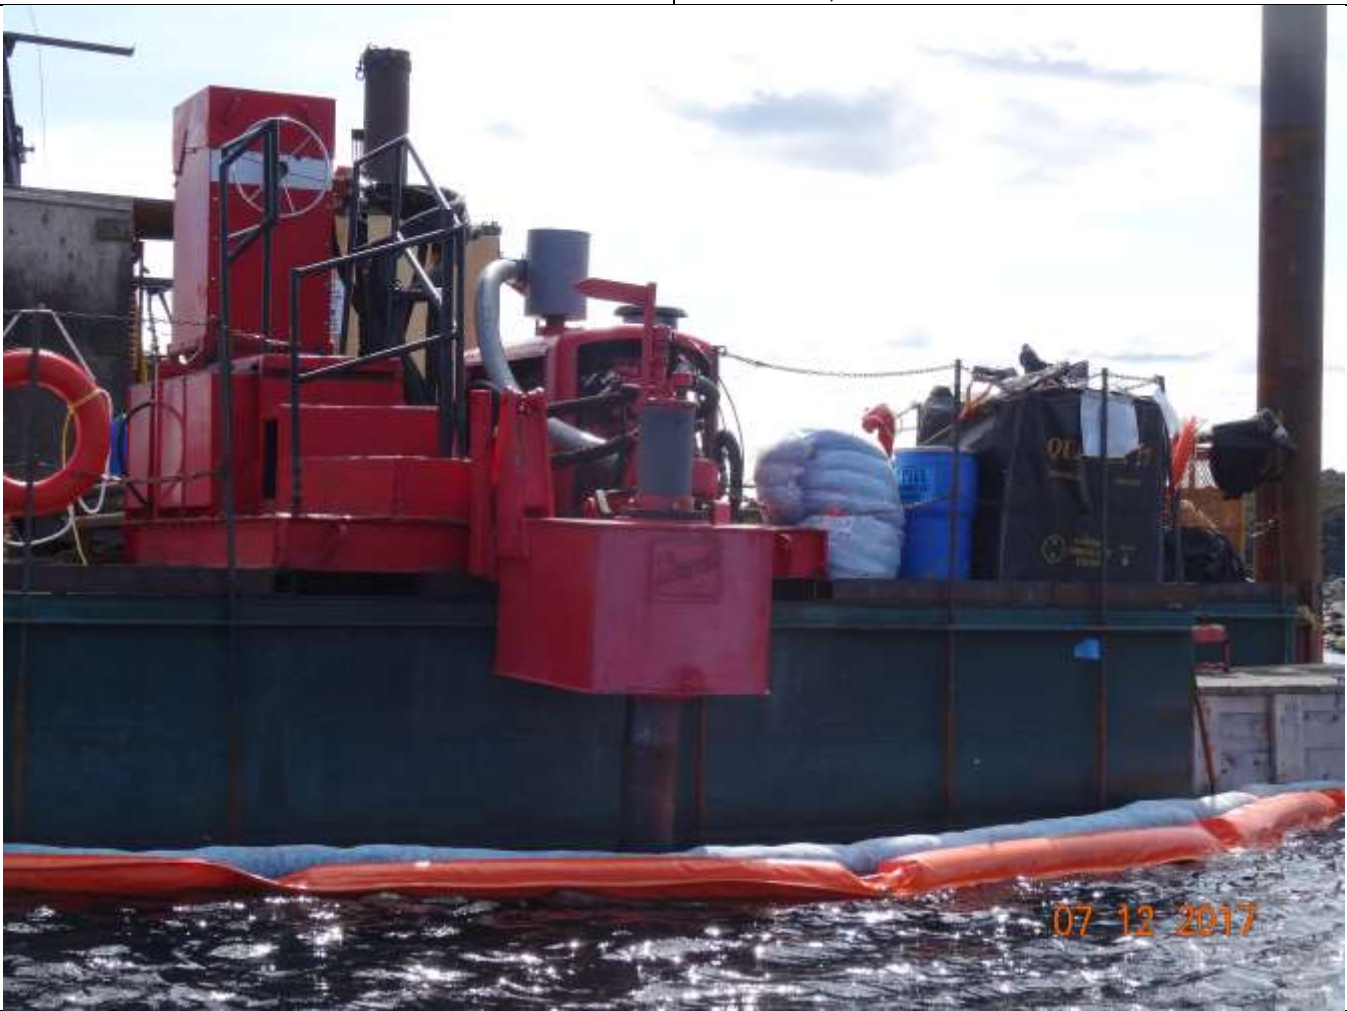
Photo No.
Photo 7

Description:
Turbidity curtain and absorbent booms around barge. Spill kits available for use.
