WATER LICENCE INSPECTION FORM

| Agnico Eagle Mines Limited | David Frenette |
| 2BB-MEA1318/ March 6 <sup>th</sup> , 2018 | Environmental Coordinator |
| July 12th, 2017 | WRO Wilson |

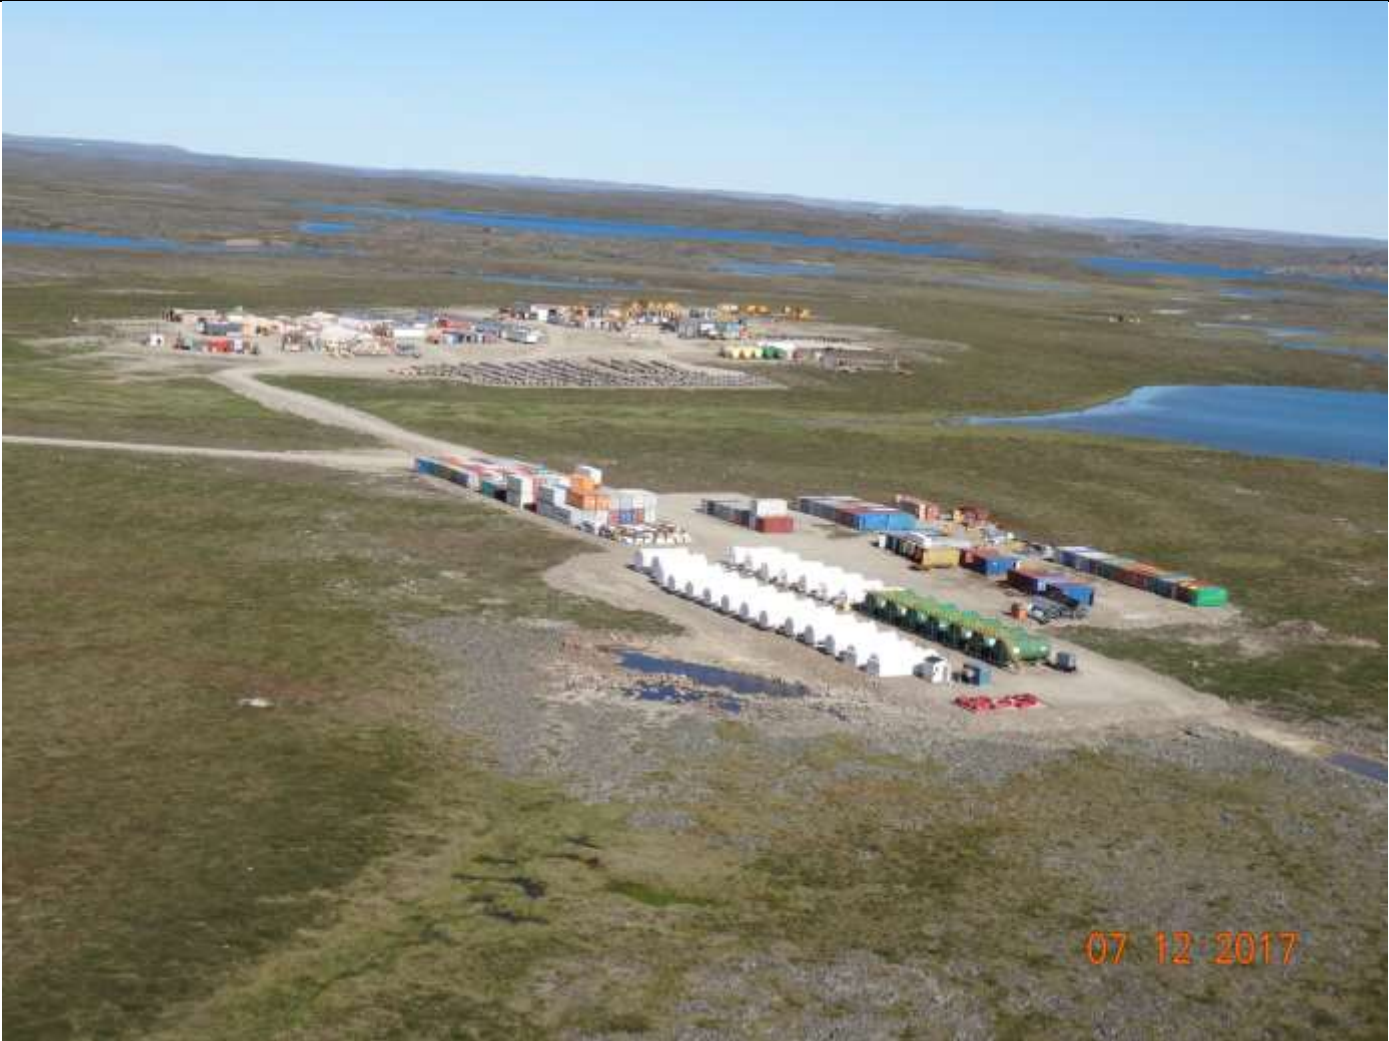
| Date: | Authorization Number: | Camera/Model: | Inspector |
|---|---|---|---|
| Photo 1 | N65° 24' 2.34", W 96° 40' 50.69" | | |

| <p>On July 12<sup>th</sup>, 2017, a regularly scheduled compliance inspection was conducted of Agnico Eagle Mines Ltd.'s Amaruq Project (photo 1) with the assistances of Agnico Eagle Mines Ltd. (AEM) Environmental Coordinator, David Frenette.</p> <p>The following report was produced with the observations noted during that inspection.</p> <p><i>Pre inspection meeting notes</i></p> <ul style="list-style-type: none"><li>-Current population of the camp is 107.</li><li>-Six drills in total are in operation; this includes the drill on the barge.</li><li>-There is at least one environmental staff onsite at all times.</li><li>-Material is being brought from Esker #7 to the camp to improve the durable ground in camp.</li></ul> <p><i>Observations</i></p> <ol style="list-style-type: none"><li>The reclamation of spill no. 15-329 is still ongoing (photo 2). The environment division collected samples of the spill excavation to confirm the location had been cleaned. The inspector noted an area close to the south end of jet A1 tank no. 9 which had a strong smell of fuel.</li><li>Contaminated soil is being stored in a temporary lined structure to avoid further contamination to the environment. AEM has extended the temporary structure a number of times to make additional room as spills occur.</li><li>Two spills have been inspected, spill no. 2017-171 a sewage spill from the Amaruq camp's sewage treatment system referred to as the 'Bionest', and spill no. 2017-180 a diesel spill at the Meadowbank exploration laydown located on the Meadowbank mine road. Both spill will be remain open and require a follow up inspection.</li><li>The culvert installation, which was constructed September 2015, at culvert crossing 181 between Amaruq Exploration Camp and the fuel farm, showed no sedimentation or erosion which is in compliance with PART C item 8.</li><li>The lay down pad for the fuel farm and seacan storage area is fully constructed and located on durable ground in compliance with PART E item 2.</li><li>Esker #7 respects the 31 meter limit from Whale Tail Lake on the West side of its boundaries, in compliance with PART E item 9. AEM observed some run off from the borrow and installed the appropriate erosion mitigation measures as per PART E item 10.</li><li>A drill is in operation on the barge in Whale Tail Lake at location N65° 24' 4.93", W96° 41' 55.0", which is approved in PART F item 4 (photo 4).</li><li>The barge is operated closer to shore to allow for the appropriate disposal of cuttings of 31m from the high water mark, in compliance with PART F item 1.</li><li>The barge operates with a turbidity curtain and a floating berm as a mitigative measure against a release of contaminates into Whale Tail Lake (photo 5).</li><li>A sheen is noted on the water inside and outside of the floating berm (photo 6). The inspector was concerned that the drilling equipment, greasy rags and barge deck was not clean of hydrocarbon after the recent spill, allowing transfer of contaminates to the water. The drill operators immediately address the inspector concerns by deploying absorbent matting and committed to addressing the concern moving forward (photo 7).</li><li>A gravel dissipation channel was constructed at the bionest outfall. The channel appears to be providing good guarding against erosion (photo 3).</li></ol> | | | |

Facing West- Amaruq Camp, tank farm/laydown

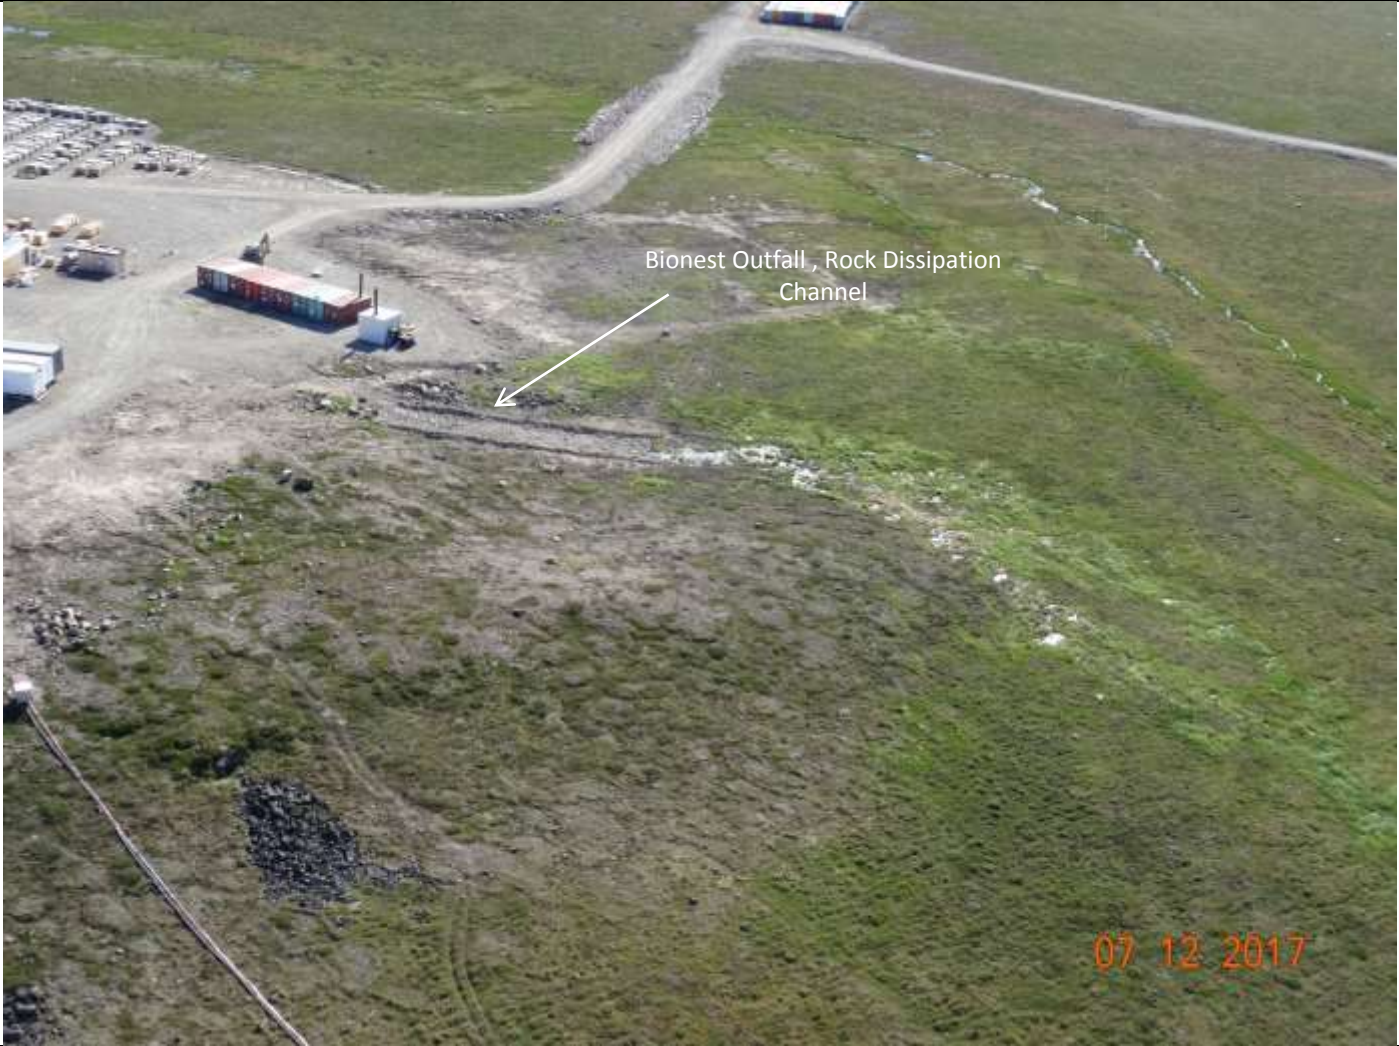
Photo No.  
Photo 3

Description:  
Rock dissipation channel, bionest outfall

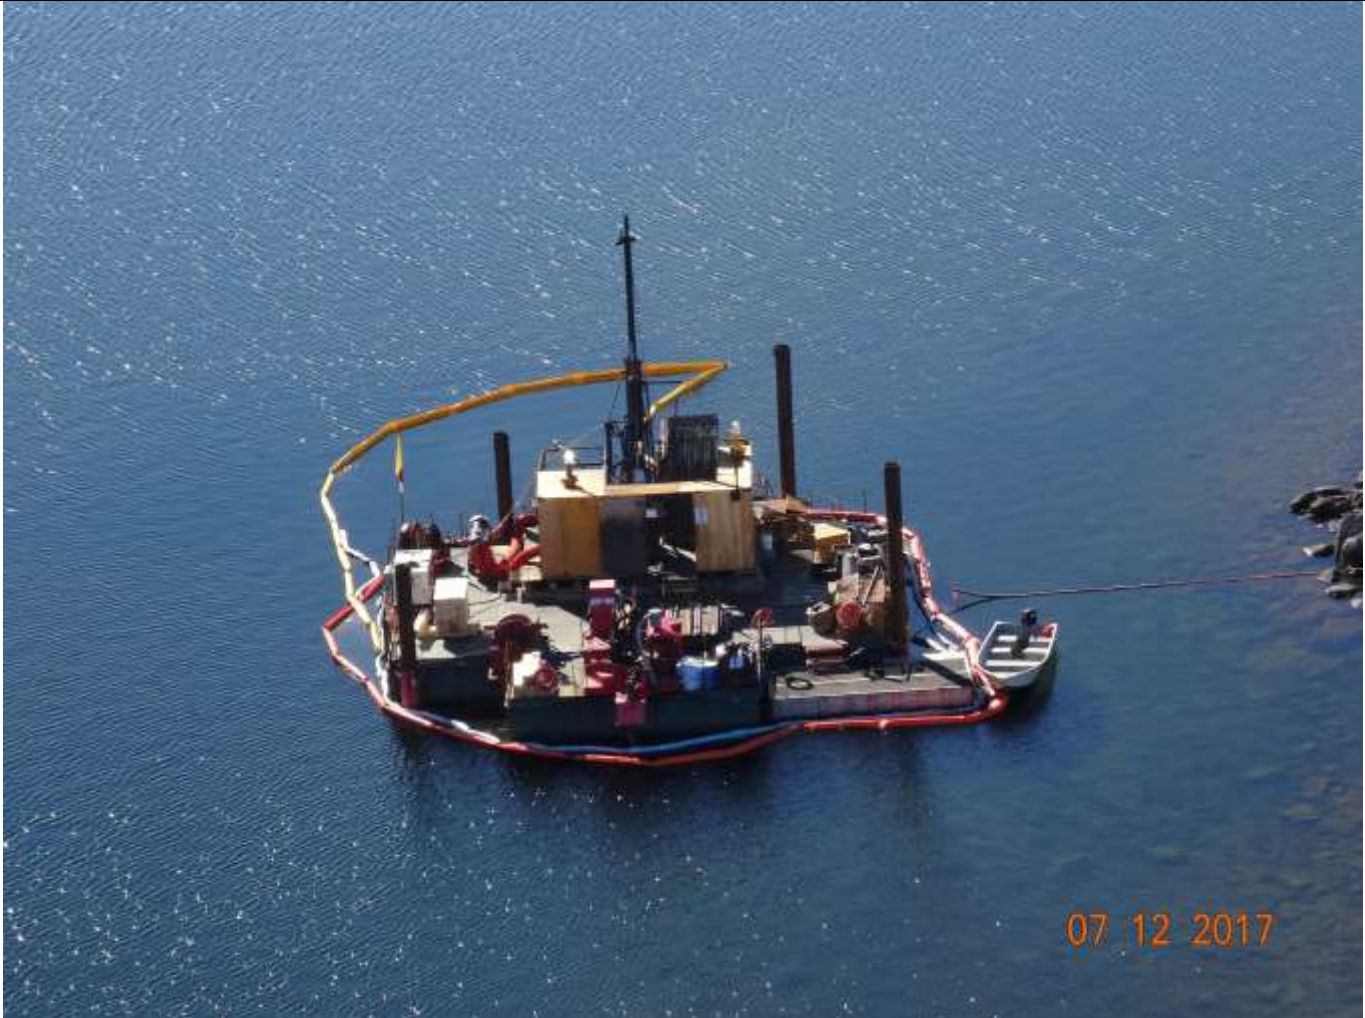
Photo No.  
Photo 4

Description:  
Barge on Whale Tail Lake

| <ul style="list-style-type: none"><li>AEM will provide a date of completion for the removal of the contaminated soil being stored temporarily at the Amaruq exploration camp, to the inspector before August 25<sup>th</sup>, 2017.</li><li>AEM will provide more information to the inspection regarding the corrective measures taken to address the hydrocarbon transfer from the barge to Whale Tail Lake in the annual report.</li></ul> | | | |

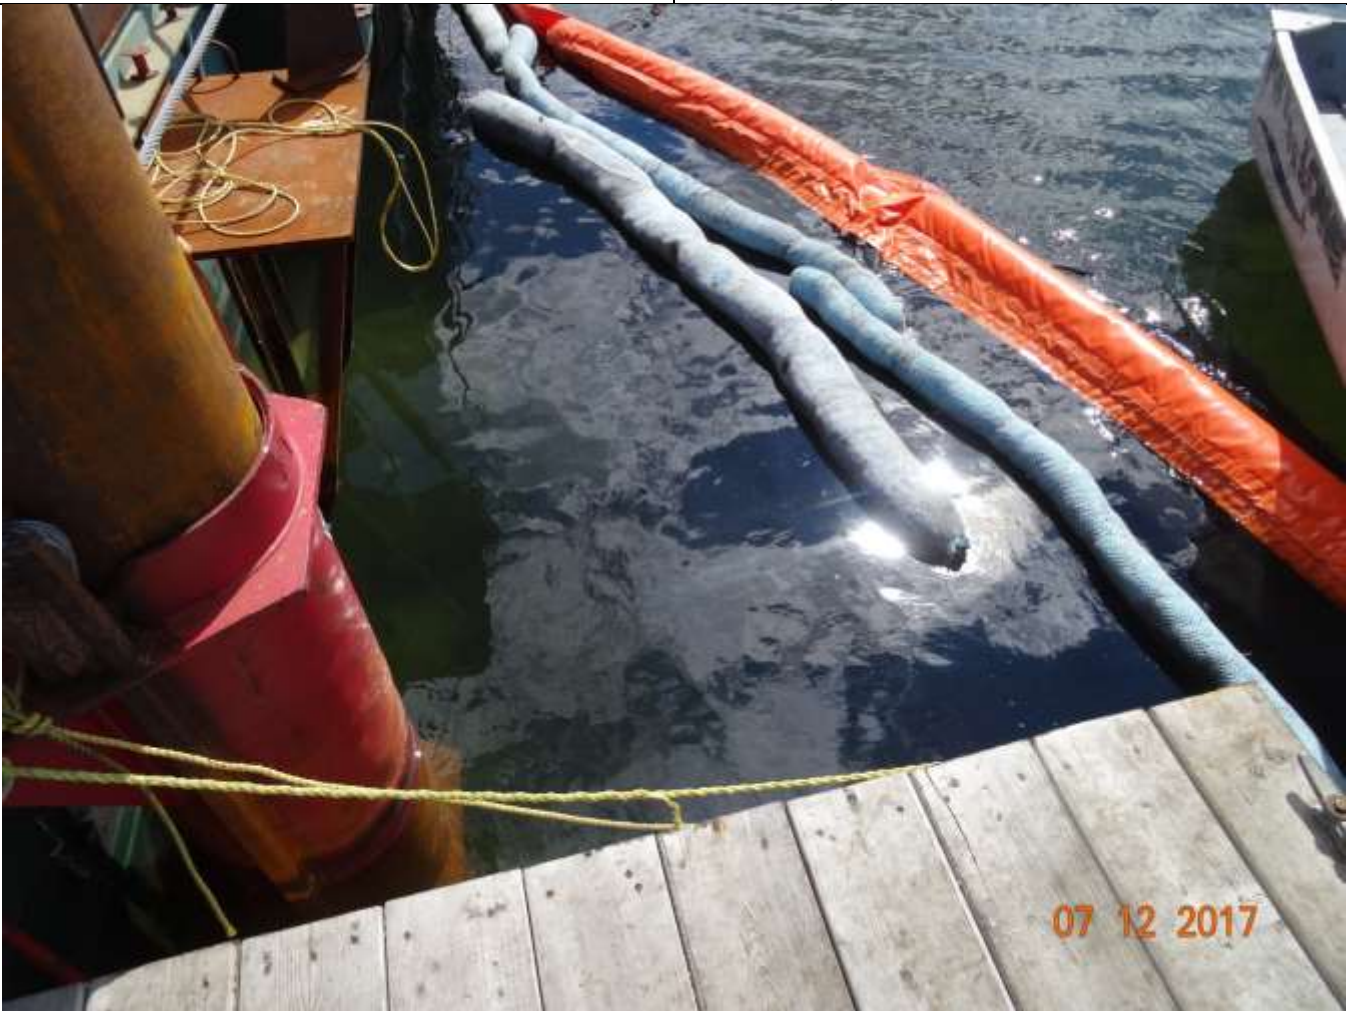
Photo No.  
Photo 6

Description:  
Sheen in water around barge

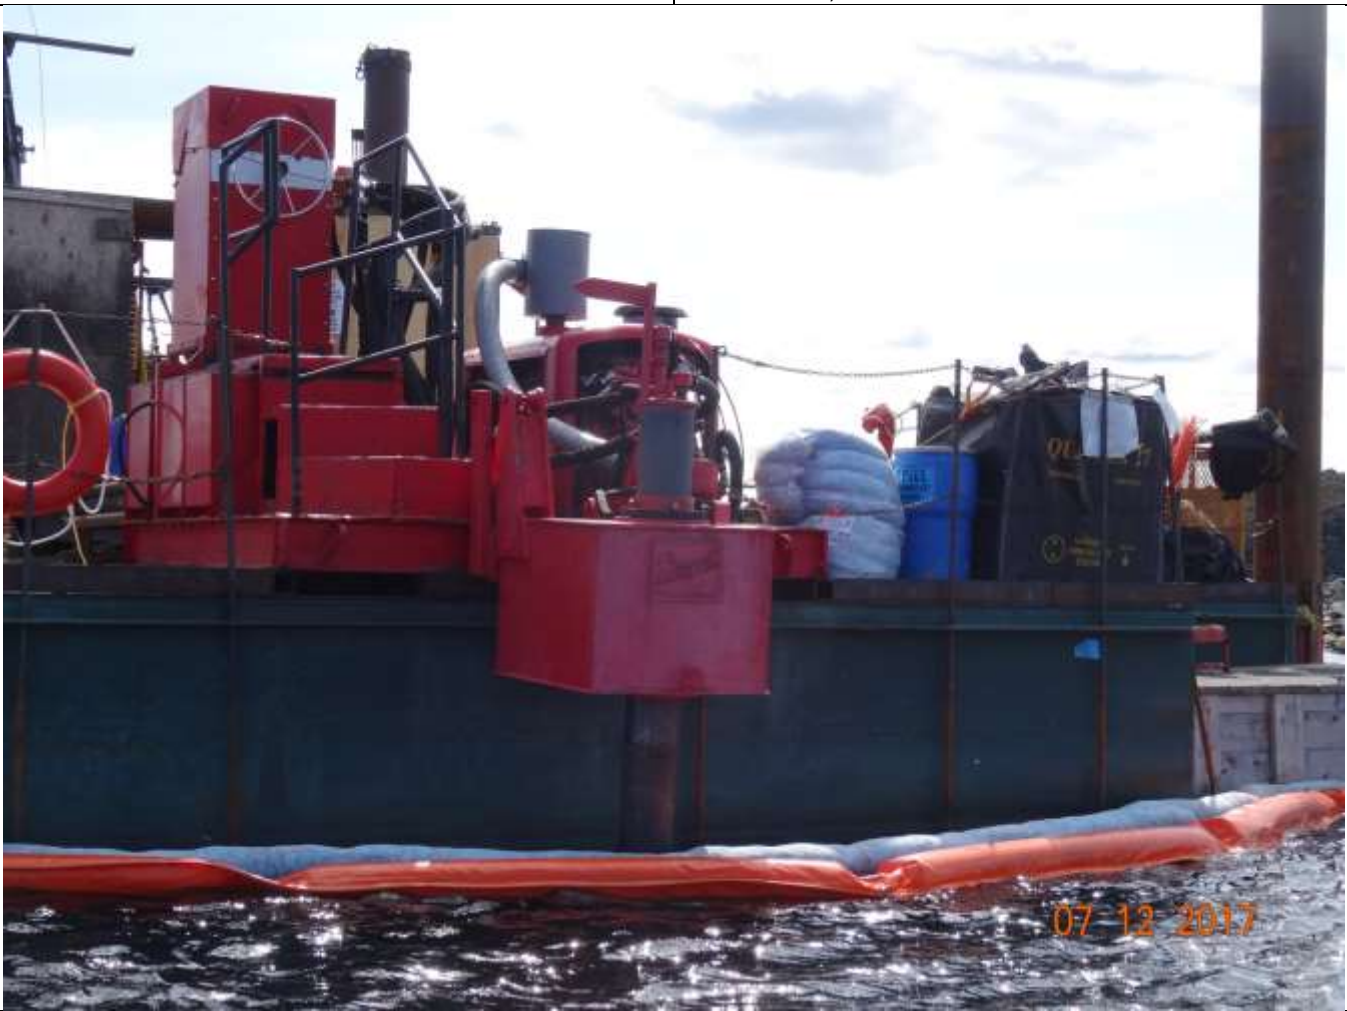
Photo No.  
Photo 7

Description:  
Turbidity curtain and absorbent booms around barge. Spill kits available for use.
