☒ Original
☐ Follow-Up Report

Attached:

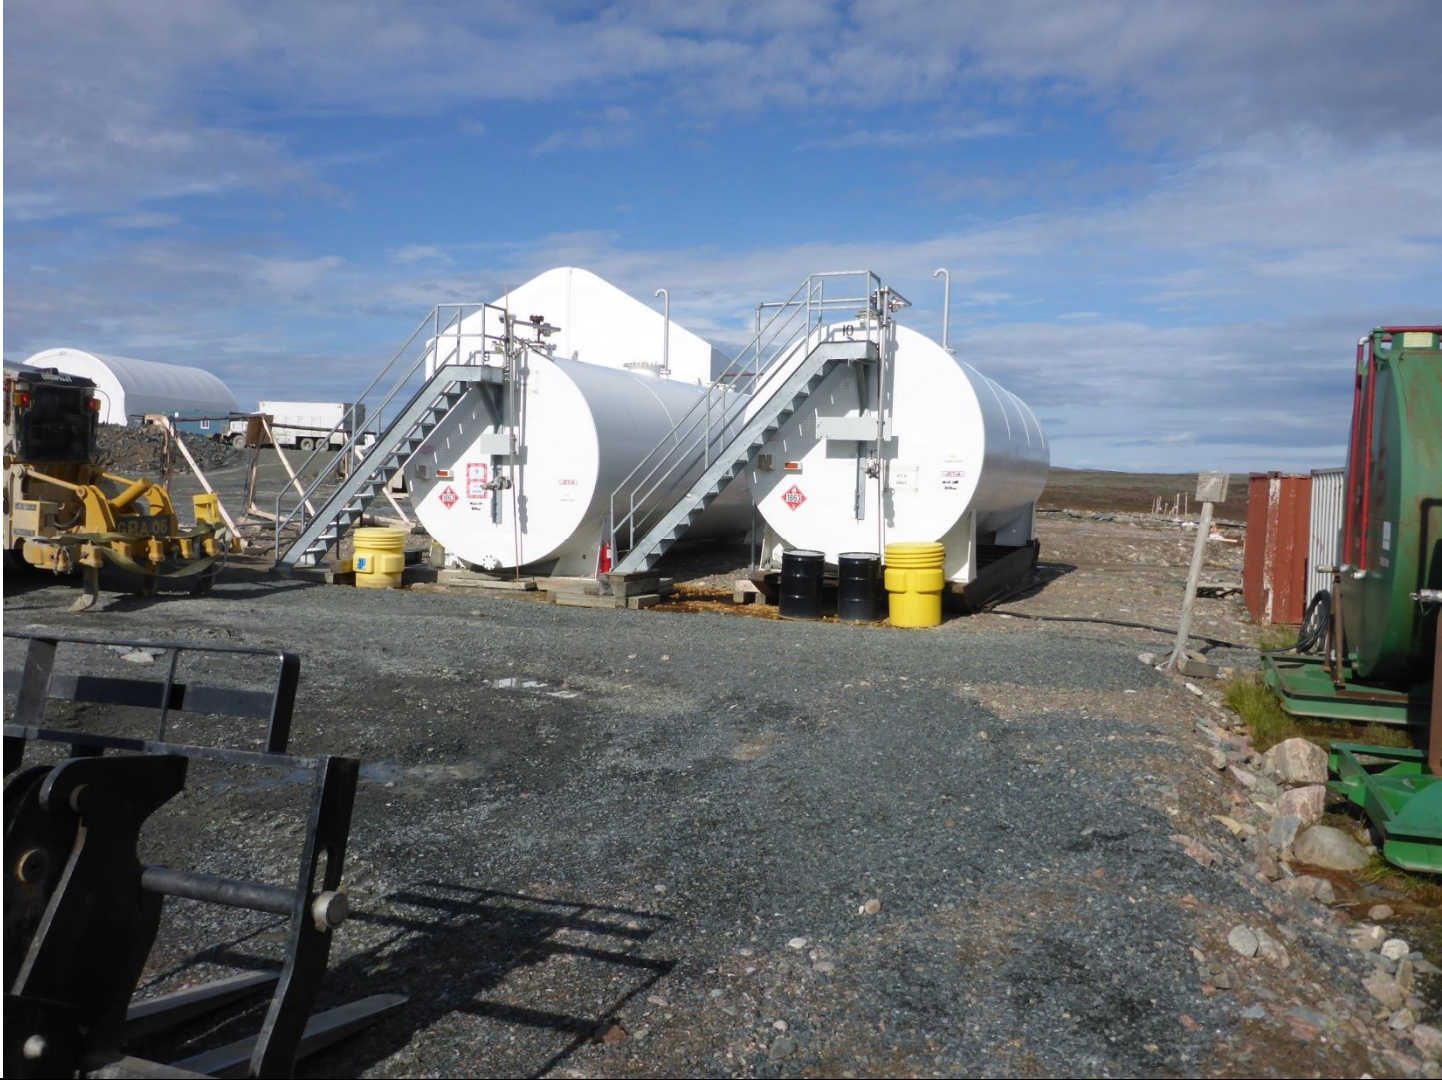
Date:	Authorization Number:	Camera/Model:	Inspector
August 28 th , 2018	2BB-MEA1828	Panasonic Lumix DMC-TS5	WRO Morton
Photo No.	Lat/Long (DD.MM.SS.SS, NAD83)		
Photo 1

Description:
Fuel storage area located northeast of the Amaruq camp.

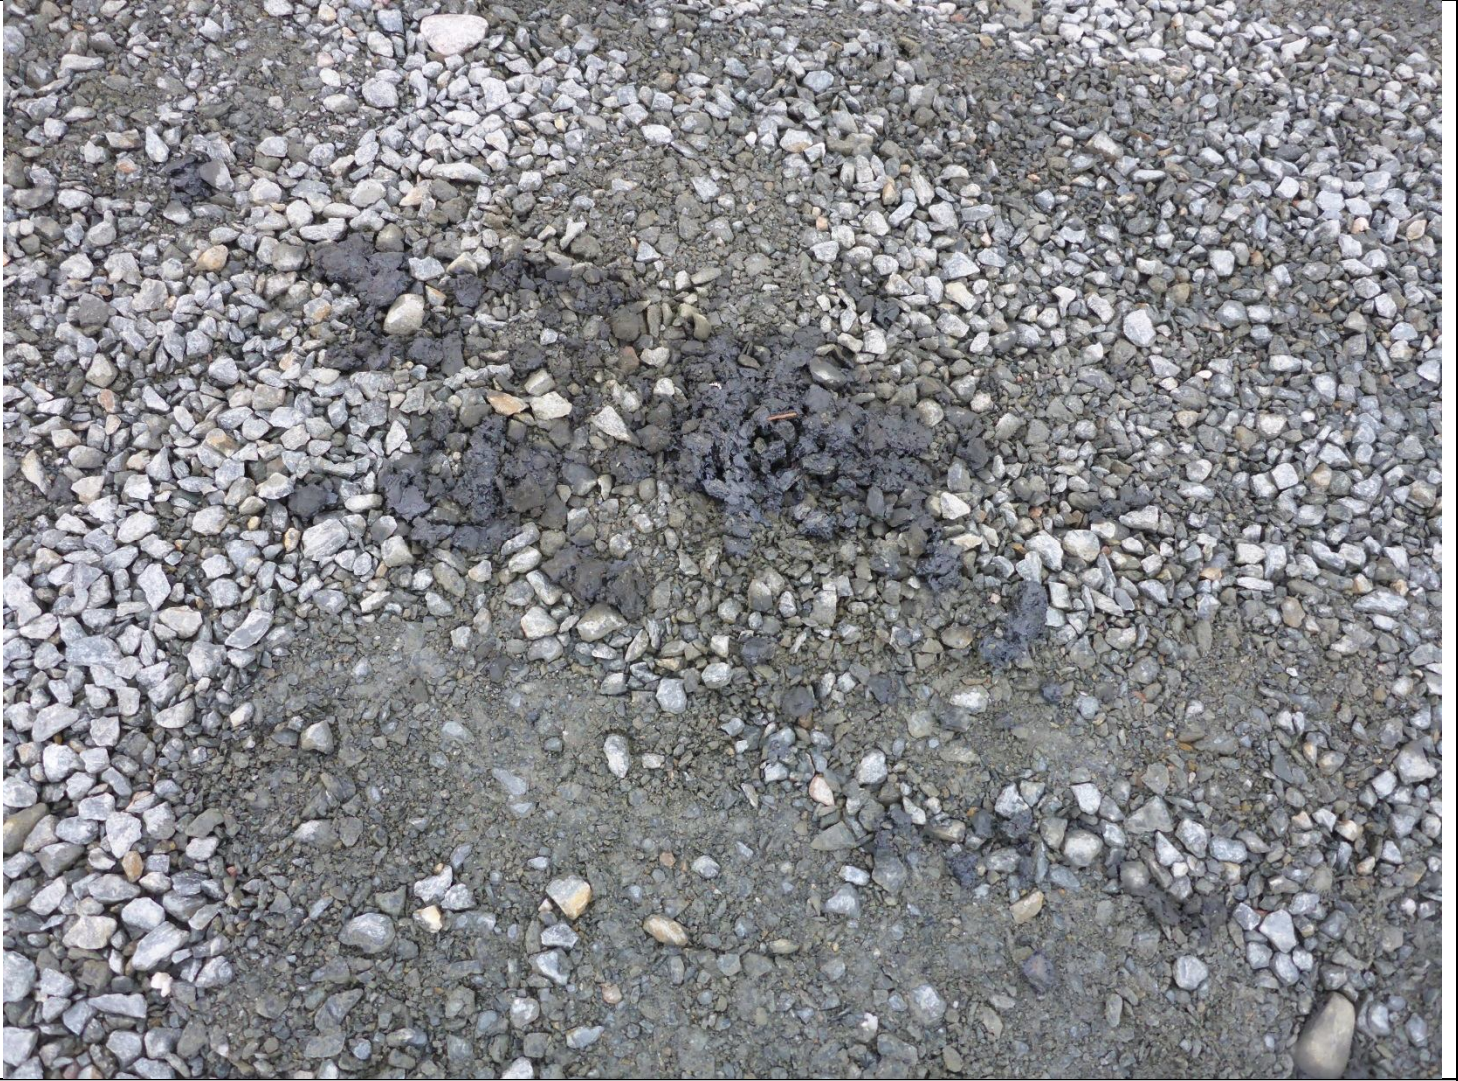
Photo No.	Lat/Long (DD.MM.SS.SS, NAD83)
Photo 2

Description: Small hydrocarbon staining located near the camp.
--

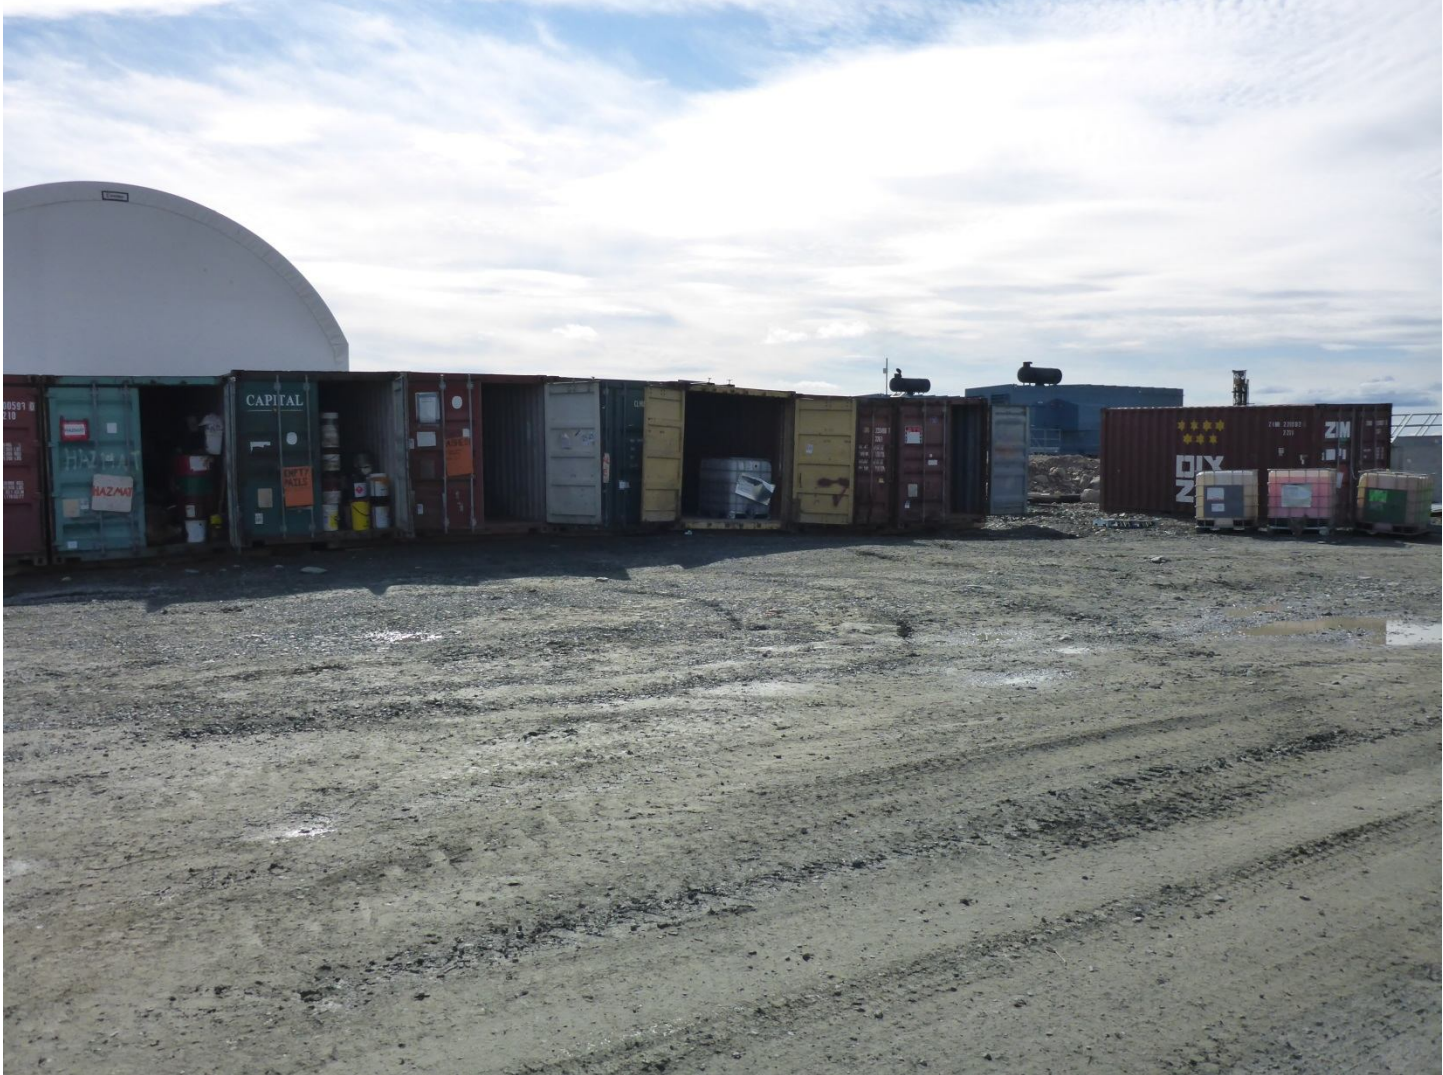
Date:	Authorization Number:	Camera/Model:	Inspector
August 29 th , 2018	2BB-MEA1828	Panasonic Lumix DMC-TS5	WRO Morton
Photo No.	Lat/Long (DD.MM.SS.SS, NAD83)		
Photo 3

Description:
Overview of the Amaruq camp hazardous waste storage area.

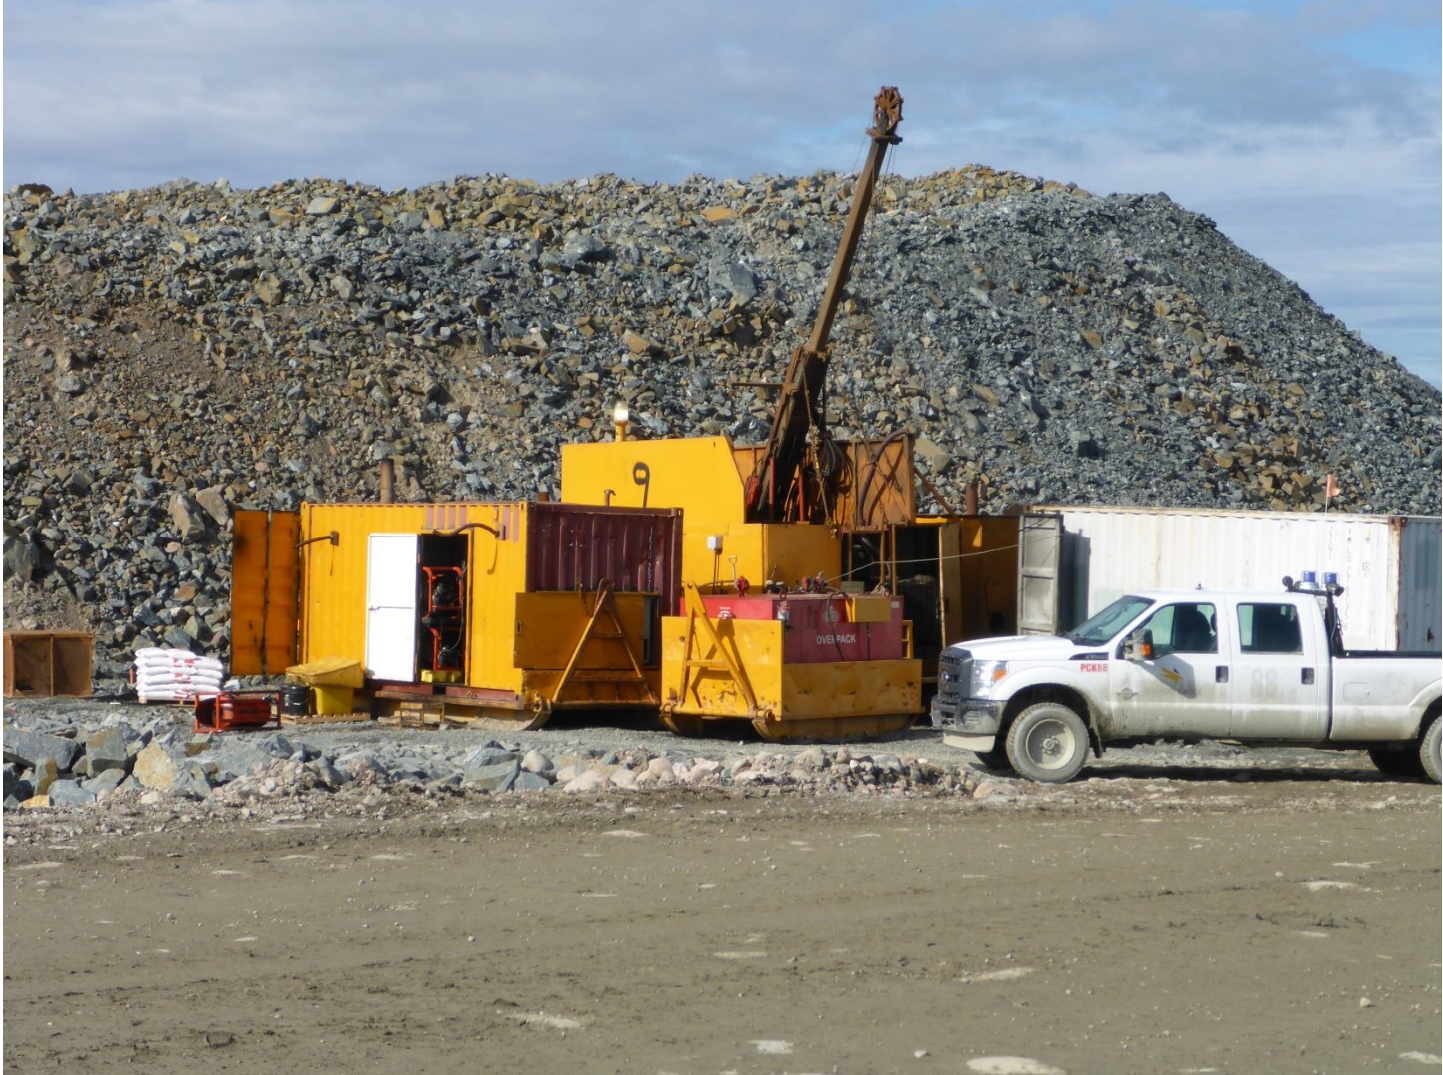
Date:	Authorization Number:	Camera/Model:	Inspector
August 29 th , 2018	2BB-MEA1828	Panasonic Lumix DMC-TS5	WRO Morton
Photo No.		Lat/Long (DD.MM.SS.SS, NAD83)	
Photo 4

Description:
Overview of drill located near the Amaruq Camp.

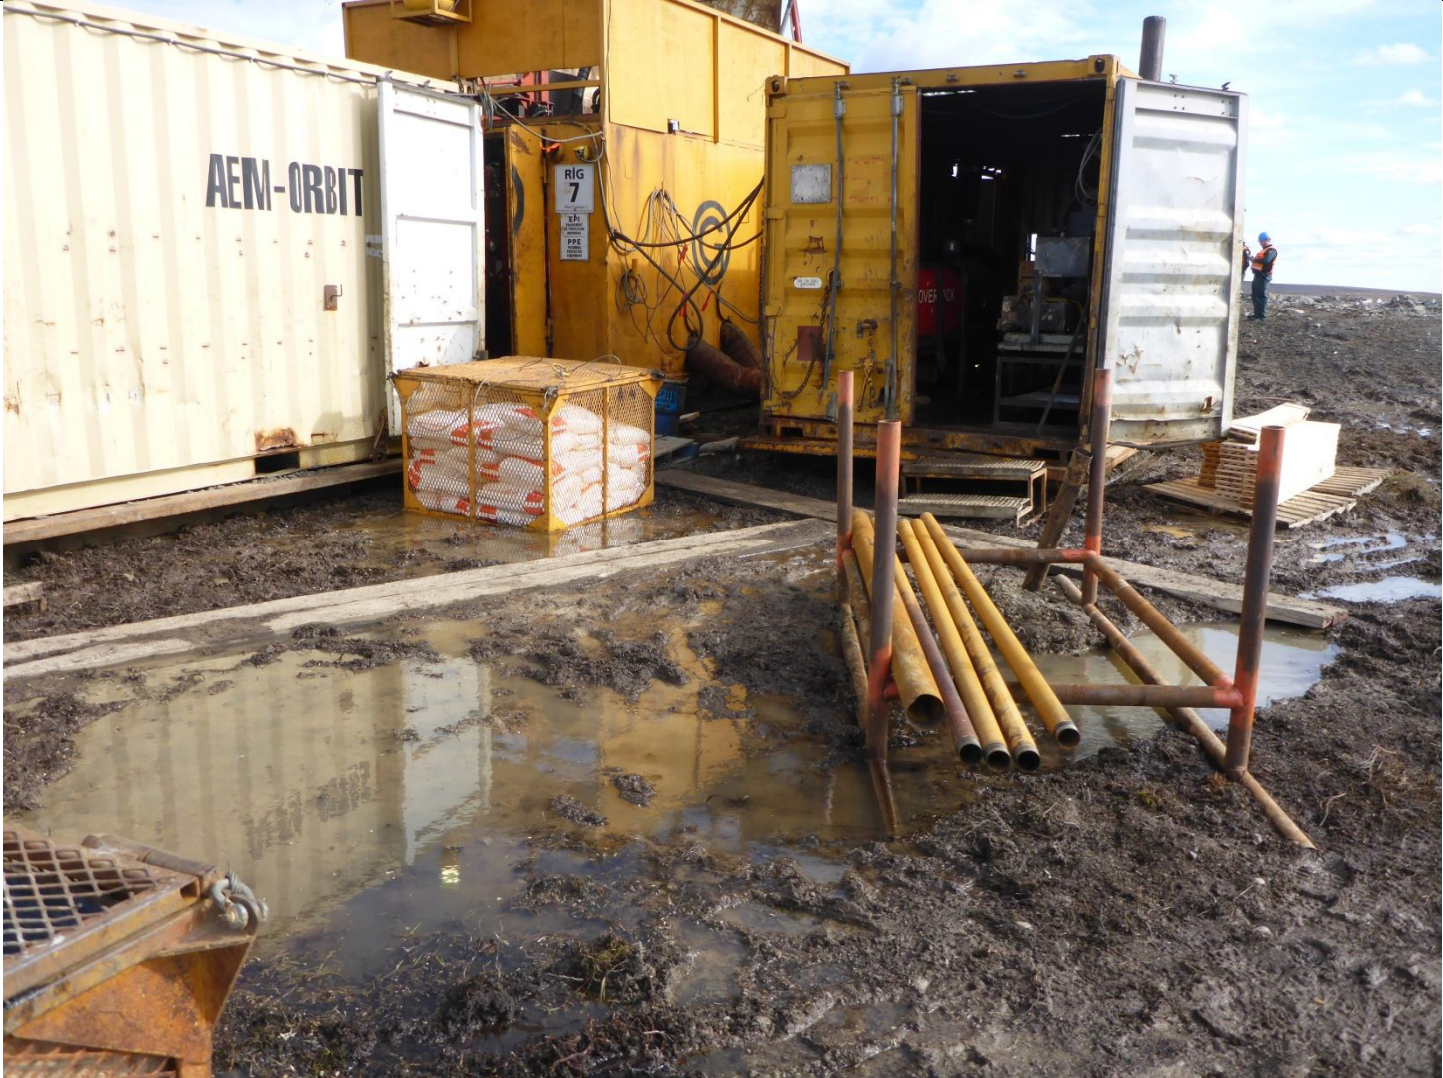
Date:	Authorization Number:	Camera/Model:	Inspector
August 29 th , 2018	2BB-MEA1828	Panasonic Lumix DMC-TS5	WRO Morton
Photo No.	Lat/Long (DD.MM.SS.SS, NAD83)		
Photo 5

Description:
Overview of the area surrounding the exploration drill.

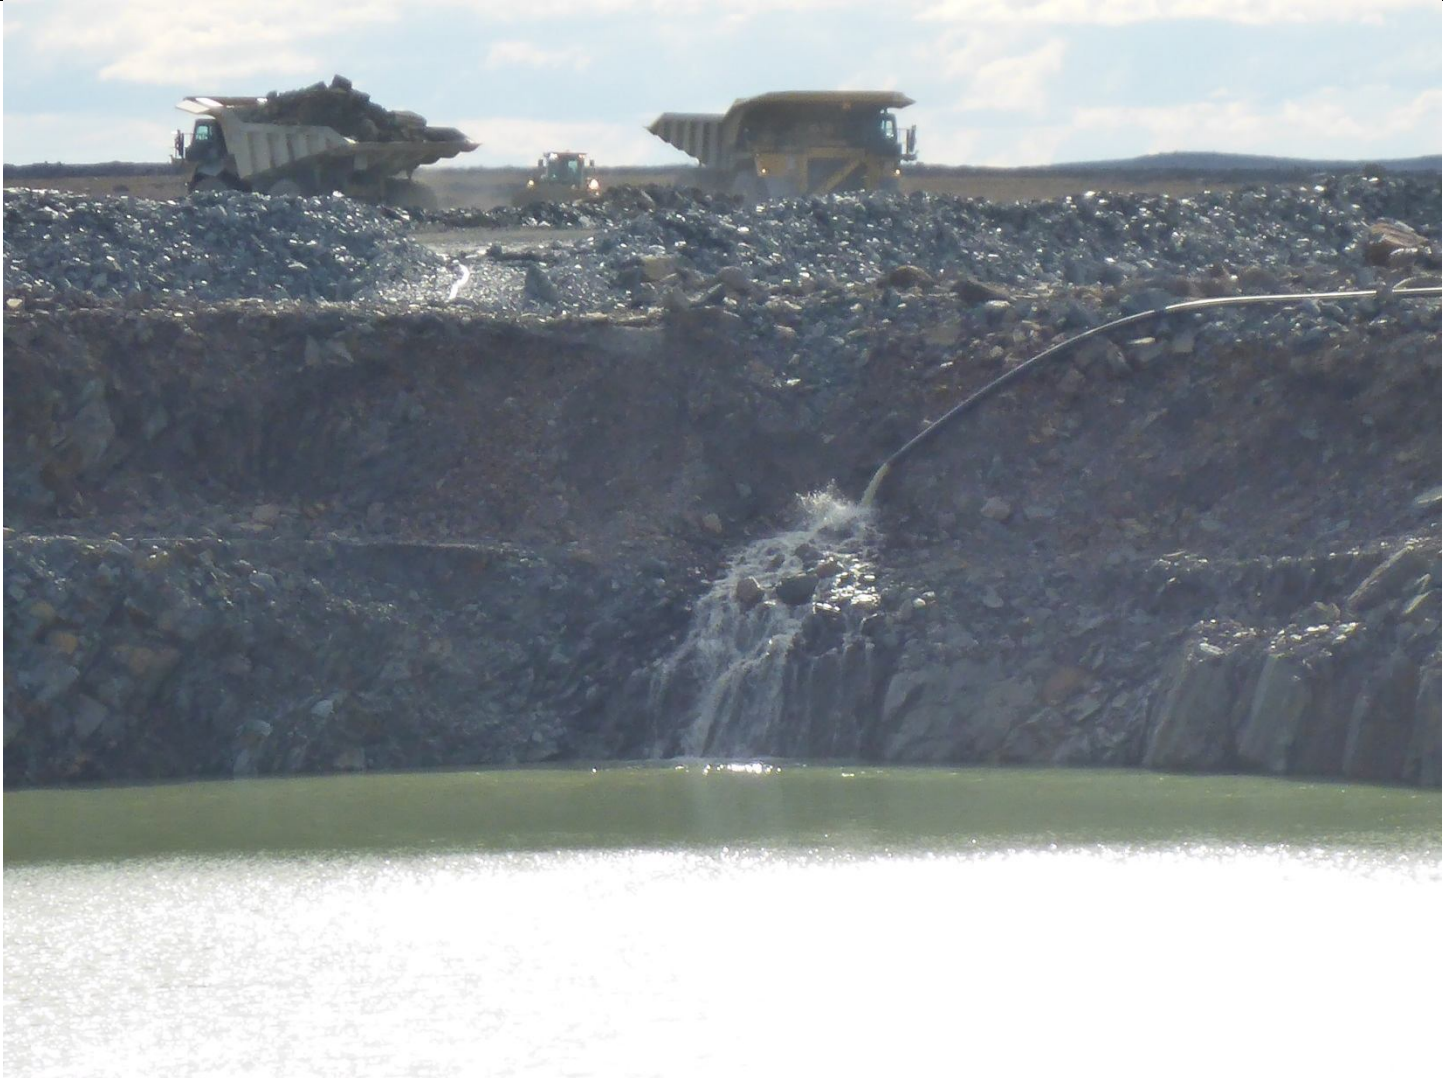
Date:	Authorization Number:	Camera/Model:	Inspector
August 29 th , 2018	2BB-MEA1828	Panasonic Lumix DMC-TS5	WRO Morton
Photo No.		Lat/Long (DD.MM.SS.SS, NAD83)	
Photo 6

Description:
Active flooding of the storm water storage pond (AP-5).

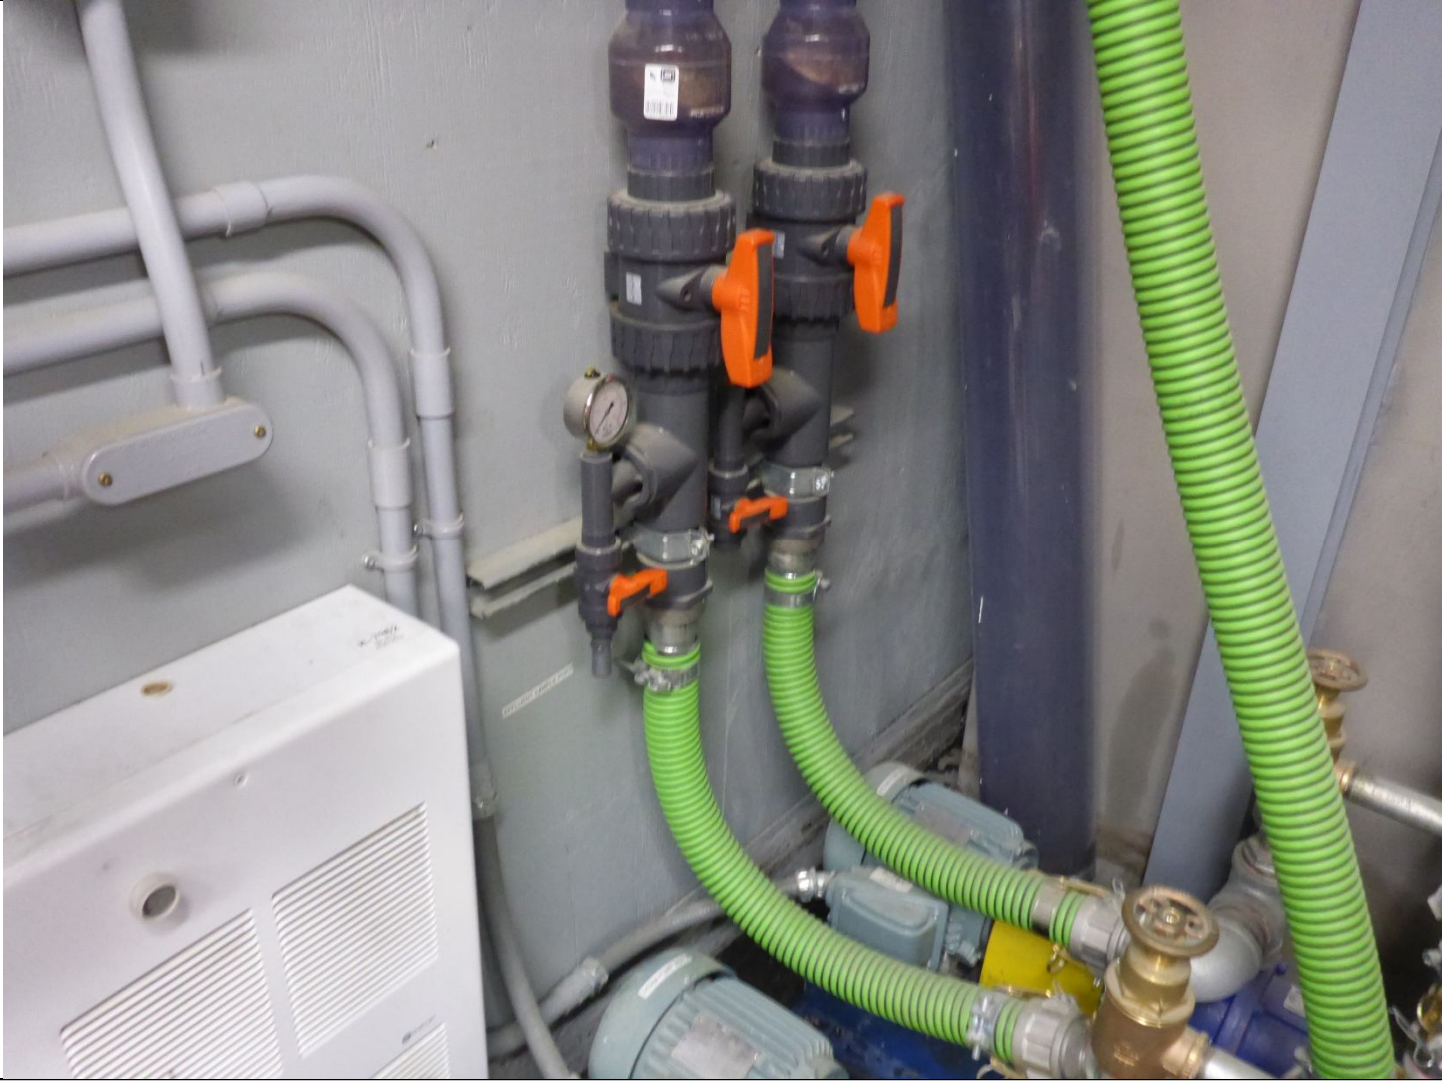
Date:	Authorization Number:	Camera/Model:	Inspector
August 29 th , 2018	2BB-MEA1828	Panasonic Lumix DMC-TS5	WRO Morton
Photo No.	Lat/Long (DD.MM.SS.SS, NAD83)		
Photo 7

Description:
MEA-2 discharge sampling location.

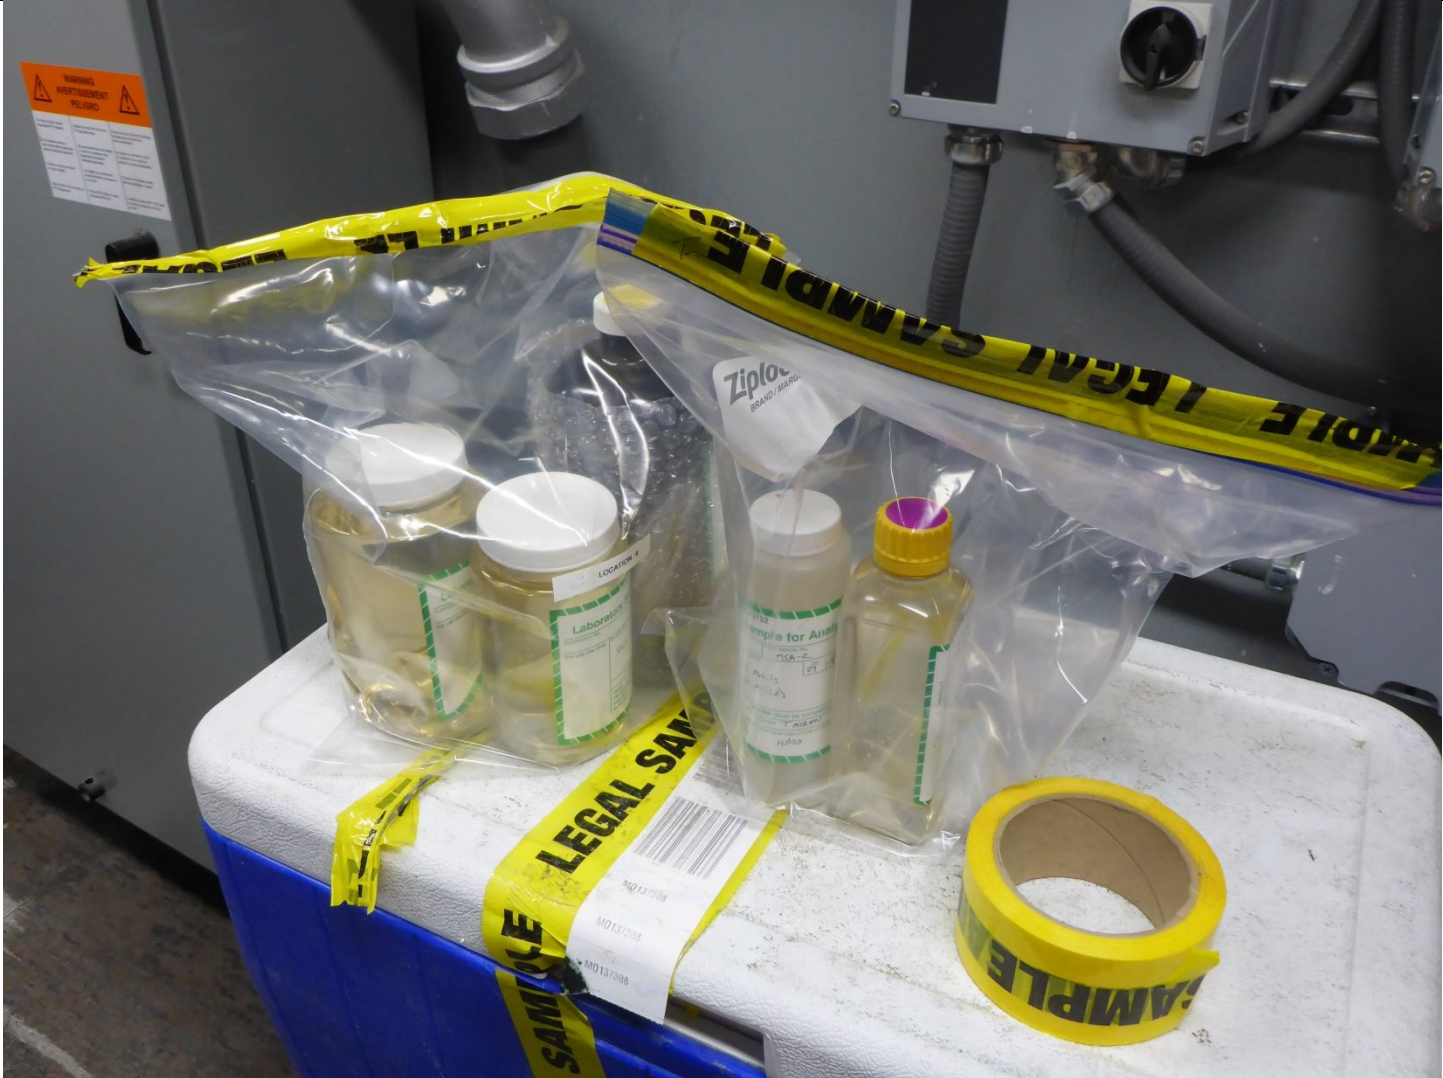
Date:	Authorization Number:	Camera/Model:	Inspector
August 29 th , 2018	2BB-MEA1828	Panasonic Lumix DMC-TS5	WRO Morton
Photo No.	Lat/Long (DD.MM.SS.SS, NAD83)		
Photo 8

Description:
MEA-2 samples prepared for shipping.
