**WATER LICENCE INSPECTION FORM**☒ Original
☐ Follow-Up Report

Licensee	Licensee Representative
Agnico Eagle Mines Ltd.	David Frenette
Licence No. / Expiry	Purpose
2BB-MEA1828/ March 6 th , 2028	Advanced Exploration
Land Authorization No. / Expiry	Project Name
N2016C0003 March 23 rd , 2023	Meadowbank Advanced Exploration Project
Date of Inspection	Inspector
September 9 th , 2022	C. Wilson
Activities Inspected	
<input type="checkbox"/> Camp	<input checked="" type="checkbox"/> Drilling
<input type="checkbox"/> Roads/Hauling	<input type="checkbox"/> Other:
<input type="checkbox"/> Mining	<input type="checkbox"/> Construction
<input type="checkbox"/> Other:	<input type="checkbox"/> Reclamation
	<input type="checkbox"/> Fuel Storage

An inspection of Agnico Eagle Mines Ltd.'s ('Licensee'), Meadowbank Advanced Exploration Project was completed by Crown-Indigenous Relations and Northern Affairs Canada's, Resource Management Officer, Christine Wilson ('Inspector'). The inspection was conducted to ensure compliance with applicable terms and conditions of water licence ('licence') no. 2BB-MEA1828.

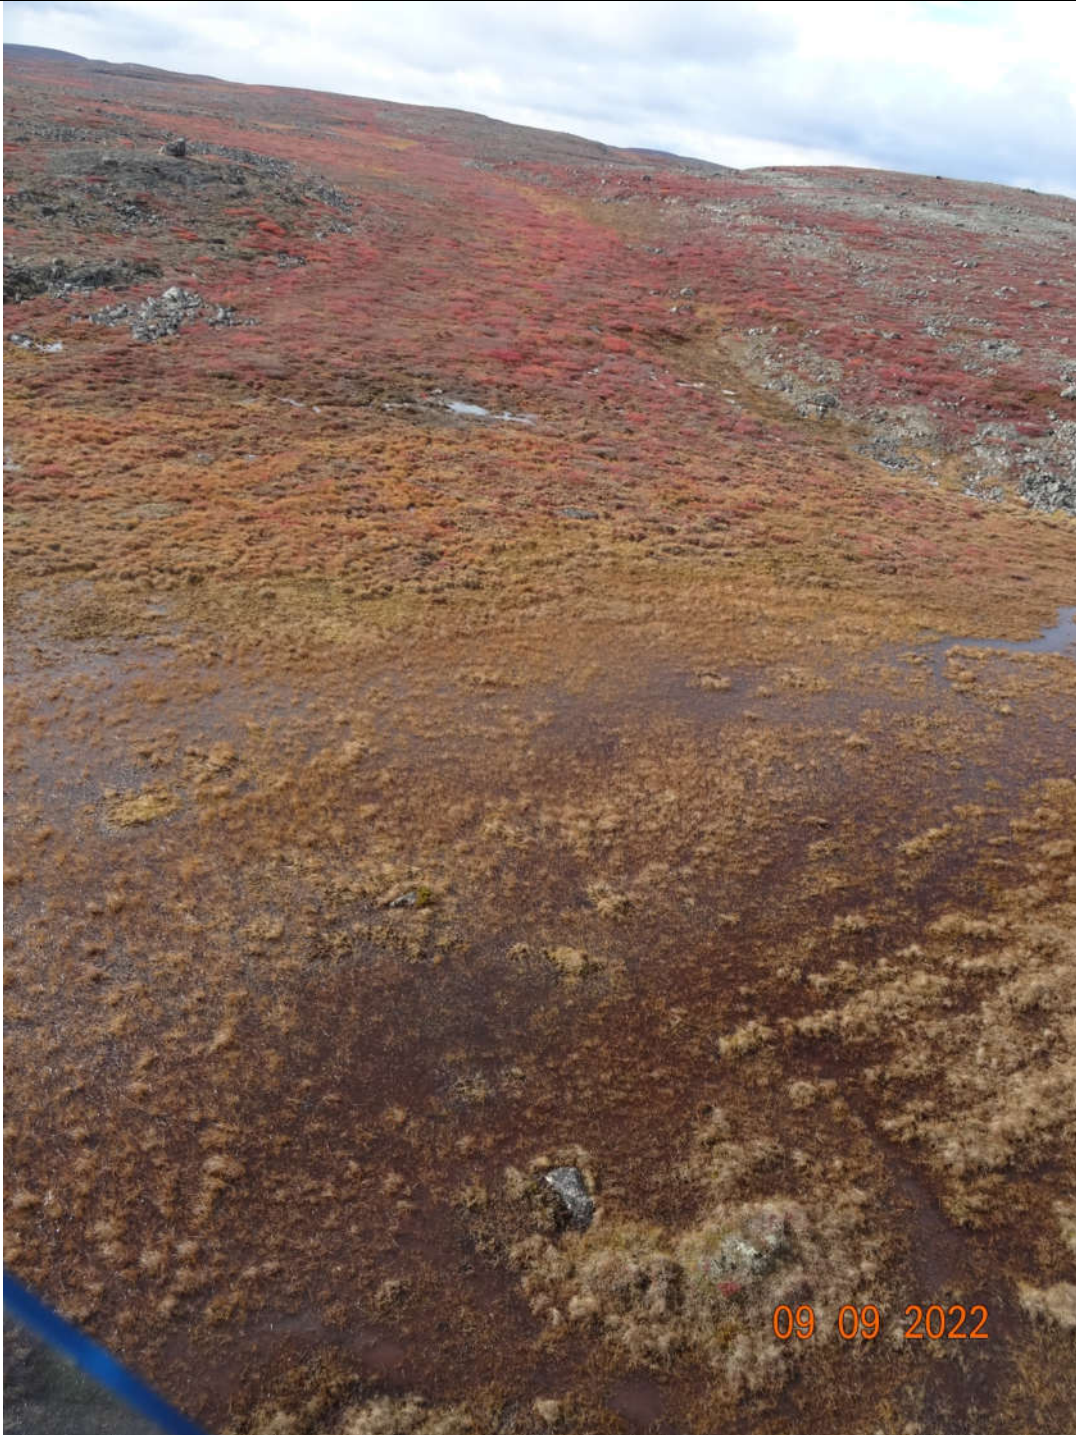
Date:	Authorization Number:	Camera/Model:	Inspector
September 9th, 2022	2BB-MEA1828	Sony DSC-HX50V Cyber shot	C. Wilson
Photo No.	Lat/Long (DD.MM.SS.SS, NAD83)		
Photo 1	N65° 6' 5.93", W96° 20' 23.45"

Location Name	Land	Notes
7001-21-042 Hole	Crown	No concerns, collar cut off at ground (photo 2).
7001-21-042 Sump	Crown	Well placed, no concerns.
7001-21-052 Hole	Crown	No concerns at the hole but the location has a lot of pooling surface water.
7001-22-066 Hole	Crown	No concerns at the hole (photo 1).
7001-21-023 Hole	Crown	No concerns in area, exact location was never determined (photo 4).
7001-22-072 Hole	IOL	No concerns at hole (photo 5).

Description:
The vicinity of drill hole 7001-21-066 and surface water accumulation from recent rainfall.

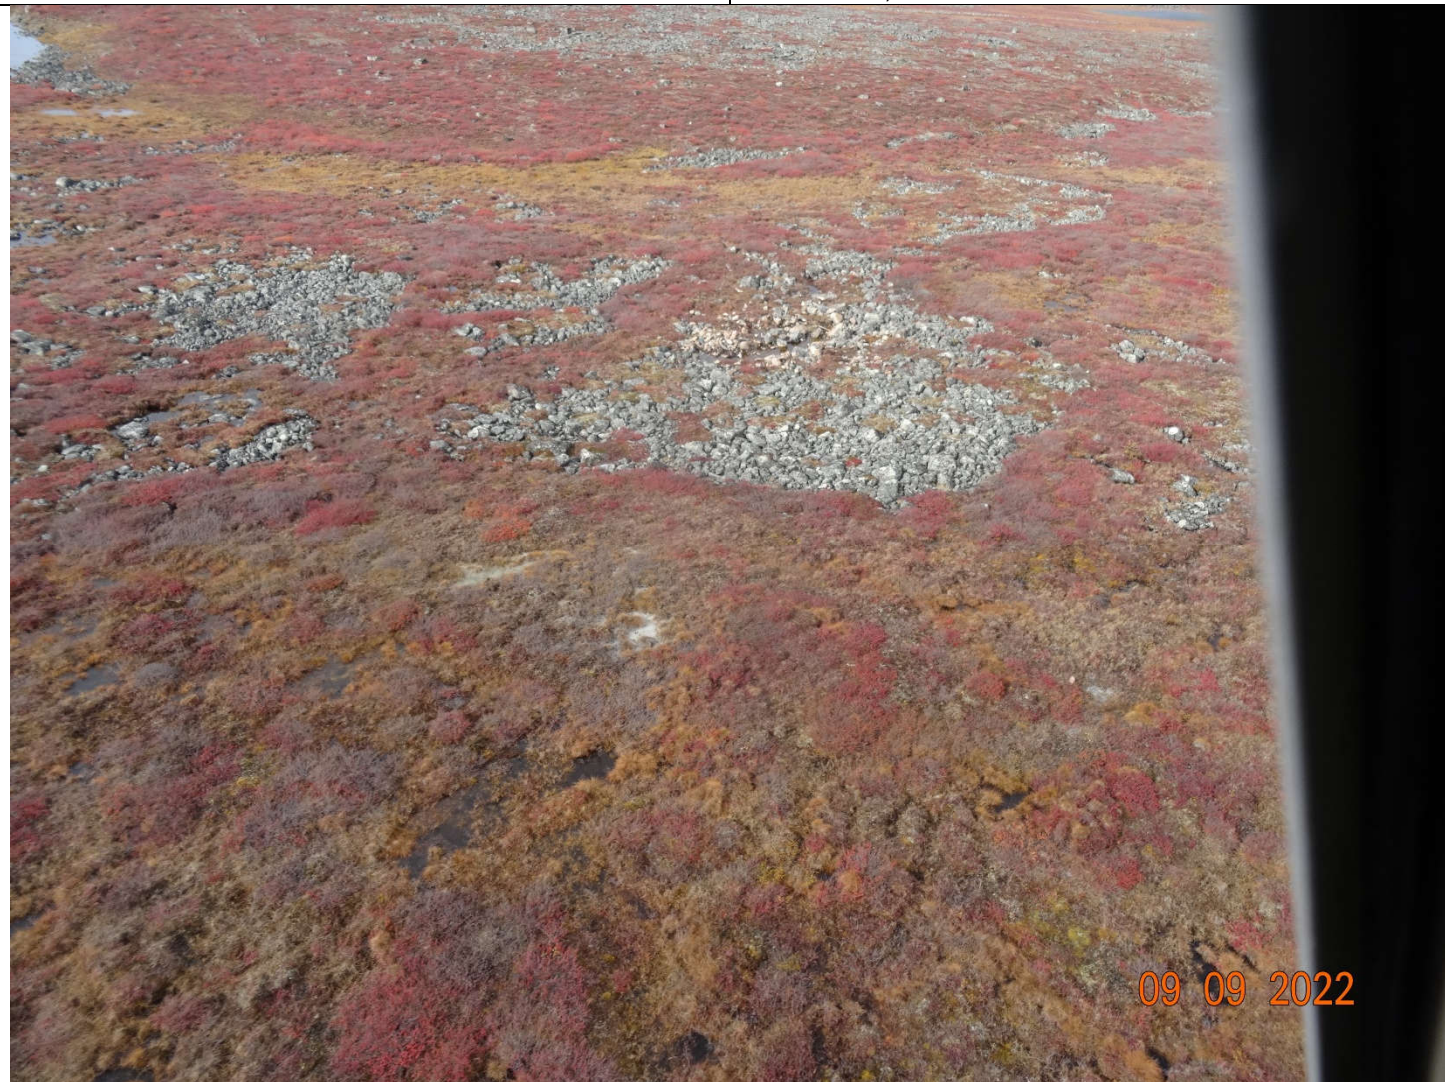
Photo 2

Drill Hole 7001-21-042

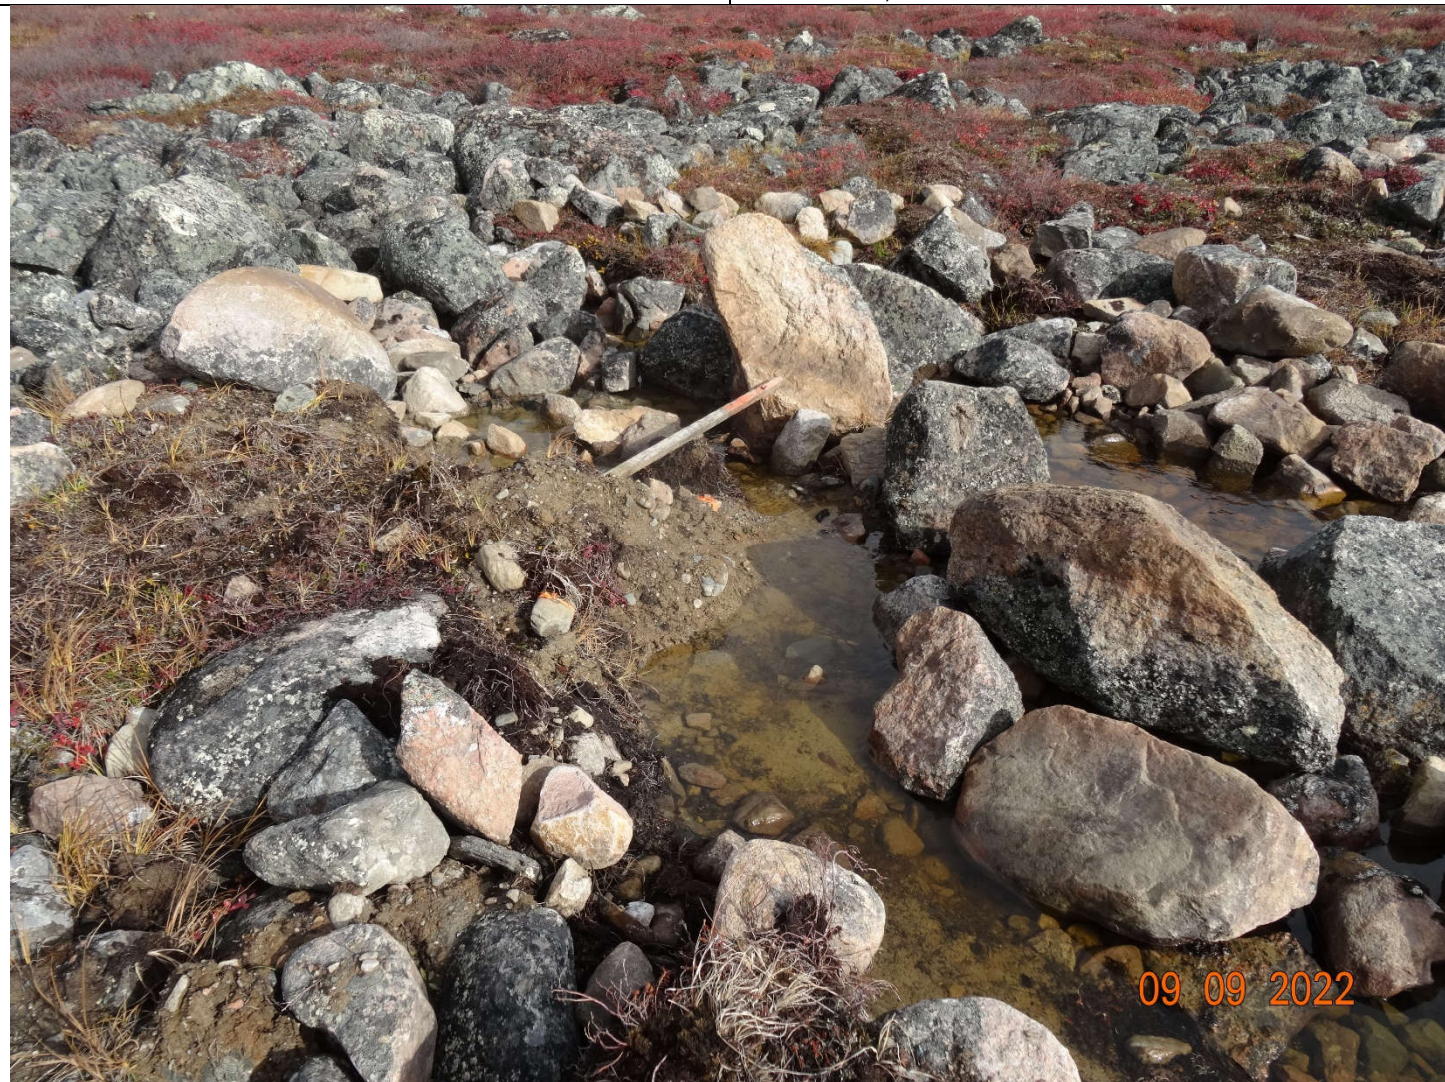
Photo 3

2. 100L of diesel was spilled to the ground in a rocky location at approximately N65° 6' 12.78", W96° 17' 23.89". Spill no. 21-388 was assigned to the file. No concerns noted relating to the spill or the remediation (photo 3). The file is recommended for closure-remediated. A spill report and follow-up report is available for review as required by Part H item 5(b) and (c).

Spill report number 21-388 approximate location. No visible sheen or smell of hydrocarbon.

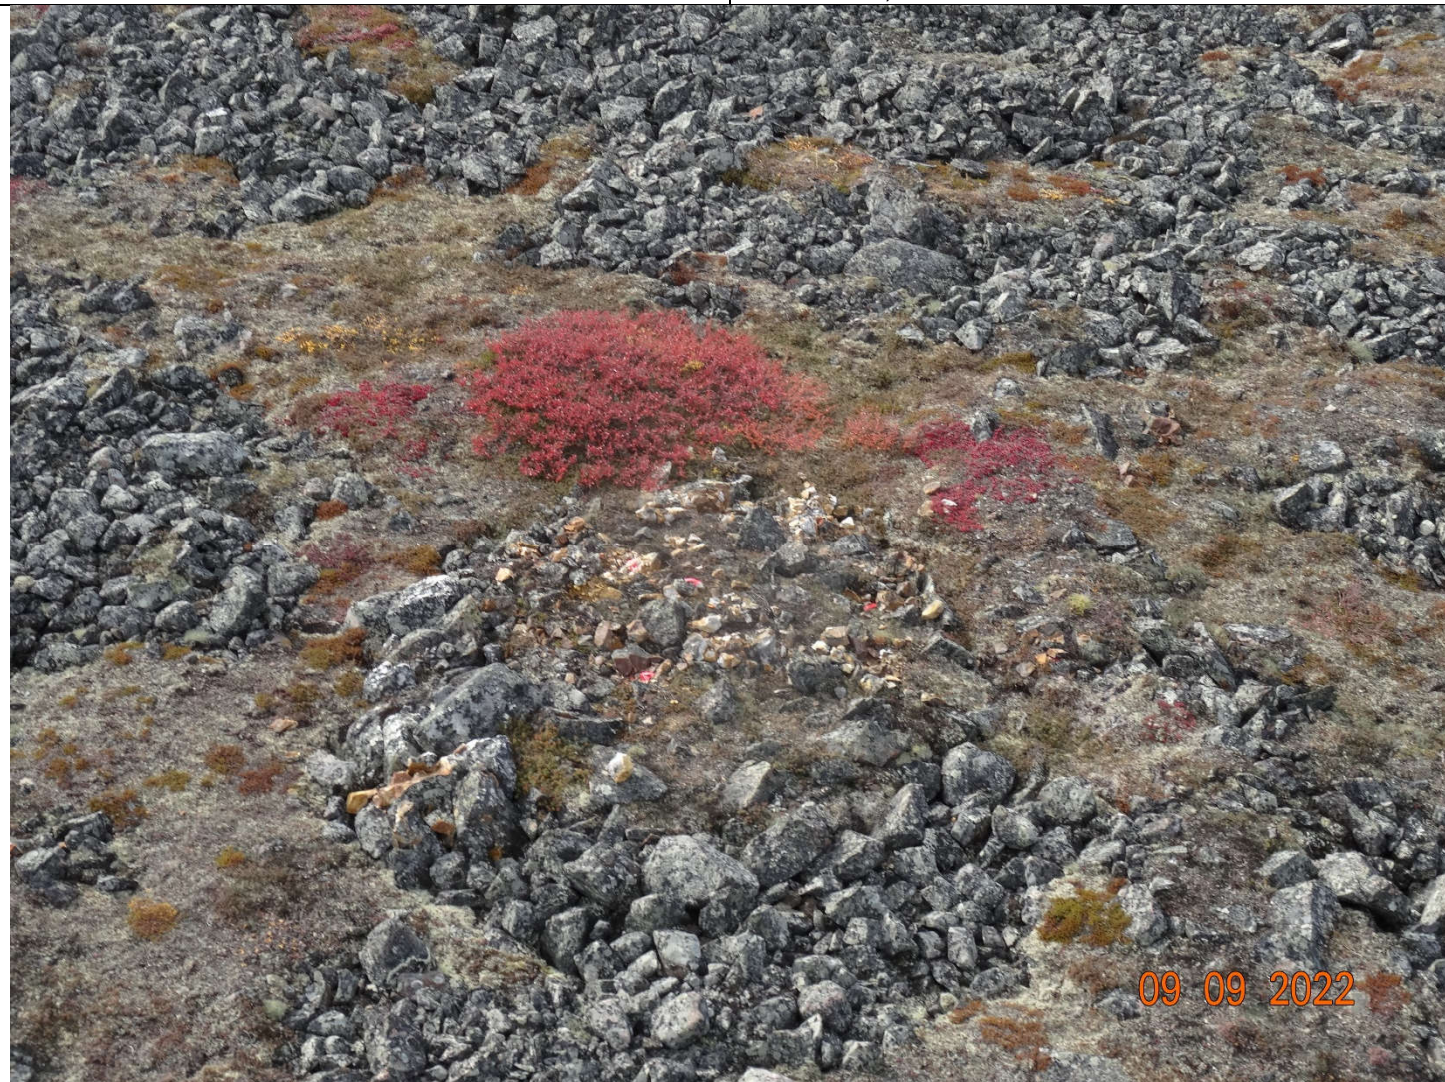
Photo 4

Drill hole 7001-21-023

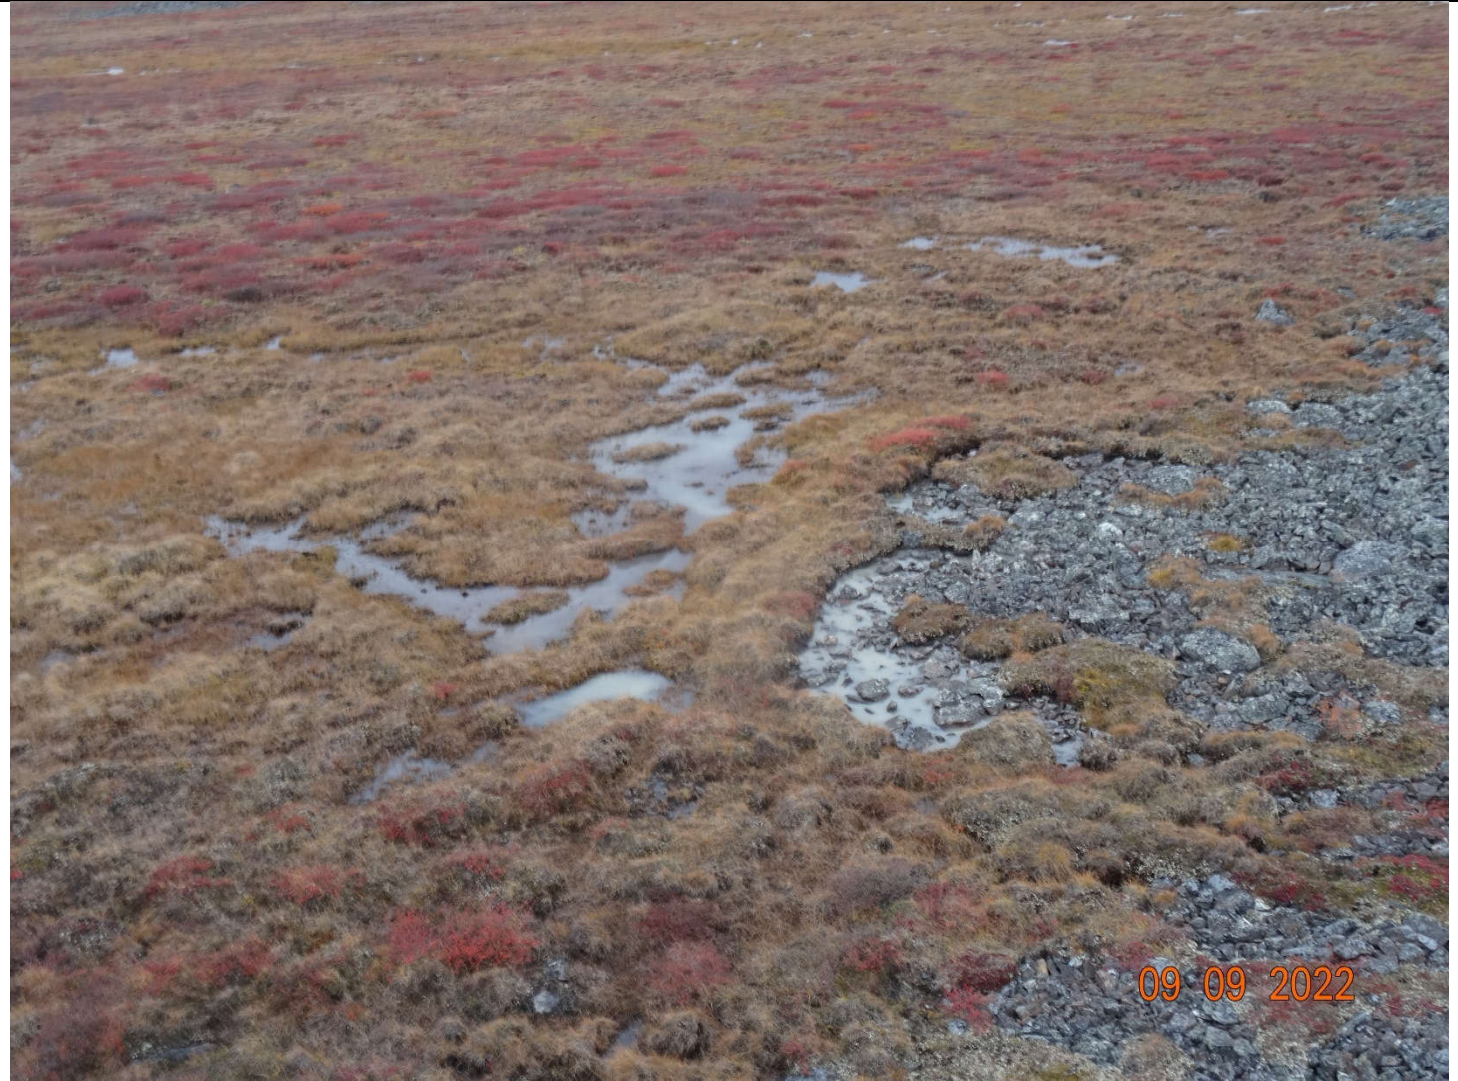
Photo 5

Drill hole 7001-21-072
