# CONSTRUCTION REPORT

## CULVERTS KM 64+425

WSP REF.: 141-21815-03

DATE : 4 DECEMBER 2017

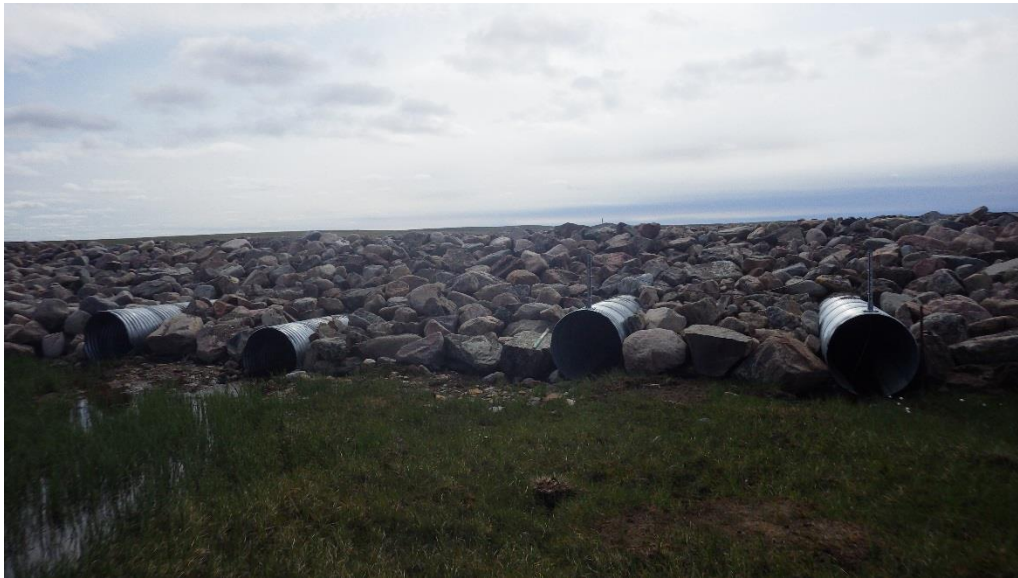
As shown in the following picture, culverts are not placed equally as specified in the plans. The location of culverts was confirmed on site by the engineer. The pipes were installed according to the position of the water trickling.

The following picture shows the four culverts after being installed.

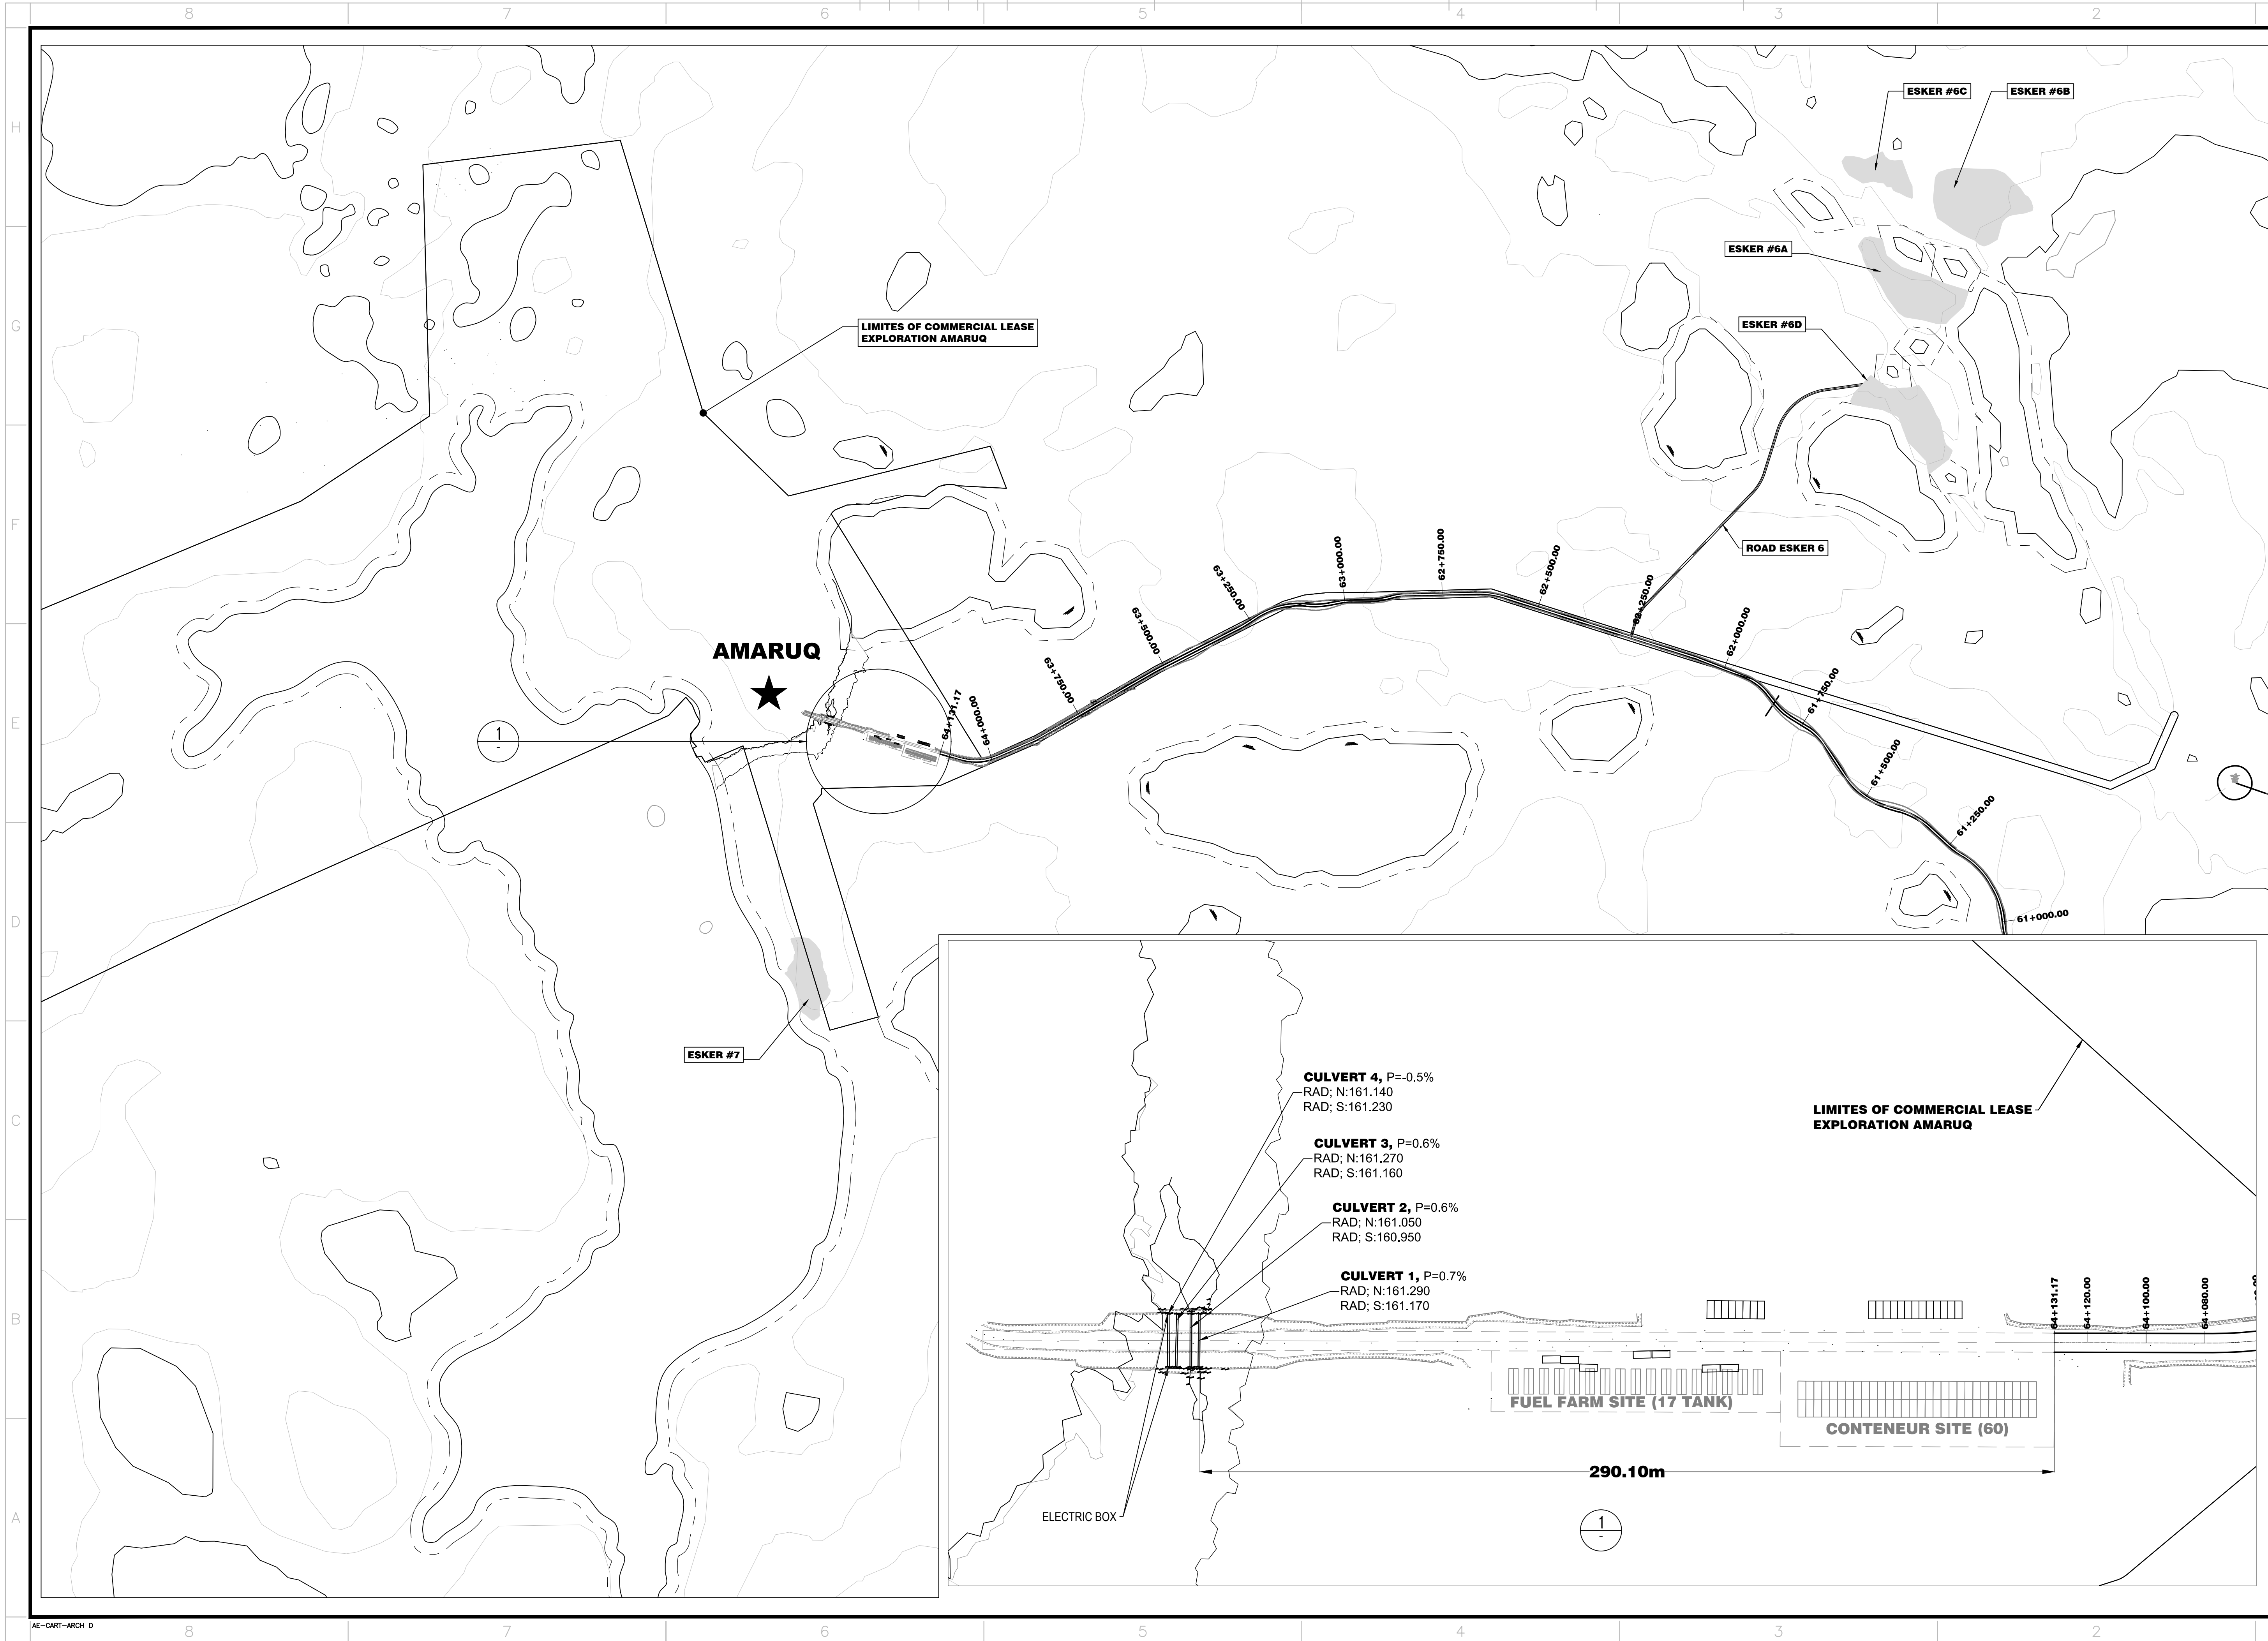
AS BUILT PLAN

The as-built plan shows that the slope of culvert 4 is in the opposite direction. This could reduce the efficiency by 15%. The culvert will work at 85% of its output. After the verification of the hydraulic study, the culvert is used as an overflow pipe. At 85% of its output, there will be no problem of draining.

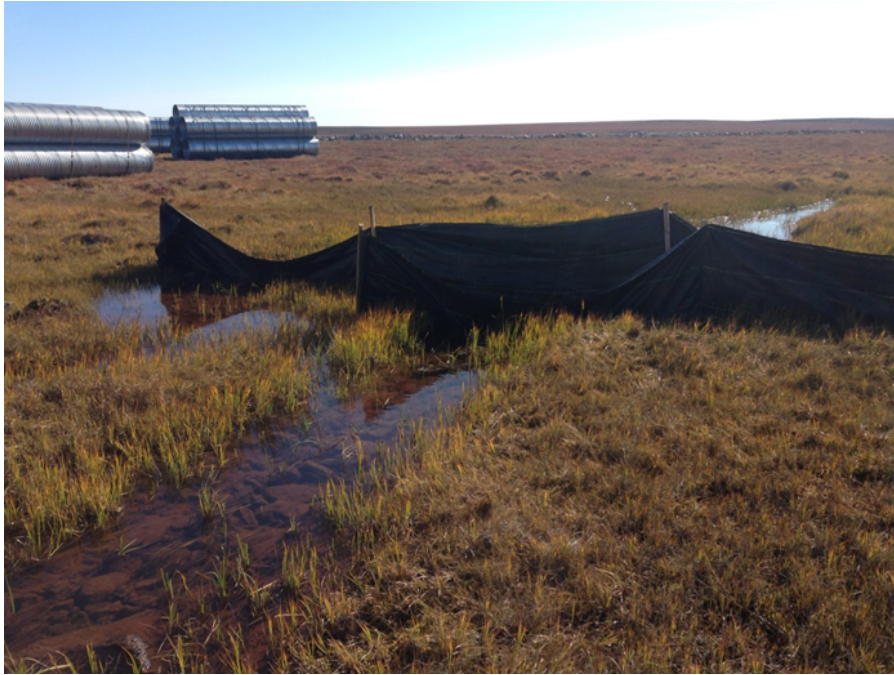
**PHOTO 1** Installation of silt fence before starting digging in the stream

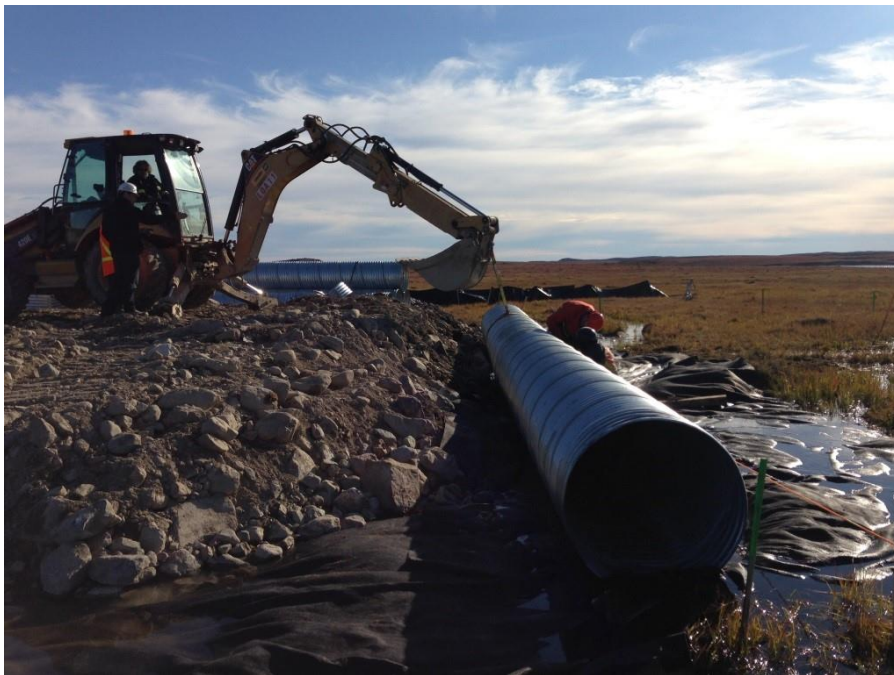
**PHOTO 2** Installation of the first culvert

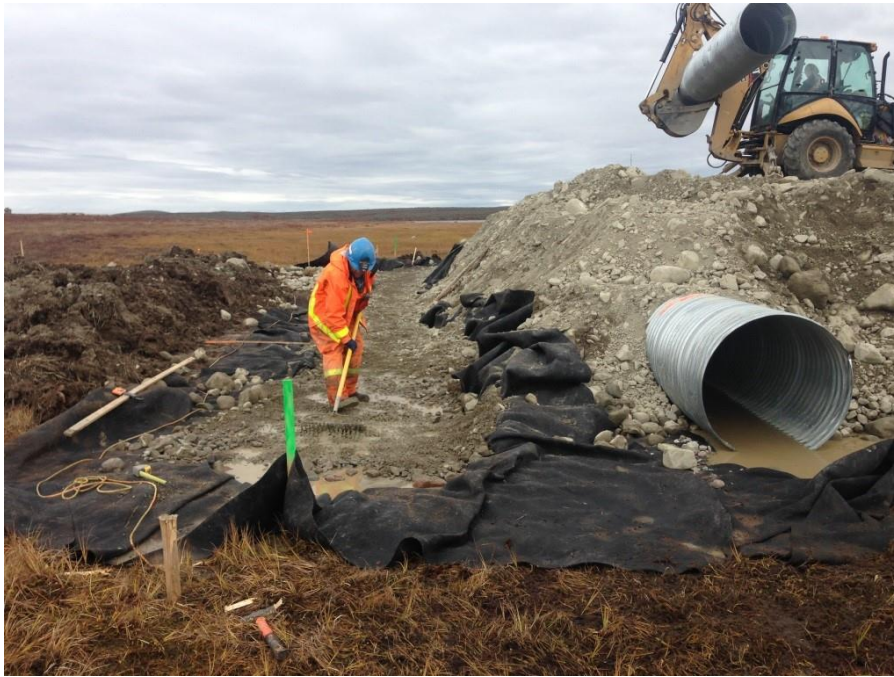
However, some of these changes don't respect the specification on plans. The culverts were installed on a thin layer of bedding material, but the contractor expanded a geotextile under the pipes to replace the material needed.

**PHOTO 3** Bedding material

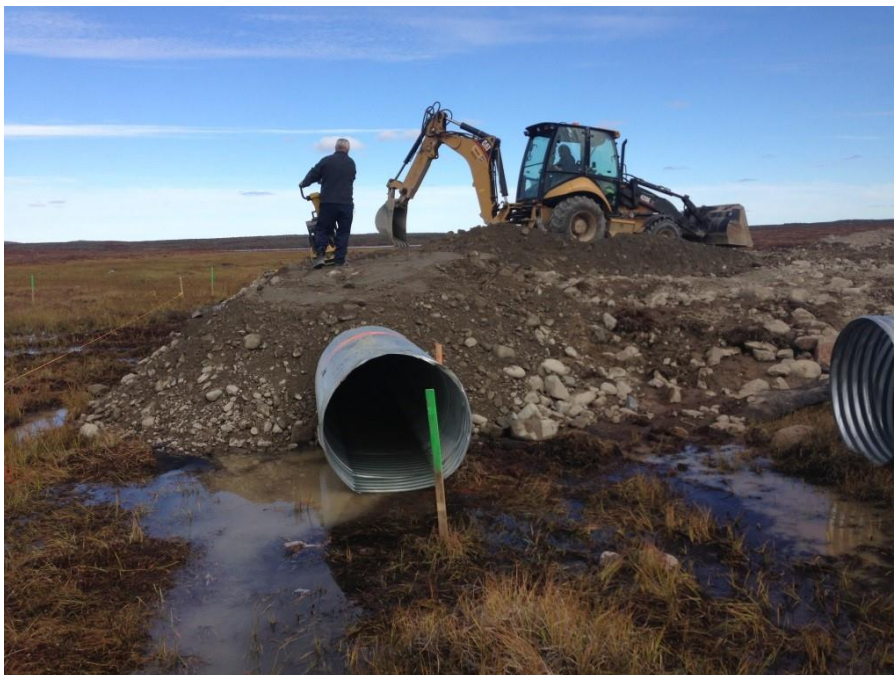
**PHOTO 4** Backfilling and compacting
