**AMARUQ GOLD PROJECT**

**Spill during Fuel Transfer**

**Incident August 6, 2015**

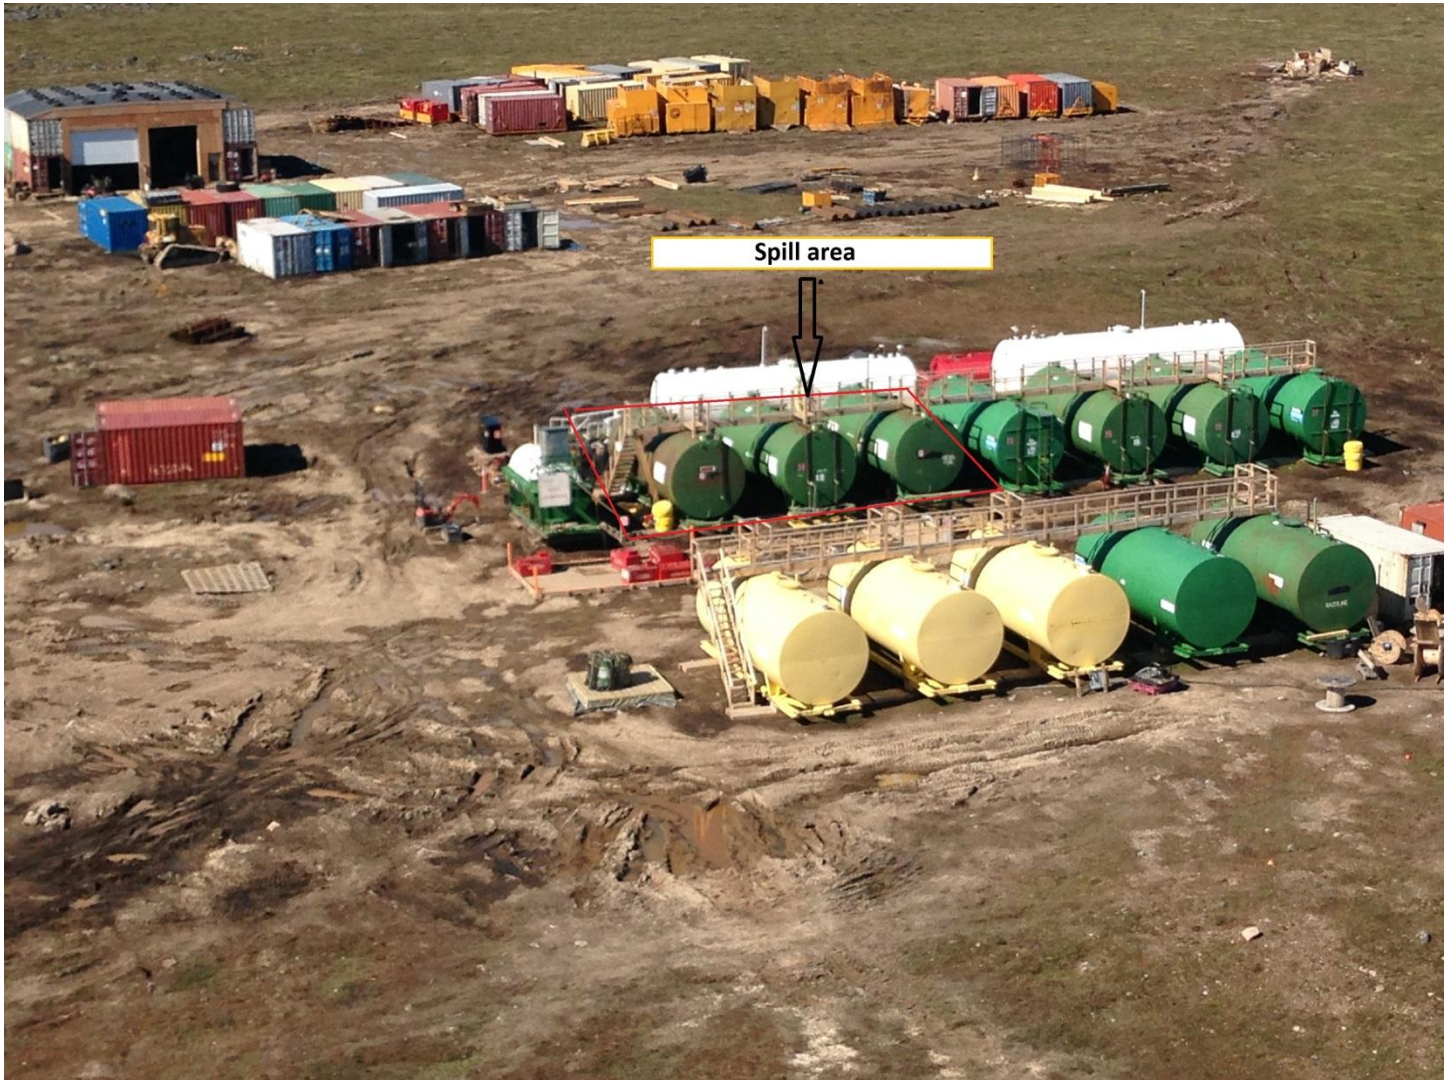
## Location of the spill area

On August 6, 2015, at 5:30 pm, a diesel fuel spill occurred on the fuel tank farm area. The spill occurred during a fuel transfer between two tanks when a hose disconnected. Approximately 1500 liters of diesel fuel spilled on the ground. The area for the fuel transfer where the spill occurred, has a preventive barrier trench in the middle of the fuel farm. The nearest body of water is located 140 meters from the spill and no connection risk was present. The spill was reported on August 7.

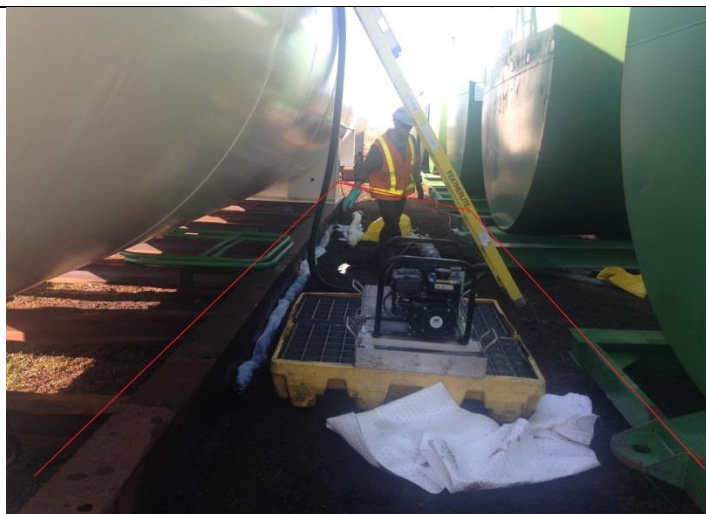
1. Spill area at 5:40 pm, August 6

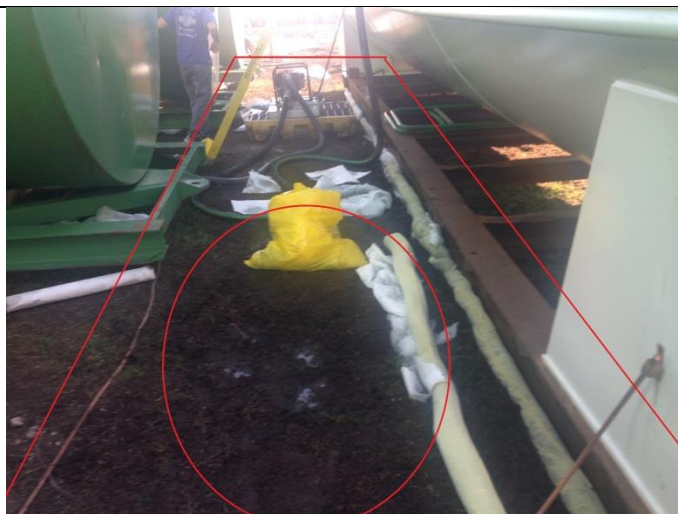
2. Main spill area East direction

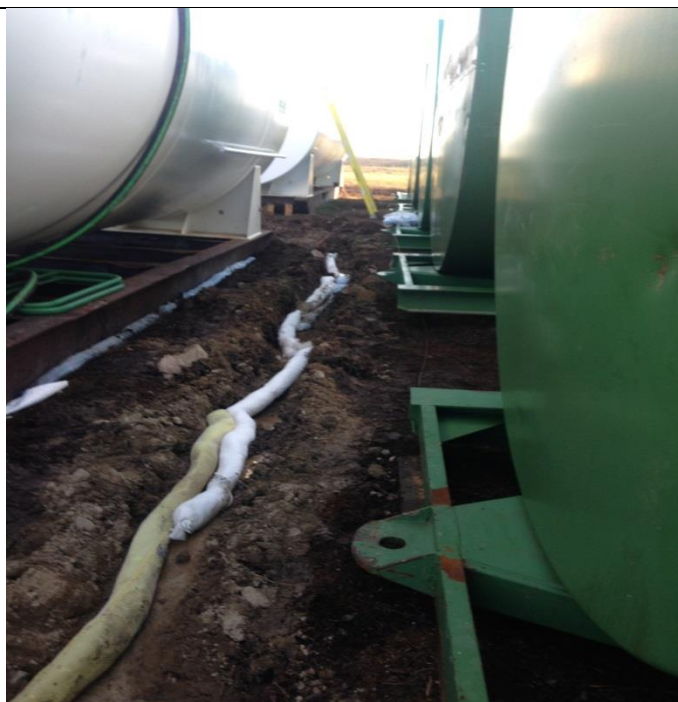
4. A Trench was dug on the night shift

A trench (10m x 1m) was dug in the middle of the spill area and about 1m<sup>3</sup> of contaminated soil was disposed of in quatrex bags. Absorbent was installed in the trench to absorb as much free fuel as possible.

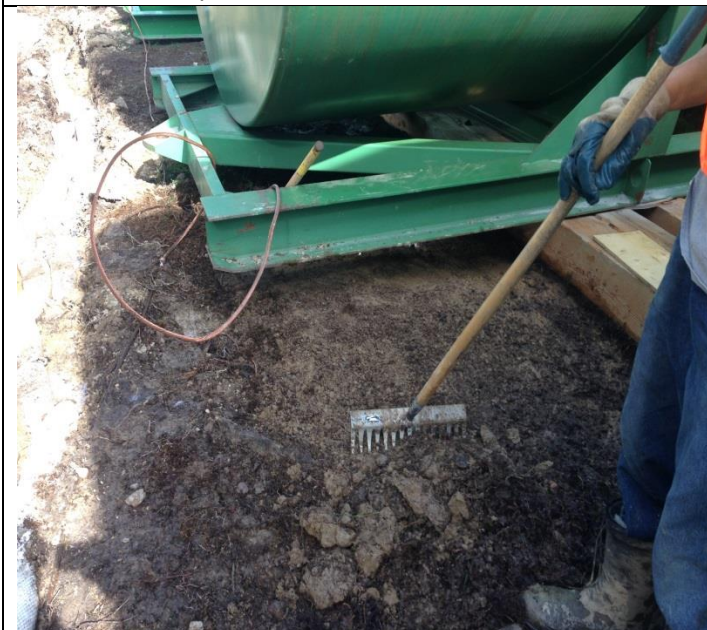
5. Scraping and shoveling the contaminated tundra/soil.

A team continued to dig using hand shovels to recover the contaminated soil and about 6m<sup>3</sup> was excavated. Another trench was dug in front of the fuel tanks to catch any fuel resurgence and ensure the containment of the fuel within a defined area. All the absorbent pads and booms used during this operation were placed in quatrex bags and drums. The contaminated soils were also placed in quatrex bags.

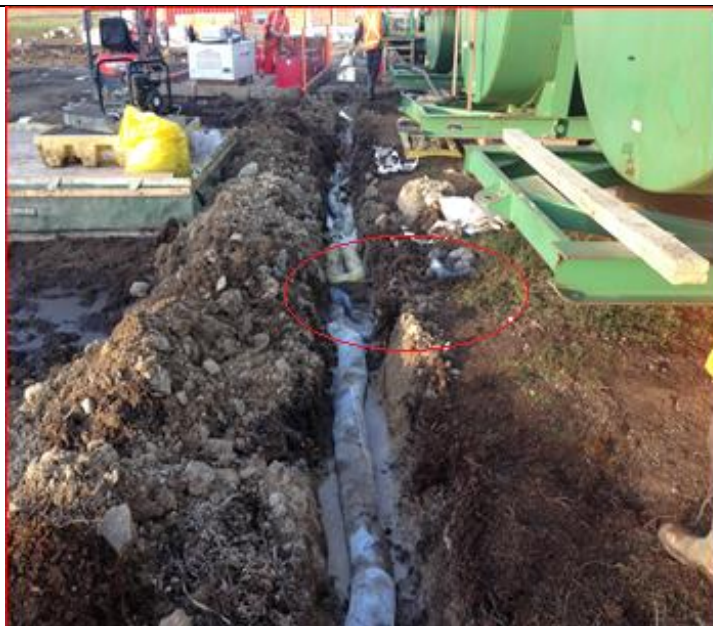
6. Trench to stop plume

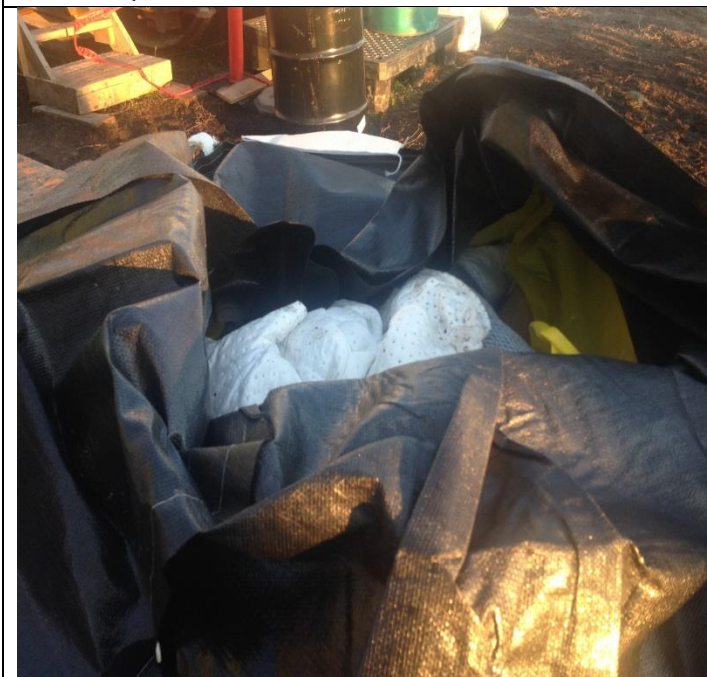
7. Quatrex and drums full of used absorbent

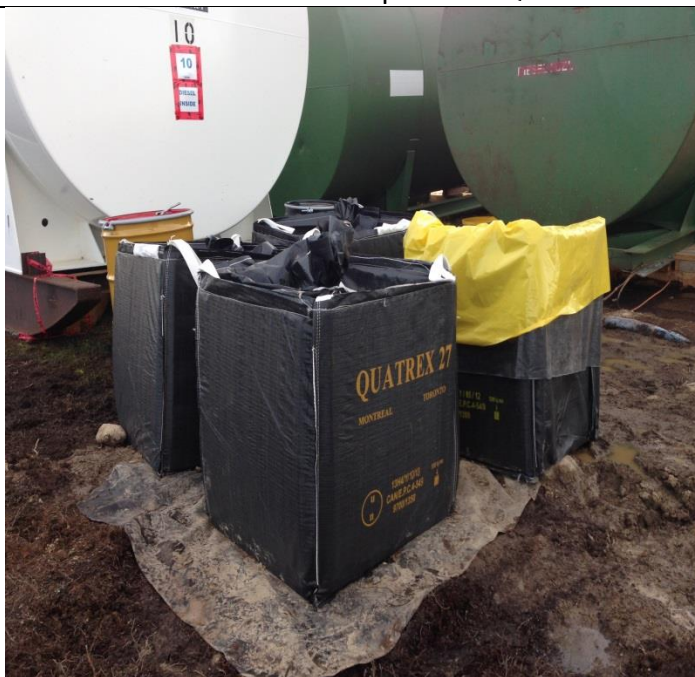
8. Soil contaminated disposed in Quatrex

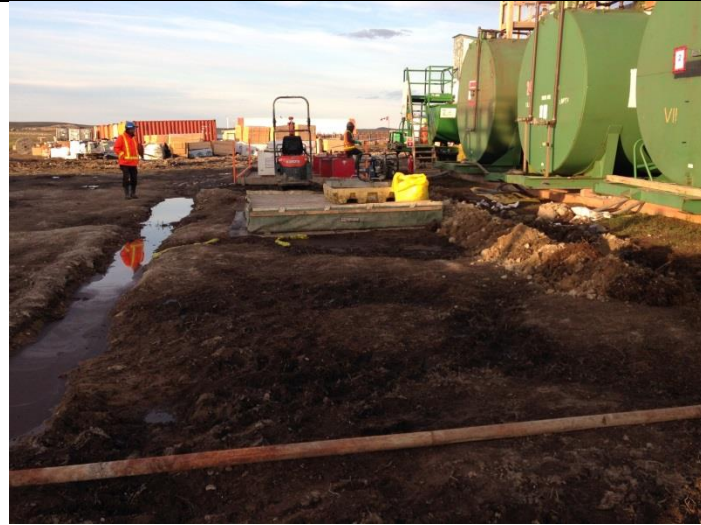
9. The fuel never migrated up to the center interception trench

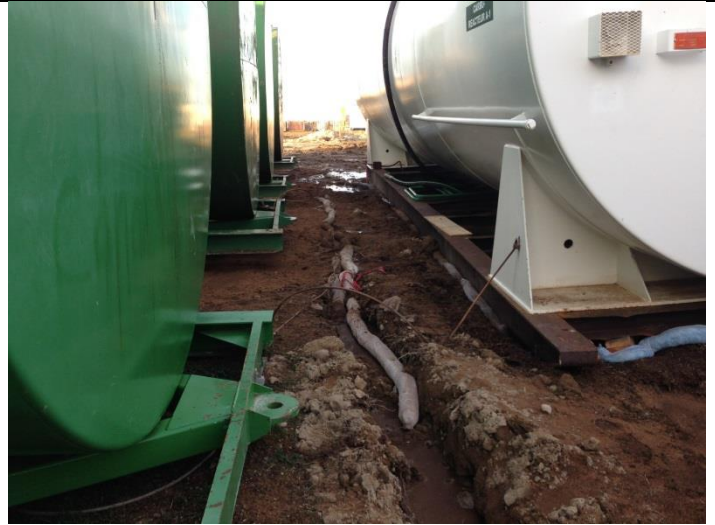
10. Peat moss was disposed all over the excavated zone to absorb free fuel if present.
